ACCELERATED DISTRIBUTION DEMONSTRATION SYSTEM

SUBJECT: Forwards description of difficulties encountered & summary of investigations re RCS loop weld insp program.

Donald C. Cook Nuclear Plant Unit 2
Docket No. 50-316
License No. DPR-74
UNIT 2 RCS LOOP WELD INSPECTION PROGRAM

UNIT 2 RCS LOOP WELD INSPECTION PROGRAM

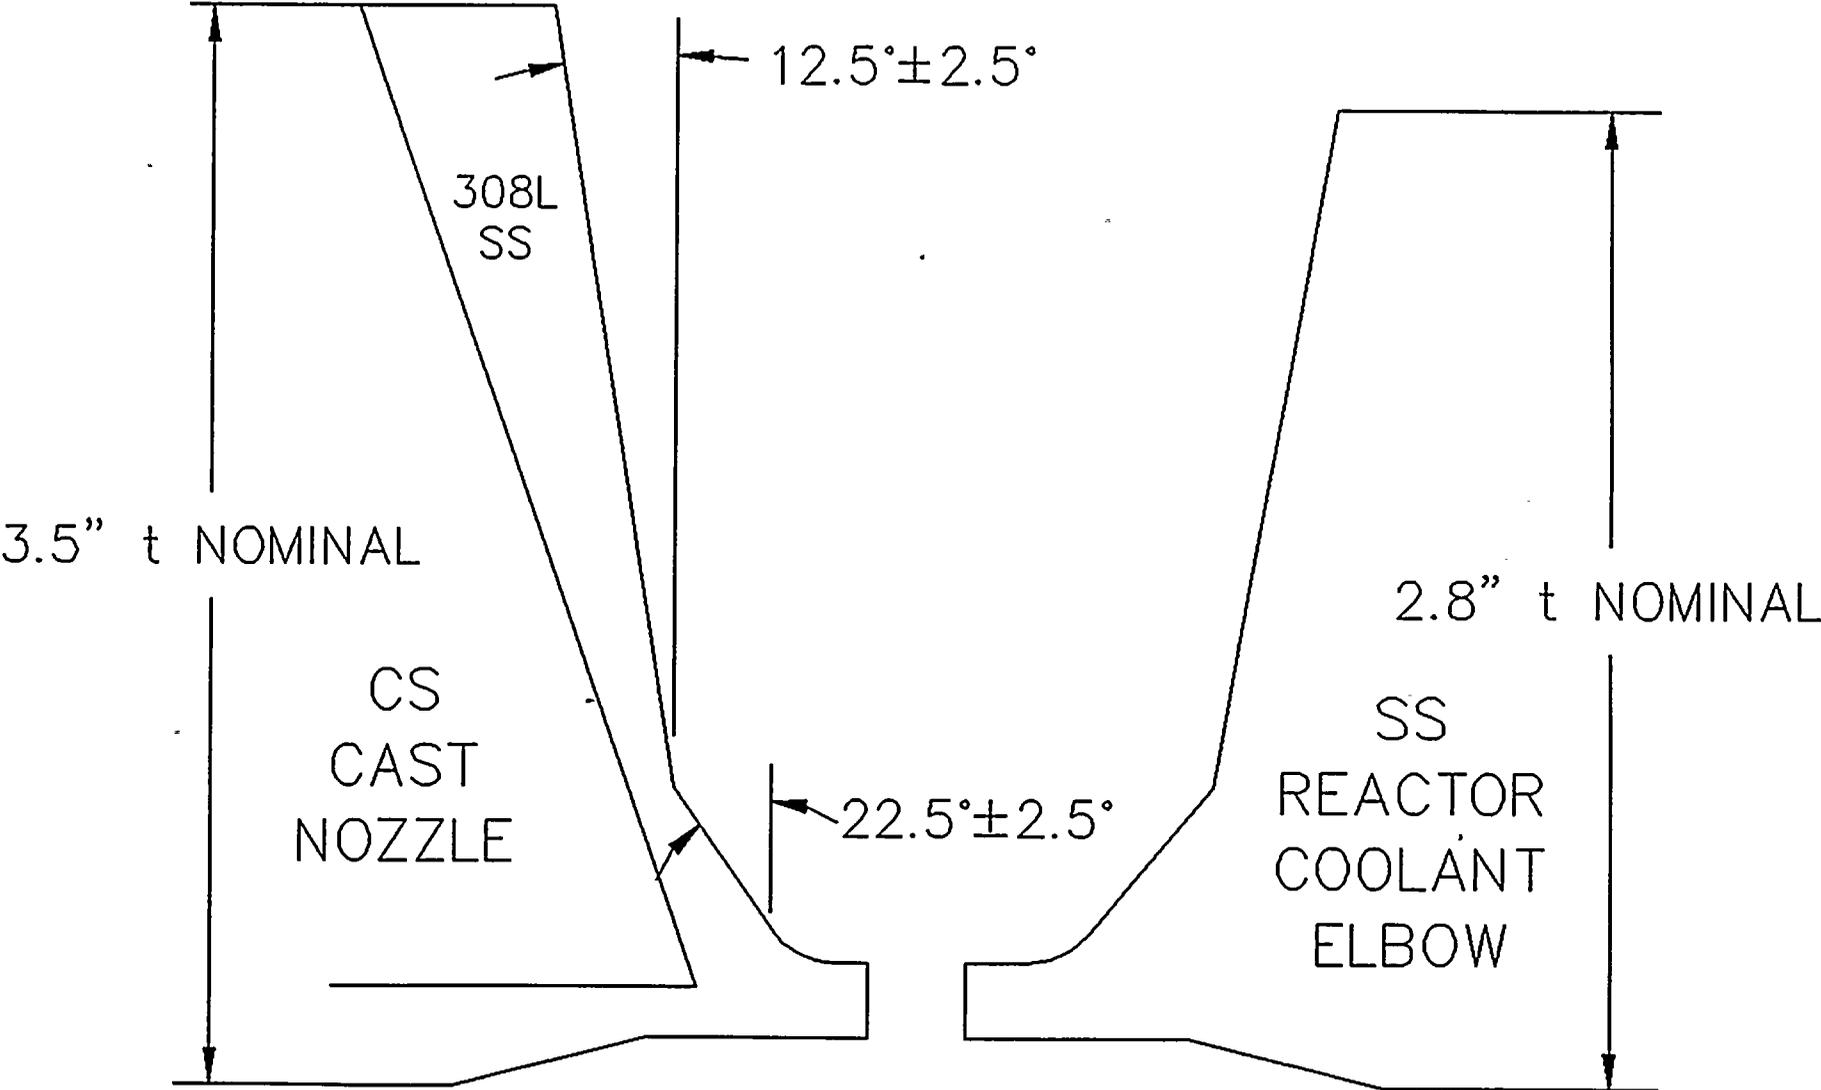
FIGURE 1

The steam generator nozzle to reactor coolant elbow weld joint is a compound bevel, single-U groove weld oriented in the 6G position (Figure 1). The nozzle is cast carbon steel (SA-216 Grade WCC) on which 308L stainless steel buttering is applied with a flux-cored arc welding process over an initial underlay of 309L. The root passes of the nozzle to elbow weld are 308 stainless steel manual gas tungsten arc welds, and the fill is 308 deposited with an automatic gas tungsten arc welding machine. The difficulty encountered was in obtaining complete fusion along the 308L buttering interface when welding progressed above the change in joint bevel. Sporadic weld pool behavior and poor wetting were observed when the gas tungsten arc weld was made over the flux core deposited buttering. Visually observable cracking occurred on the nozzle side of the joint due to poor fusion at the nozzle caused by the tight joint access, poor wetting, and the force of gravity. The poor fusion at the nozzle created a notch at the interface between the weld metal and nozzle buttering from which a crack was propagating as a result of shrinkage stresses in the deposited layer.

In addition to in-process informational radiographs and final code acceptance radiographs, all Unit 2 steam generator nozzle to reactor coolant elbow welds have been radiographed at an angle to the weld joint. These radiographs were oriented along the 12.5° joint prep angle shown in Figure 1. This was done to provide maximum detectability of any planar indications on the nozzle side of the joint.

SG NOZZLE TO REACTOR COOLANT ELBOW JOINT DETAIL

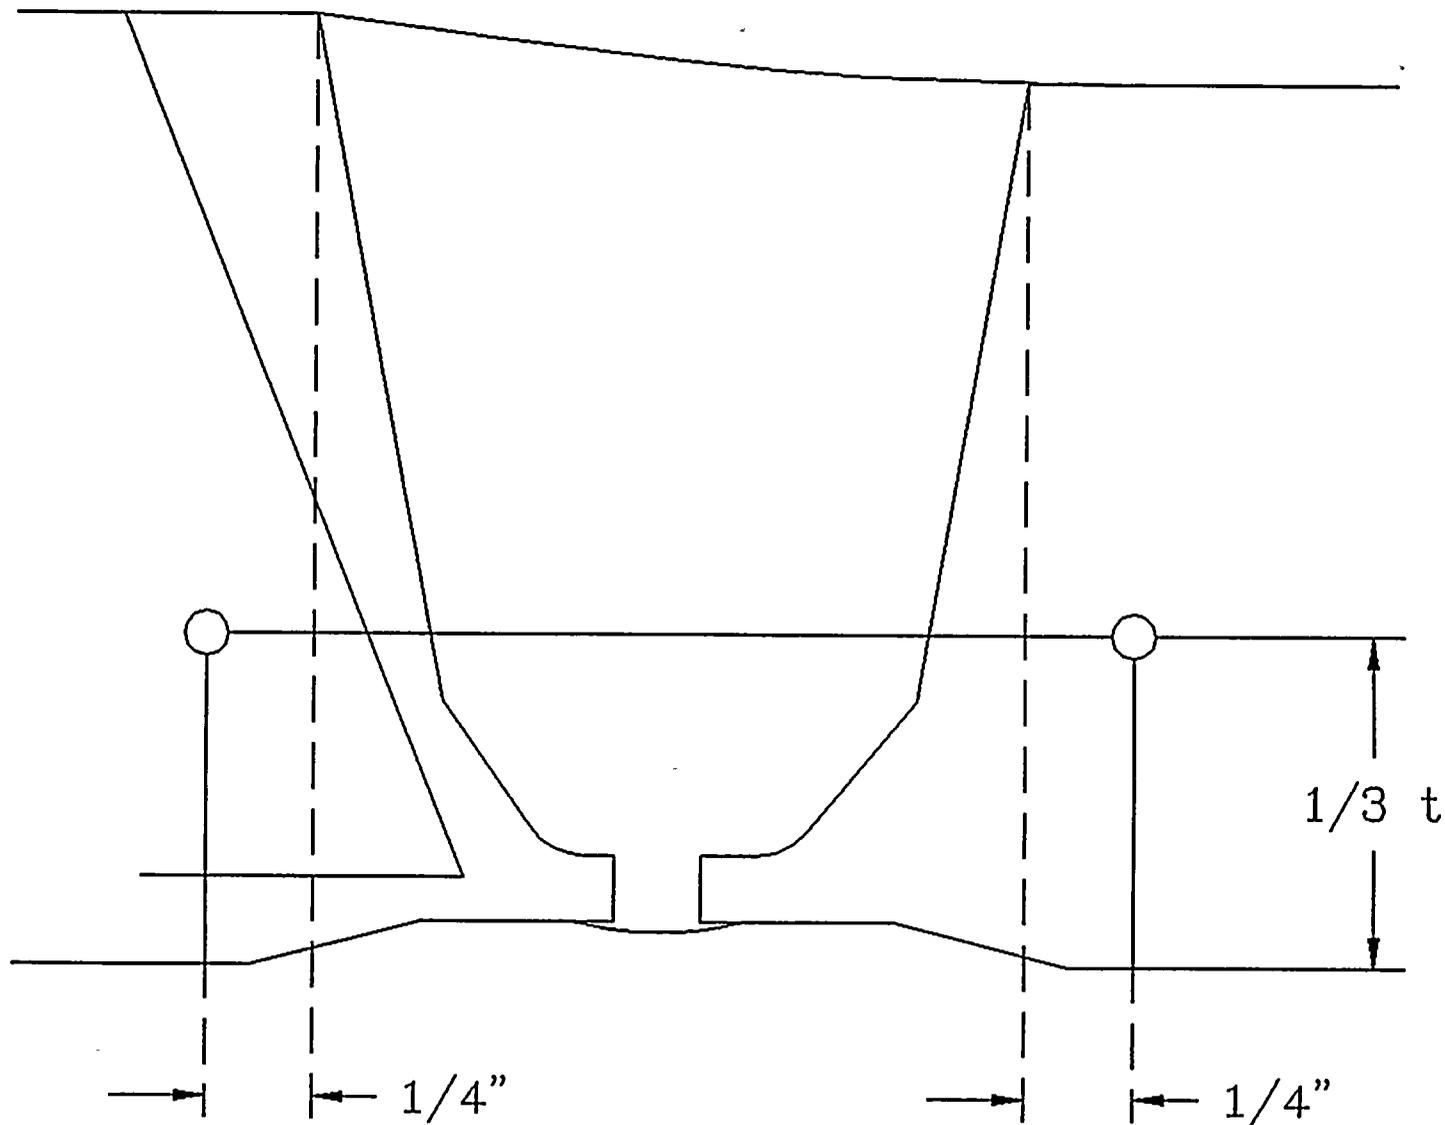
FIGURE 4

Figure 4 shows the code required ultrasonic examination volume for preservice and inservice examinations of the steam generator nozzle to reactor coolant elbow welds. As discussed previously, all indications on these welds occurred in the middle 1/3 of the thickness, outside of the code required examination volume. As an additional level of assurance, we will perform essentially full volume ultrasonic examination of these welds during the Unit 2 preservice and inservice inspections. This expanded ultrasonic examination volume will cover the area of interest for inservice monitoring of the integrity of these welds.

ASME SECTION XI ULTRASONIC EXAMINATION VOLUME
SG NOZZLE TO REACTOR COOLANT ELBOW
