SUBJECT: LER 89-002-00: on 890116, non-svc induced deformation of ECCS suction line seismic restraint.

LICENSEE EVENT REPORT (LER)

FACILITY NAME (1) D. C. Cook Nuclear Plant - Unit 2	DOCKET NUMBER (2) 0 5 0 0 0 3 1 1 6 1	PAGE (3) 1 OF 0 5
--	--	----------------------

TITLE (4) Non-Service Induced Deformation of Emergency Core Cooling System Suction Line Seismic Restraint

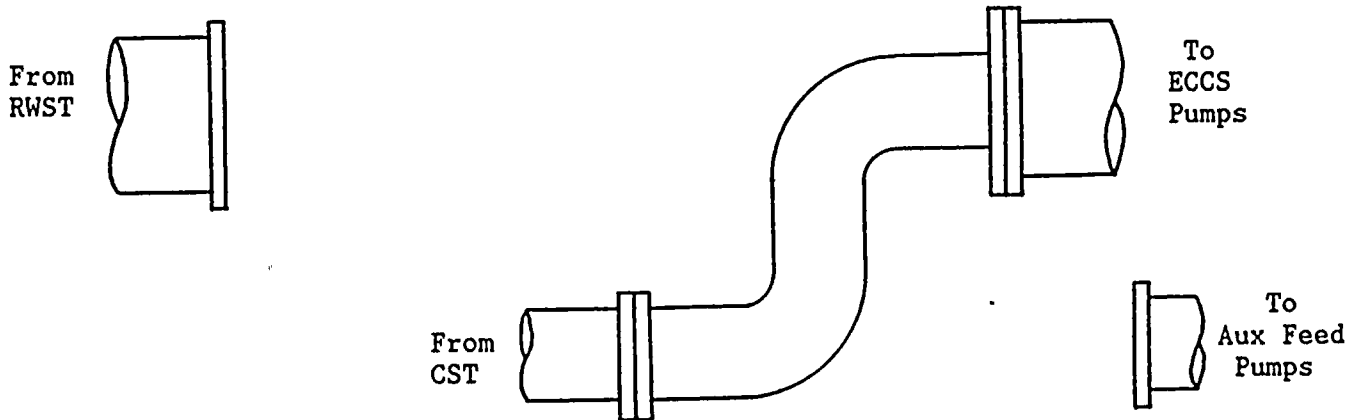
PIPING CONFIGURATION USED FOR FLUSHING AND TESTING

A review of modifications made to the system identified one potential cause for the deformation of 2GSI-L102. In order to facilitate flushing and other startup activities prior to initial unit startup a modification was made to the system, (changing this section of piping to a spool piece) to allow this portion of piping to be removed and replaced with a "jumper" spool piece. The modification, performed in 1976, was completed with one minor change to the original design; ie, the subject restraint was moved to prevent interference with newly installed flanges. No other problems were noted. A Quality Control inspection report from August 1977 noted no problems with the restraint. The startup activities removed the modified pipe section and replaced it with a spool piece connecting the ECCS pump suction to the Condensate Storage Tank (CST) (see ATTACHMENT 1). Upon completion of the startup activities, the piping was restored. It is believed that the deformation of the restraint occurred during this evolution; however, no documentation of such deformation could be located. The corresponding restraint for Unit 1 was examined. There was no similar modification performed on Unit 1 and no deformation of the restraint was seen.

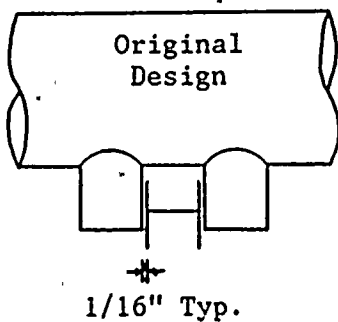
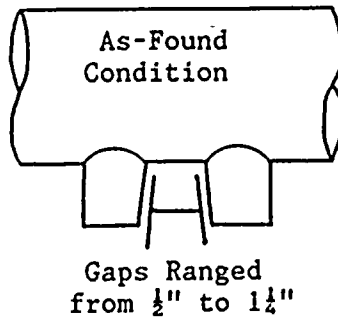
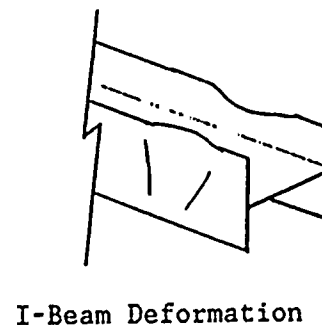
SUPPORT 2-GSI-L102 DETAIL

The deformation of the restraint was identified as deformation of the I-beam attached to the wall, along with deformation of two stanchions attached to the suction pipe (see ATTACHMENT 1). The deformation caused significant increases in the gap between the I-beam and the stanchions. Examination of the ECCS piping itself revealed no damage. The original seismic design required a one-sixteenth inch gap on each side. The gaps found from the deformation ranged from one-half to one and one-quarter inches. The design of the restraint is for seismic considerations and by definition is exempt from ISI visual examination per ASME Section XI. The restraint carries no load during normal plant operation in any plane. The purpose of the restraint is to limit horizontal movement of the suction line during a seismic event.

The investigation concluded that it is highly unlikely that the deformation of 2GSI-L102 was service induced as there have been no recorded unusual operating conditions, including a Design Basis Earthquake, which could have resulted in such significant deformation. The location of the restraint, on the suction side of the ECCS pumps, supports the likelihood that this type of deformation did not occur during service.

Due to the extent of the deformation of 2GSI-L102, it was not possible to return the restraint to its original design configuration. A revised design was developed to reinforce the restraint and reestablish the gap clearances specified by the original seismic design. A modification was initiated along with an ASME Section XI repair plan to repair the restraint. Repairs have been completed and the restraint visually inspected for final acceptance.
