SUBJECT: LER 89-017-00:on 891019,loss of turbine driven auxiliary
 feed pump flow retention.

FACILITY NAME (1) D. C. Cook Plant - Unit 2	DOCKET NUMBER (2) 0 5 0 0 0 3 1 6	PAGE (3) 1 OF 0 5
--	--	----------------------------

TITLE (4)
Loss of Turbine Driven Auxiliary Feed Pump Flow Retention

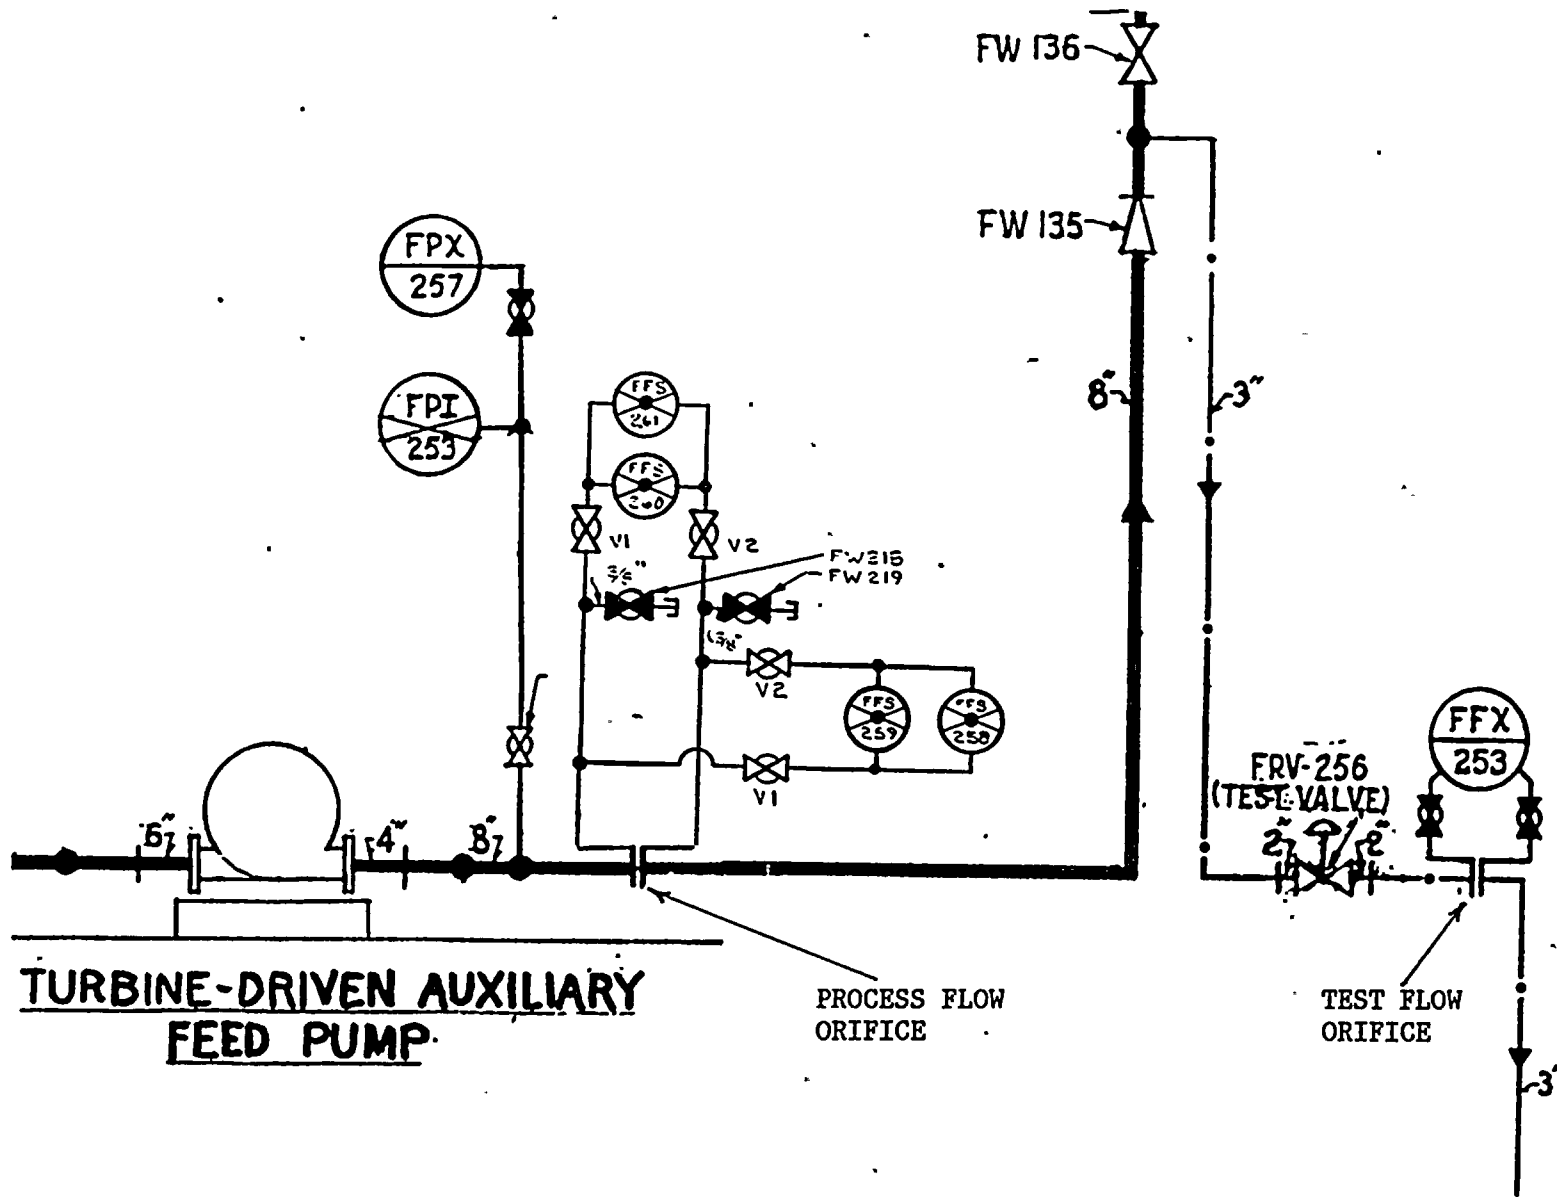
TURBINE DRIVEN AUXILIARY FEED PUMP RECIRCULATION LINEUP

On October 19, 1989 at 0900 hours, an NRC Inspector conducting an IST Audit discovered an instrument discrepancy between the Turbine Driven Auxiliary Feedpump (TDAFP) (EIIS/BA-P) test line flow indication (FFX-253) and the in-series process flow indicating switches (FFS-258 and FFS-260) (EIIS/BA-FS). Attached is a drawing describing the configuration of these instruments. Instrumentation at the process flow switches indicated a flow of 550 GPM while test instrumentation indicated a flow of 700 GPM. The process flow switch actuates a flow retention signal when the TDAFP flow reaches 975 GPM. This flow retention function prevents pump runout during a feedwater line break. With the process instrumentation reading 78 percent of actual flow, the flow retention function would have actuated at a TDAFP approximate flow of approximately 1225 GPM. Therefore, flow retention would not have actuated before pump runout occurred. The process flow indication had not been used for testing since 1978. The test orifice had been used exclusively.

FW-136 CLOSED
FRV-256 OPENED
