U.S. NUCLEAR REGULATORY COMMISSION
REGION I

Report No. 50-316/88-24

Facility Name: Donald C. Cook

Inspection Conducted: September 6 through September 15, 1988

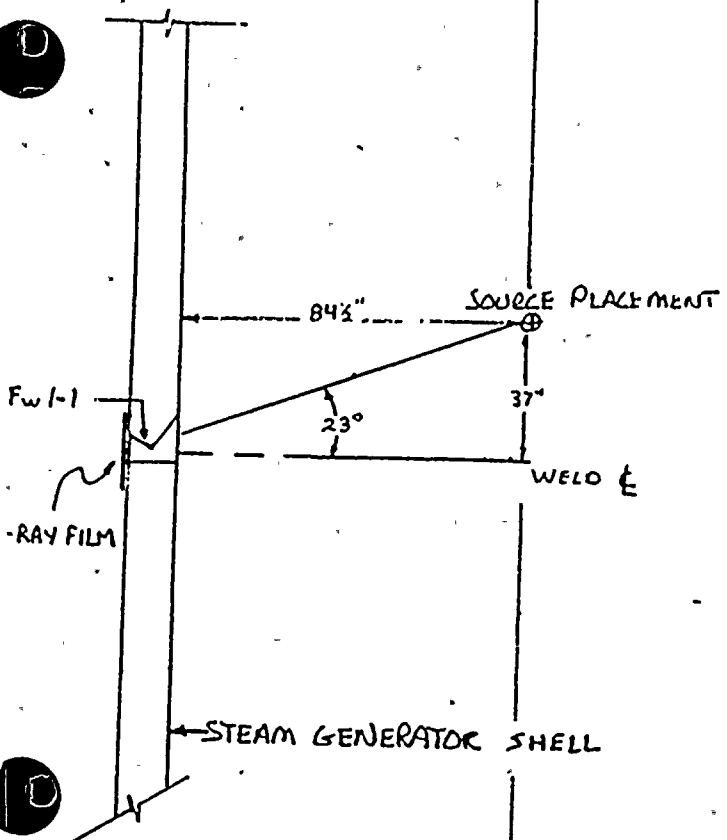
(A)

The inspector reviewed the radiographic technique employed by the licensee's contractor for radiography of the steam generator field girth welds. The radiographic set up consisted of centering the source tube on the I.D. of the steam generator shell course (87½" SFD) and positioning 300 curies of Cobalt 60 23° (37") off of the centerline of the closure girth weld (See Attachment 1). This technique does not comply with ASME Section V Article 22, Radiographic Standards; SE-142 Standard Method for Controlling Quality of Radiographic Testing; paragraph 3.0, Direction of Radiation. One of the five Geometric Principles of radiography states that the direction of the central beam of radiation shall be perpendicular to the recording surface (film). ASME Section V, Article 2 paragraph T-273 has the same requirement. Site radiographic procedure FQP-9.4 attachment 3 displays three suggested techniques that meet SE-142 paragraph 3.0. These techniques could have been used to radiograph these girth welds but were not employed. ASME Section V, Article I, paragraph T-110(e) requires when special techniques are used they must be equivalent to or superior to the techniques described in the Code Section. The techniques shall be capable of detecting discontinuities by demonstration and shall be equivalent to the capabilities of the techniques described in the Code. A review of the welding history of these girth welds indicated above normal frequency of weld defects. On September 12, 1988, the NRC radiographed two film areas out of 42 on steam generator number 21 girth weld FW1-1. The NRC radiographic technique used was to place the film on the ID while the source was centered on the weld on the OD at 30" SFD. A 37 curie cobalt 60 source was used. This technique is in site procedure FQP9.4 attachment 3(c). NRC film area 23-24 disclosed a rejectable slag indication that ran the entire length of the film (17"). A review of the licensee's radiograph for this same area disclosed that this indication was not present. It was the inspector's understanding that this girth weld, FW-1-1, was to undergo post weld heat treatment (PWHT) after the NRC was finished with the radiography of the weld. The inspector also understood that the licensee planned to use the same configuration to perform radiography after PWHT that they had used originally with the exception of using

- FIG A IS THE OLD RADIOGRAPHIC TECHNIQUE
- FIG B IS THE NEW RADIOGRAPHIC TECHNIQUE
- FIG C IS JOINT DESIGN

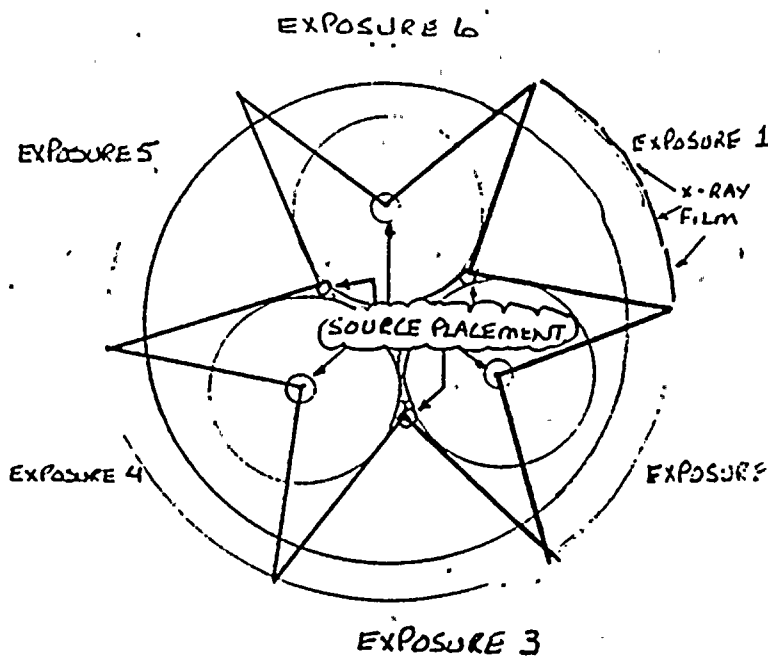
(B)

type "AA" film rather than type "T" film. The licensee changed their radiographic technique after review of the NRC film for area 23-24. The improved radiographic technique as described in site radiographic procedure FQP9.4 attachment 3 is in use now. This technique meets SE 142 paragraph 3.0 requirements. (See attachment 1). Use of radiographic techniques not satisfying applicable ASME Code requirement is an apparent violation (50-316/88-24-01).

SOURCE WAS PLACED AT THE WELD E (SEE FIG A) AND PERPENDICULAR TO FILM

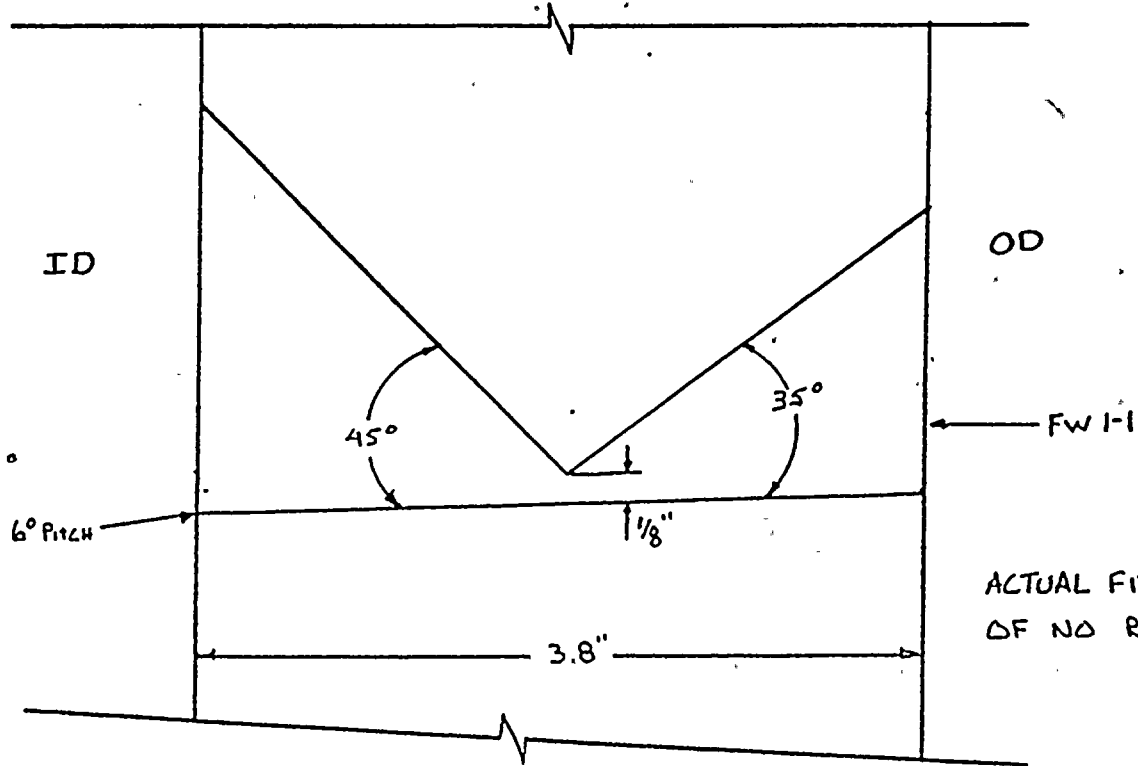
(C)

ACTUAL FITUP CONSISTS OF NO ROOT GAP
