SUBJECT: LER 89-002-01: on 890116, non-svc induced deformation of  
 energy core cooling sys suction line. W/890407 ltr.  
W/8                      ltr.

FACILITY NAME (1) **D. C. Cook Plant - Unit 2** DOCKET NUMBER (2) **0 5 0 0 0 3 1 6 1** PAGE (3) **1 OF 0 6**

TITLE (4) **Non-Service Induced Deformation of Energy Core Cooling System Suction Line Seismic Restraint**

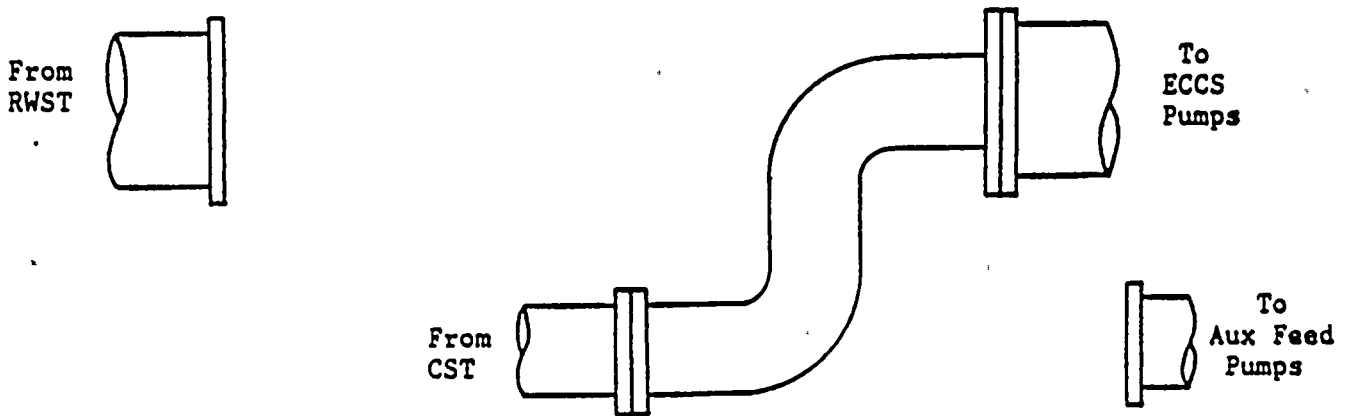
PIPING CONFIGURATION USED FOR FLUSHING AND TESTING

A review of modifications made to the system identified one potential cause for the deformation of 2GSI-L102. In order to facilitate flushing and other startup activities prior to initial unit startup a modification was made to the system, (changing this section of piping to a spool piece) to allow this portion of piping to be removed and replaced with a "jumper" spool piece. The modification, performed in 1976, was completed with one minor change to the original design; i.e., the subject restraint was moved to prevent interference with newly installed flanges. No other problems were noted. A Quality Control inspection report from August 1977 noted no problems with the restraint. The startup activities removed the modified pipe section and replaced it with a spool piece connecting the ECCS pump suction to the Condensate Storage Tank (CST) (see ATTACHMENT 1). Upon completion of the startup activities, the piping was restored. It is believed that the deformation of the restraint occurred during this evolution; however, no documentation of such deformation could be located. The corresponding restraint for Unit 1 was examined. There was no similar modification performed on Unit 1 and no deformation of the restraint was seen.

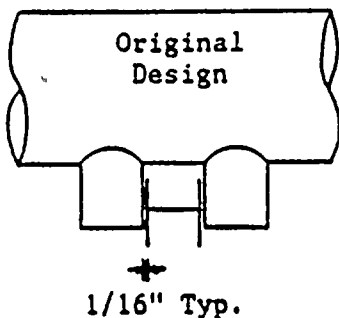
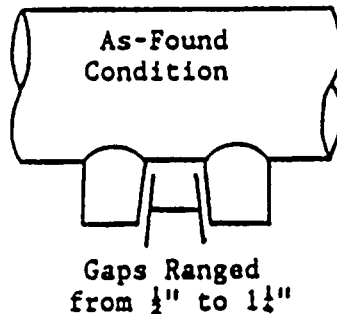
SUPPORT 2-GSI-L102 DETAIL

The deformation of the restraint was identified as deformation of the I-beam attached to the wall, along with deformation of two stanchions attached to the suction pipe (see ATTACHMENT 1). The deformation caused significant increases in the gap between the I-beam and the stanchions. Examination of the ECCS piping itself revealed no damage. The original seismic design required a one-sixteenth inch gap on each side. The gaps found from the deformation ranged from one-half to one and one-quarter inches. The design of the restraint is for seismic considerations and by definition is exempt from ISI visual examination per ASME Section XI. The purpose is primarily to restrain the suction line axially. It carries nominal loads during normal plant operation.

The investigation concluded that it is highly unlikely that the deformation of 2GSI-L102 was service induced as there have been no recorded unusual operating conditions, including a Design Basis Earthquake, which could have resulted in such significant deformation. The location of the restraint, on the suction side of the ECCS pumps, supports the likelihood that this type of deformation did not occur during service.

I-Beam Deformation

Due to the extent of the deformation of 2GSI-L102, it was not possible to return the restraint to its original design configuration. A revised design was developed to reinforce the restraint and reestablish the gap clearances specified by the original seismic design. A modification was initiated along with an ASME Section XI repair plan to repair the restraint. Repairs have been completed and the restraint visually inspected for final acceptance.
