# ACCELERATED DISTRIBUTION DEMONSTRATION SYSTEM

SUBJECT: LER 90-008-00: on 900619, 10CFR App R deficiencies resulting  
 in potential for loss of auto start of svc water pumps.  
 w/9      ltr.

FACILITY NAME (1) D.C. Cook Nuclear Plant, Unit 1	DOCKET NUMBER (2) 0 5 0 0 0 3 1 5	PAGE (3) 1 OF 0 6
--	--------------------------------------	----------------------

TITLE (4) 10 CFR Appendix R Deficiencies Resulting in Potential for Loss of Auto Start of Service Water Pumps Due to Incorrect Implementations of Design Change

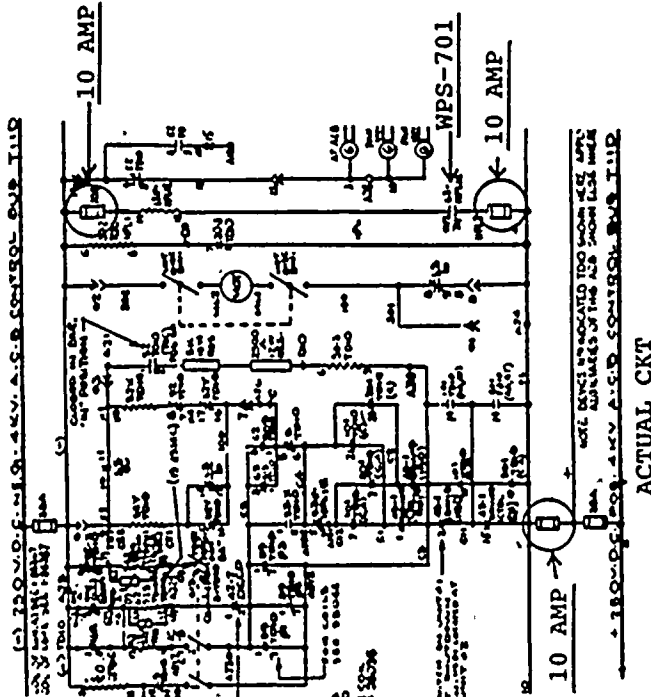
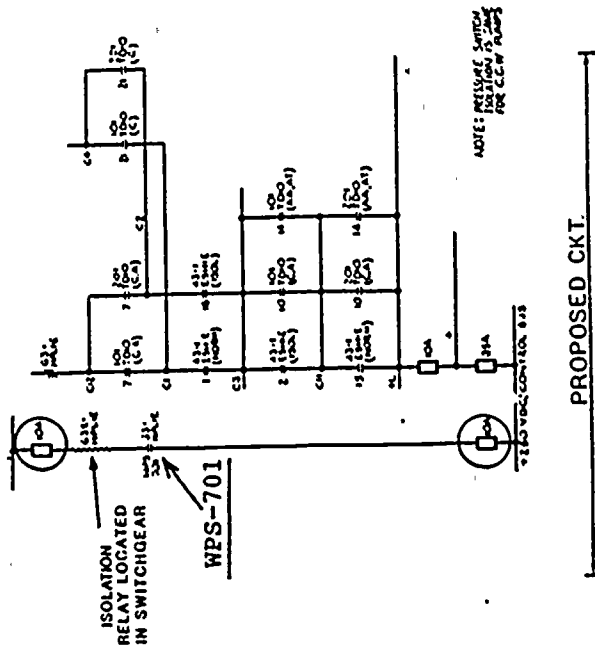
To get a better understanding of the problem, please refer to the attached sketch. This sketch is typical for all ESW and CCW pumps. The circuit labeled "Proposed CKT" shows how the isolation was supposed to be provided. In the "Proposed Circuit," the pressure switch contact and the isolation relay would be isolated from the rest of the control circuit by 10 amp fuses. A fault at pressure switch WPS-701 would result in one of the isolation relay fuses being blown. The 10 amp control circuit fuse would be left unaffected.

The circuit labeled "Actual CKT" shows what was actually installed. As shown on the sketch, the 10 amp isolation relay fuses were placed in series with the 10 amp control circuit fuse.

Since the fuses have the same rating and characteristics, there is a chance that the control circuit fuse would blow before the isolation relay fuse in the event of a fault at WPS-701. If this happened, the pump's close circuit would become inoperable. If the pump was already running, it would continue to run, but if it was not running or was subsequently shutdown, the pump could not be restarted without manual action by the operators at the pump's electrical breaker.

The immediate corrective action was to replace the 10 amp isolation relay fuses with 5 amps fuses to provide proper fuse coordination with the 10 amp control circuit fuse. This action was completed in both units on June 22, 1990.

The breaker control circuits for Unit 2 ESW and CCW pumps will be modified during the current Unit 2 refueling outage (Plant Modification number 12-MM-110). The breaker control circuits for Unit One ESW and CCW pumps will be modified during the next Unit One refueling outage (Plant Modification number 12-MM-110).
