SUBJECT: Informs of preliminary assessment of 900713 electrical contact accident at facility.

The purpose of this letter is to inform you of our preliminary assessment of the electrical contact accident that occurred at the Donald C. Cook Nuclear Plant on July 13, 1990.

DESCRIPTION OF ACCIDENT - July 13, 1990

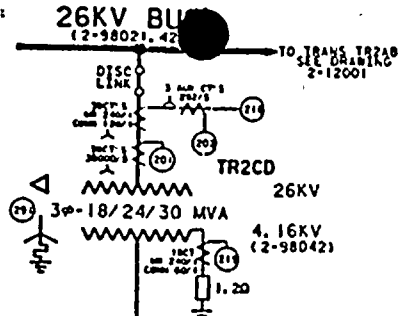
View Showing Closeup of CTs

the Instrument Maintenance Supervisor stated his belief that the CTs could be reached from the front of the breaker cabinet. There was no drawing with the job package showing the CT location. The Instrument Maintenance Supervisor then took the men to the I&C shop to meet the I&C Technician. The I&C Technician and the NSS-2 proceeded to the Unit-2 4KV Breaker Room. The MMA told the NSS-1 to get the high voltage tester and insulating gloves and meet him in the 4KV Breaker Room. The MMA's intention was to check things out and then get the needed tools. The MMA then went to the Shift Supervisor's office to sign on the clearance permit #2900759. This clearance included, in part, breakers T21C1, T21C2, T21C3, 21C1, bus T21C, and transformer TR21C. A ground had been placed on the 4KV side of transformer TR21C. The 4KV breaker room door entry record showed that the I&C Technician and NSS-2 entered at 12:57 p.m. and the NSS-1 entered at 12:58 p.m. The record also shows that the Electrical Maintenance Supervisor entered at 12:58 p.m. and the MMA entered at 13:00 p.m. The Electrical Maintenance Supervisor was on his way to check a job in an adjoining room and, when he saw the men, stopped at the front of T21C cabinet to briefly discuss the job. The Electrical Maintenance Supervisor did not remember who was present. During the discussion, he cautioned them of possible backfeed from potential transformers in the cabinet. He walked around to the back of breaker T21C1 and commented that the CTs may be behind the bus bars. He said that the back cabinet door was open. He then left through the north fire door to the adjoining room. The MMA said that he arrived at the job site as the Electrical Maintenance Supervisor and the NSS-1 were talking behind the breaker cabinet. Due to the noise, the MMA could not hear their conversation. He said the NSS-2 and the I&C Technician were standing behind the NSS-1. He also said that he thought it was strange that the men were behind the breaker cabinet because he was not sure everything had been checked out. The MMA said that he looked around and did not see a high voltage tester or insulating gloves. The MMA said that he told the NSS-1 to leave the cabinet alone. The MMA added that he would go to get the high voltage tester and insulating gloves. He turned to leave and within seconds, he heard an explosion. The Electrical Maintenance Supervisor who was in an adjoining room, grabbed a fire
