U.S. NUCLEAR REGULATORY COMMISSION

Reports No. 50-315/90026(DRS); 50-316/90026(DRS)

Facility Name: D. C. Cook Nuclear Power Station, Units 1 and 2

Type of Meeting: Enforcement Conference

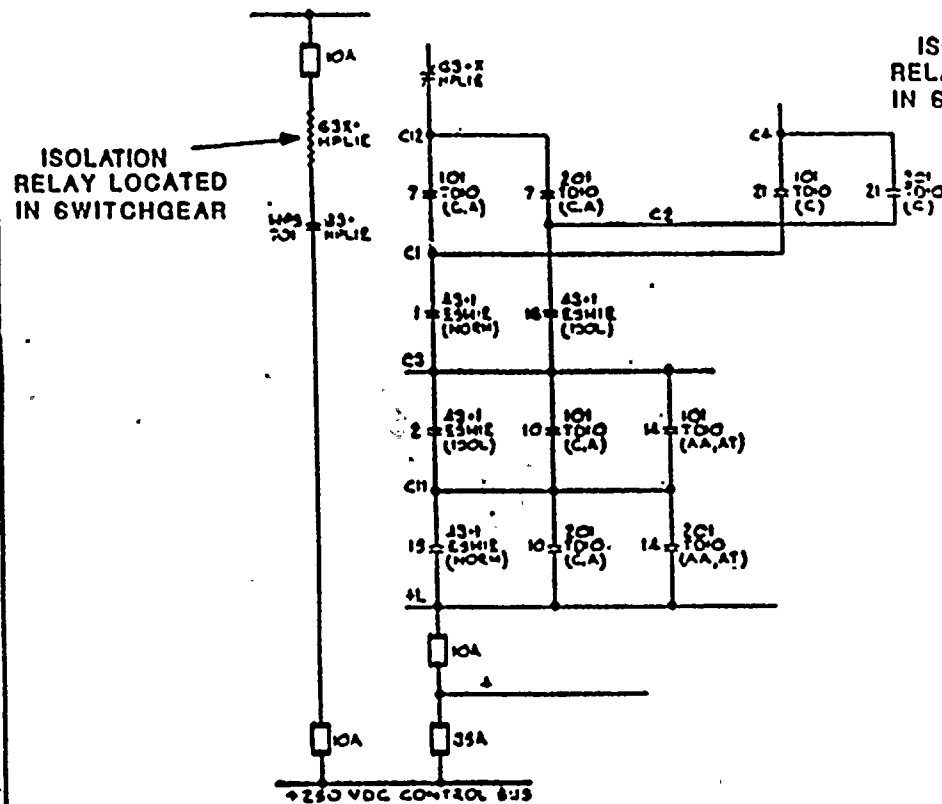
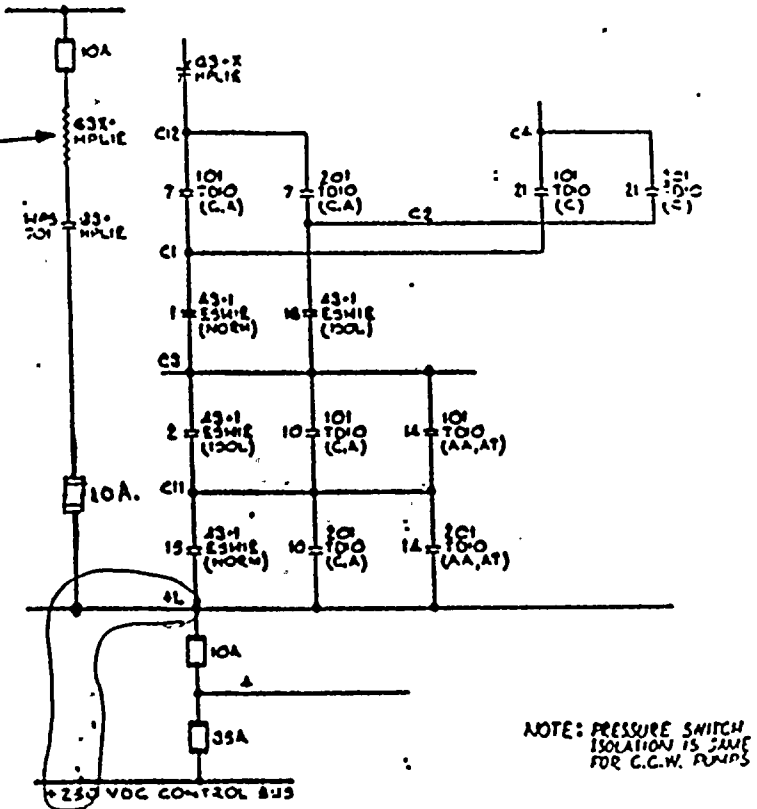
# Problem

As Designed

As Translated & Installed

ISOLATION RELAY LOCATED IN SWITCHGEAR

ESSENTIAL SERVICE WATER PUMP CKT. BREAKER CLOSE CIRCUIT  
UNIT 1 ESW PUMP CIRCUIT SHOWN (TYPICAL FOR ALL ESW PUMPS)

**DESIGN WAS INAPPROPRIATELY  
TRANSLATED TO ELEMENTARY DRAWINGS**

**INAPPROPRIATE ENGINEERING & DESIGN  
CHECKING OF DRAWINGS IN 1983**

- EFFECTS MANUAL RESTART**
- SHORT ON ALL 4 CABLES INTERNALLY REQUIRED**
- ONE ESW PUMP REQUIRED**
- ONE CCW PUMP REQUIRED FOR CSD**

**PROCEDURE ADEQUATELY ADDRESSES LOCAL  
MANUAL RESTART OF THE PUMPS**

**NO SAFETY SIGNIFICANCE**

**REPLACE EXISTING 10 AMP. FUSE  
WITH 5 AMP.**

**RESTORE CIRCUIT TO  
"AS-DESIGNED" CONFIGURATION**

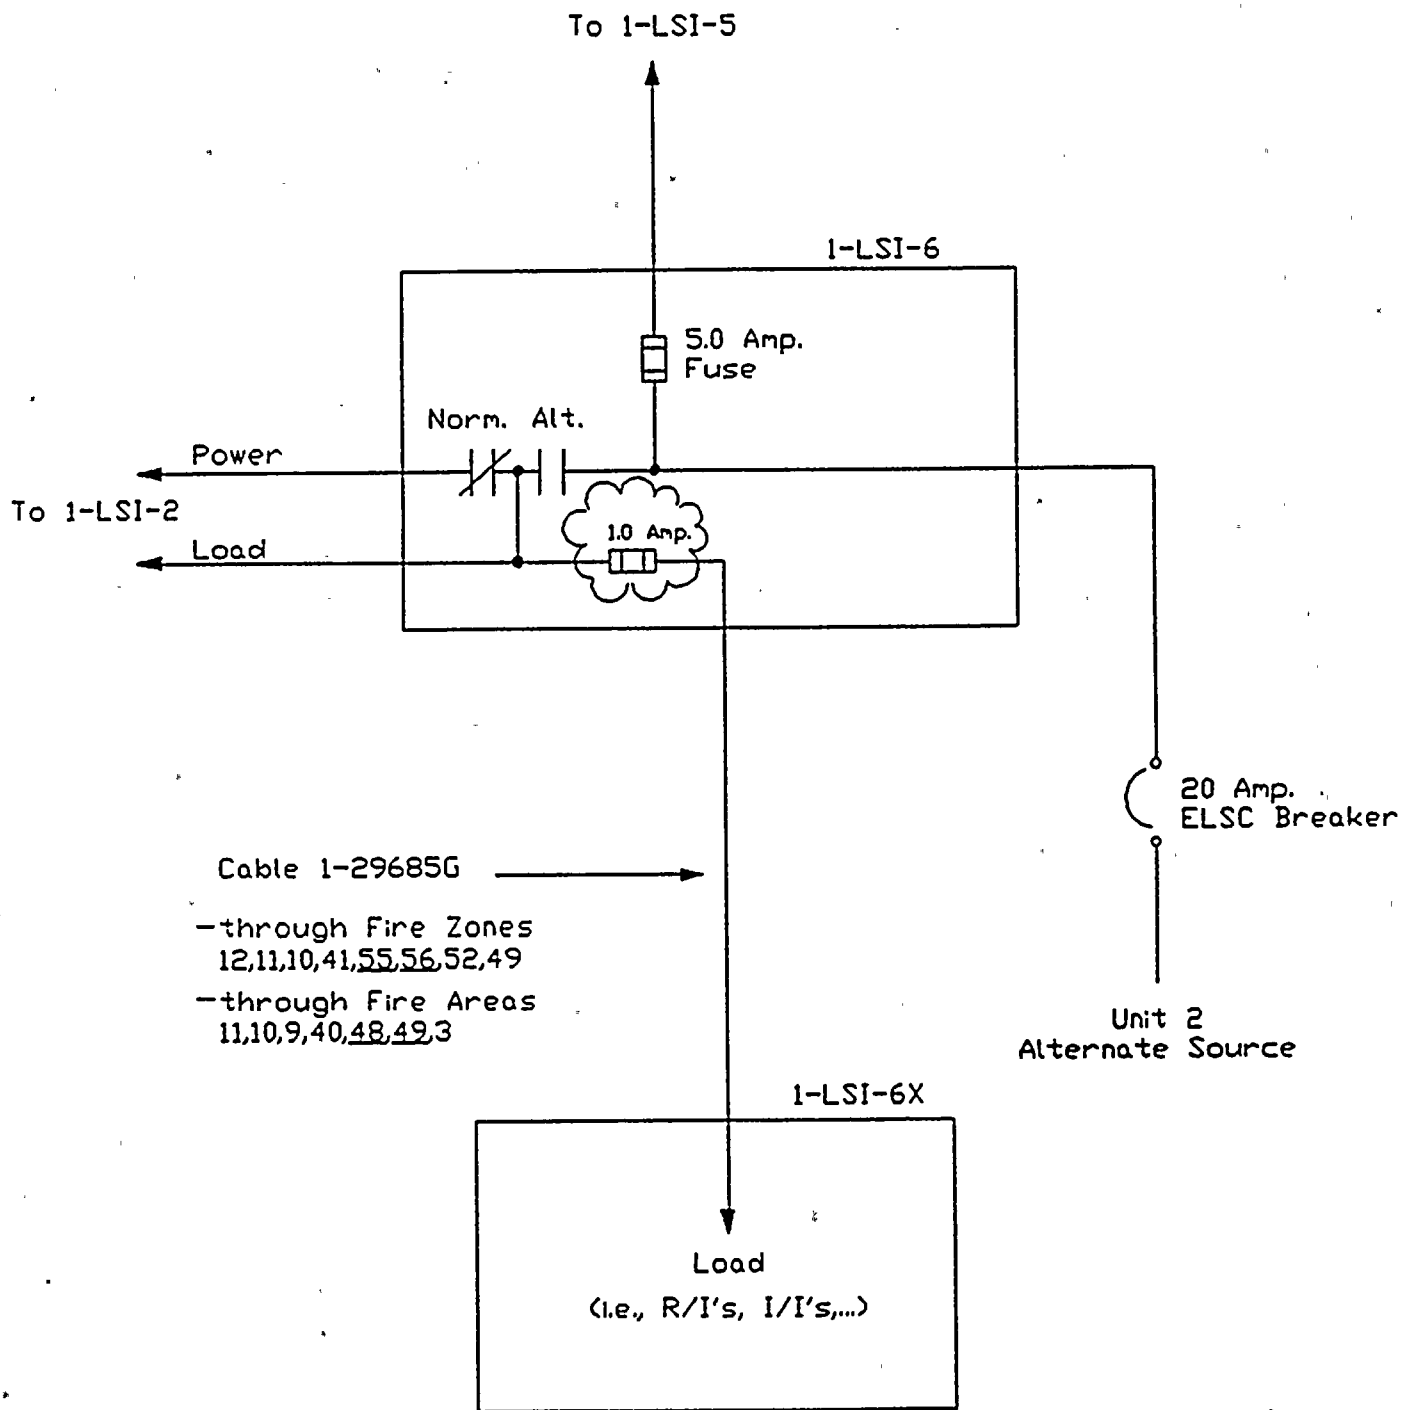
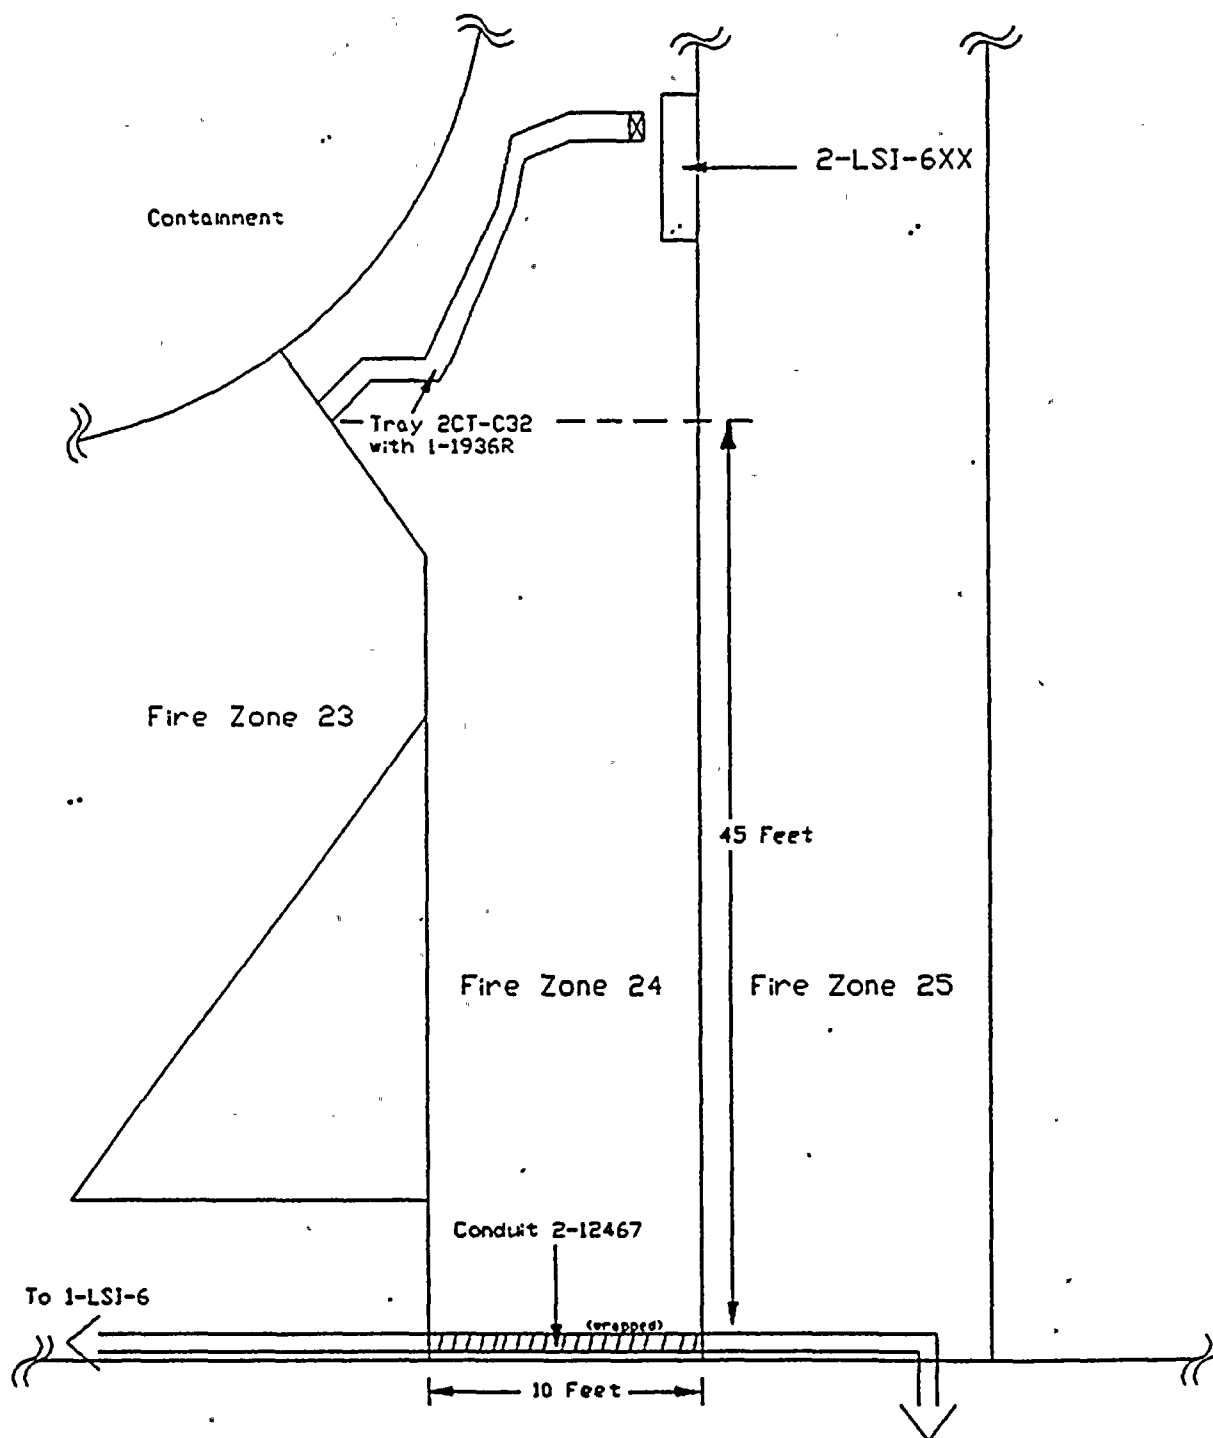
REVIEW OF APPENDIX R SAFE SHUTDOWN CABLE ROUTES BY FIRE ZONE IDENTIFIED A NUMBER OF INSTANCES WHERE THE ACTUAL CABLE ROUTE DIFFERED FROM THE ROUTE DETERMINED IN SUPPORT OF PLANT MODIFICATIONS WITH POTENTIAL APPENDIX R IMPACT. OF THESE INSTANCES, TWO WERE DETERMINED TO VIOLATE APPENDIX R CABLE SEPARATION/ PROTECTION CRITERIA:

1. CABLE 1-29685G RUNNING BETWEEN LOCAL SHUTDOWN INDICATION (LSI) PANELS 1-LSI-6 AND 1-LSI-6X.

2. CABLES 1-1936R/2-12467

1-1936R = UNIT 1 ALTERNATE POWER SOURCE CABLE  
TO THE UNIT 2 LSI PANELS

2-12467 = UNIT 2 NORMAL LSI POWER SOURCE CABLE

BOTH OF THE ABOVE INSTANCES CREATED A POSSIBILITY FOR A FIRE-INDUCED LOSS OF PROCESS MONITORING INSTRUMENTATION REQUIRED BY PROCEDURES. THE LSI CABLE ROUTING DISCREPANCIES WERE REPORTED IN LER NO. 90-010 AND WERE REITERATED BY INSPECTION REPORT NO. 90018 ITEM 4.C. ACTIONS HAVE BEEN TAKEN TO CORRECT BOTH PROBLEMS.

INSUFFICIENT CONTROLS WERE IN PLACE TO ENSURE THAT  
NEW CABLES ADDED TO THE PLANT COMPLIED WITH  
APPENDIX R REQUIREMENTS.

THE UNIT 1 LSI PANEL CABLE ROUTING ERROR CREATED THE POSSIBILITY FOR A FIRE IN FIRE AREAS 48 AND 49 TO DISABLE BOTH THE UNIT 1 CONTROL ROOM AND LSI PANEL PROCESS MONITORING INSTRUMENTATION.

SINCE FIRES PROPAGATE AT A FINITE RATE AND FIRE DETECTION AND SUPPRESSION IS PROVIDED IN THE AREAS OF CONCERN, WE CONCLUDED THAT THE CONDITION DID NOT ADVERSELY IMPACT THE HEALTH AND SAFETY OF THE PUBLIC.

**OUR PROGRAM FOR ENSURING CONTINUED APPENDIX R COMPLIANCE WILL BE REVISED TO CORRECT THE CONDITIONS THAT LED TO APPENDIX R NON-COMPLIANCE FOR SAFE SHUTDOWN CABLES. PREVENTIVE ACTIONS INCLUDE:**
