SUBJECT: LER 89-017-03: on 891019, discovered instrument discrepancy between turbine-drive auxiliary feed pump test line flow indication & process flow indication. Caused by inaccurate flow measurement. Switches reset. W/910228 ltr.

FACILITY NAME (1) **D. C. Cook Plant - Unit 2** DOCKET NUMBER (2) **05000316** PAGE (3) **1 OF 7**

TITLE (4) **Loss of Turbine Driven Auxiliary Feed Pump Flow Retention Due to Inaccurate Flow Measurement**

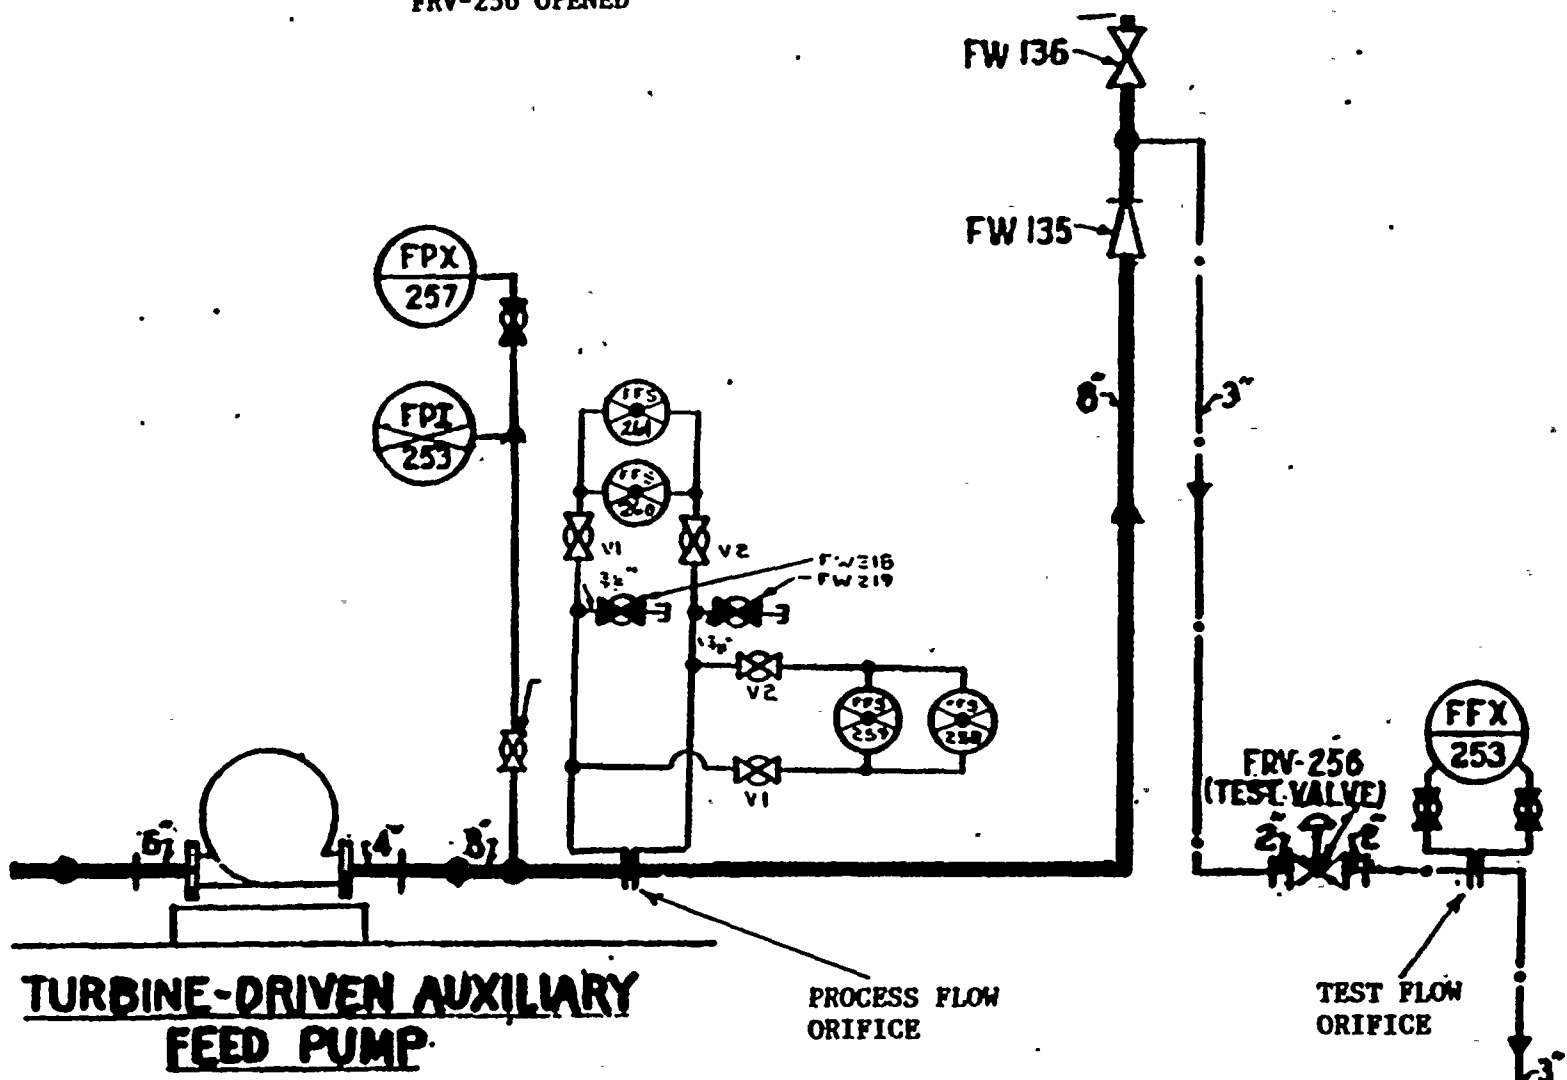
TURBINE DRIVEN AUXILIARY FEED PUMP RECIRCULATION LINEUP

On October 19, 1989 at 0900 hours, an NRC Inspector conducting an IST Audit discovered an instrument discrepancy between the Turbine Driven Auxiliary Feedpump (TDAFP) (EIIS/BA-P) test line flow indication (FFX-253) and the in-series process flow indicating flow switches (FFS-258 and FFS-260) (EIIS/BA-FS). Attached is a drawing describing the configuration of these instruments. Instrumentation at the process flow switches indicated a flow of 550 gpm while test instrumentation indicated a flow of 700 gpm. The process flow switch actuates a flow retention signal when the TDAFP flow reaches 975 gpm. This flow retention function prevents pump runout during feedwater line break. With the process instrumentation reading 78 percent of actual flow, the flow retention function would have actuated at a TDAFP approximate flow of approximately 1225 gpm. Therefore, flow retention would not have actuated before pump runout occurred.

A fluid dynamic situation is believed to exist in the TDAFP discharge line, causing oscillations/turbulence across the orifice and resulting in erroneous differential pressure/flow indication. The root cause for the turbulence cannot be determined at this time. A resolution for this deficiency is being developed. An updated report will be submitted by July 30, 1991.

This testing had no effect on the readings obtained from the process flow instrumentation. The test line orifice (2-FFX-253) consistently read 24% higher than the process orifice (2-FFX-259).

On October 25, 1989, the Unit 2 TDAFP process flow indicating switches, which provide flow retention actuation, were reset for proper actuation. The verified test orifice was used as a standard for determining the process orifice curve.
