SUBJECT: Requests temporary waiver of compliance w/Limiting Condition
 for Operation of Tech Spec Section 3.5.2 re ECCS boron
 injection tank charging sys to repair body-to-bonnet leak in
 valve 1-CS-356 in chemical & vol control sys.

Donald C. Cook Nuclear Unit 1
License No. DPR-58
Docket No. 50-315
REQUEST FOR TEMPORARY REGIONAL WAIVER OF COMPLIANCE

SIMPLIFIED FLOW DIAGRAM OF THE
UNIT 1 CVCS CROSS-TIE SYSTEM

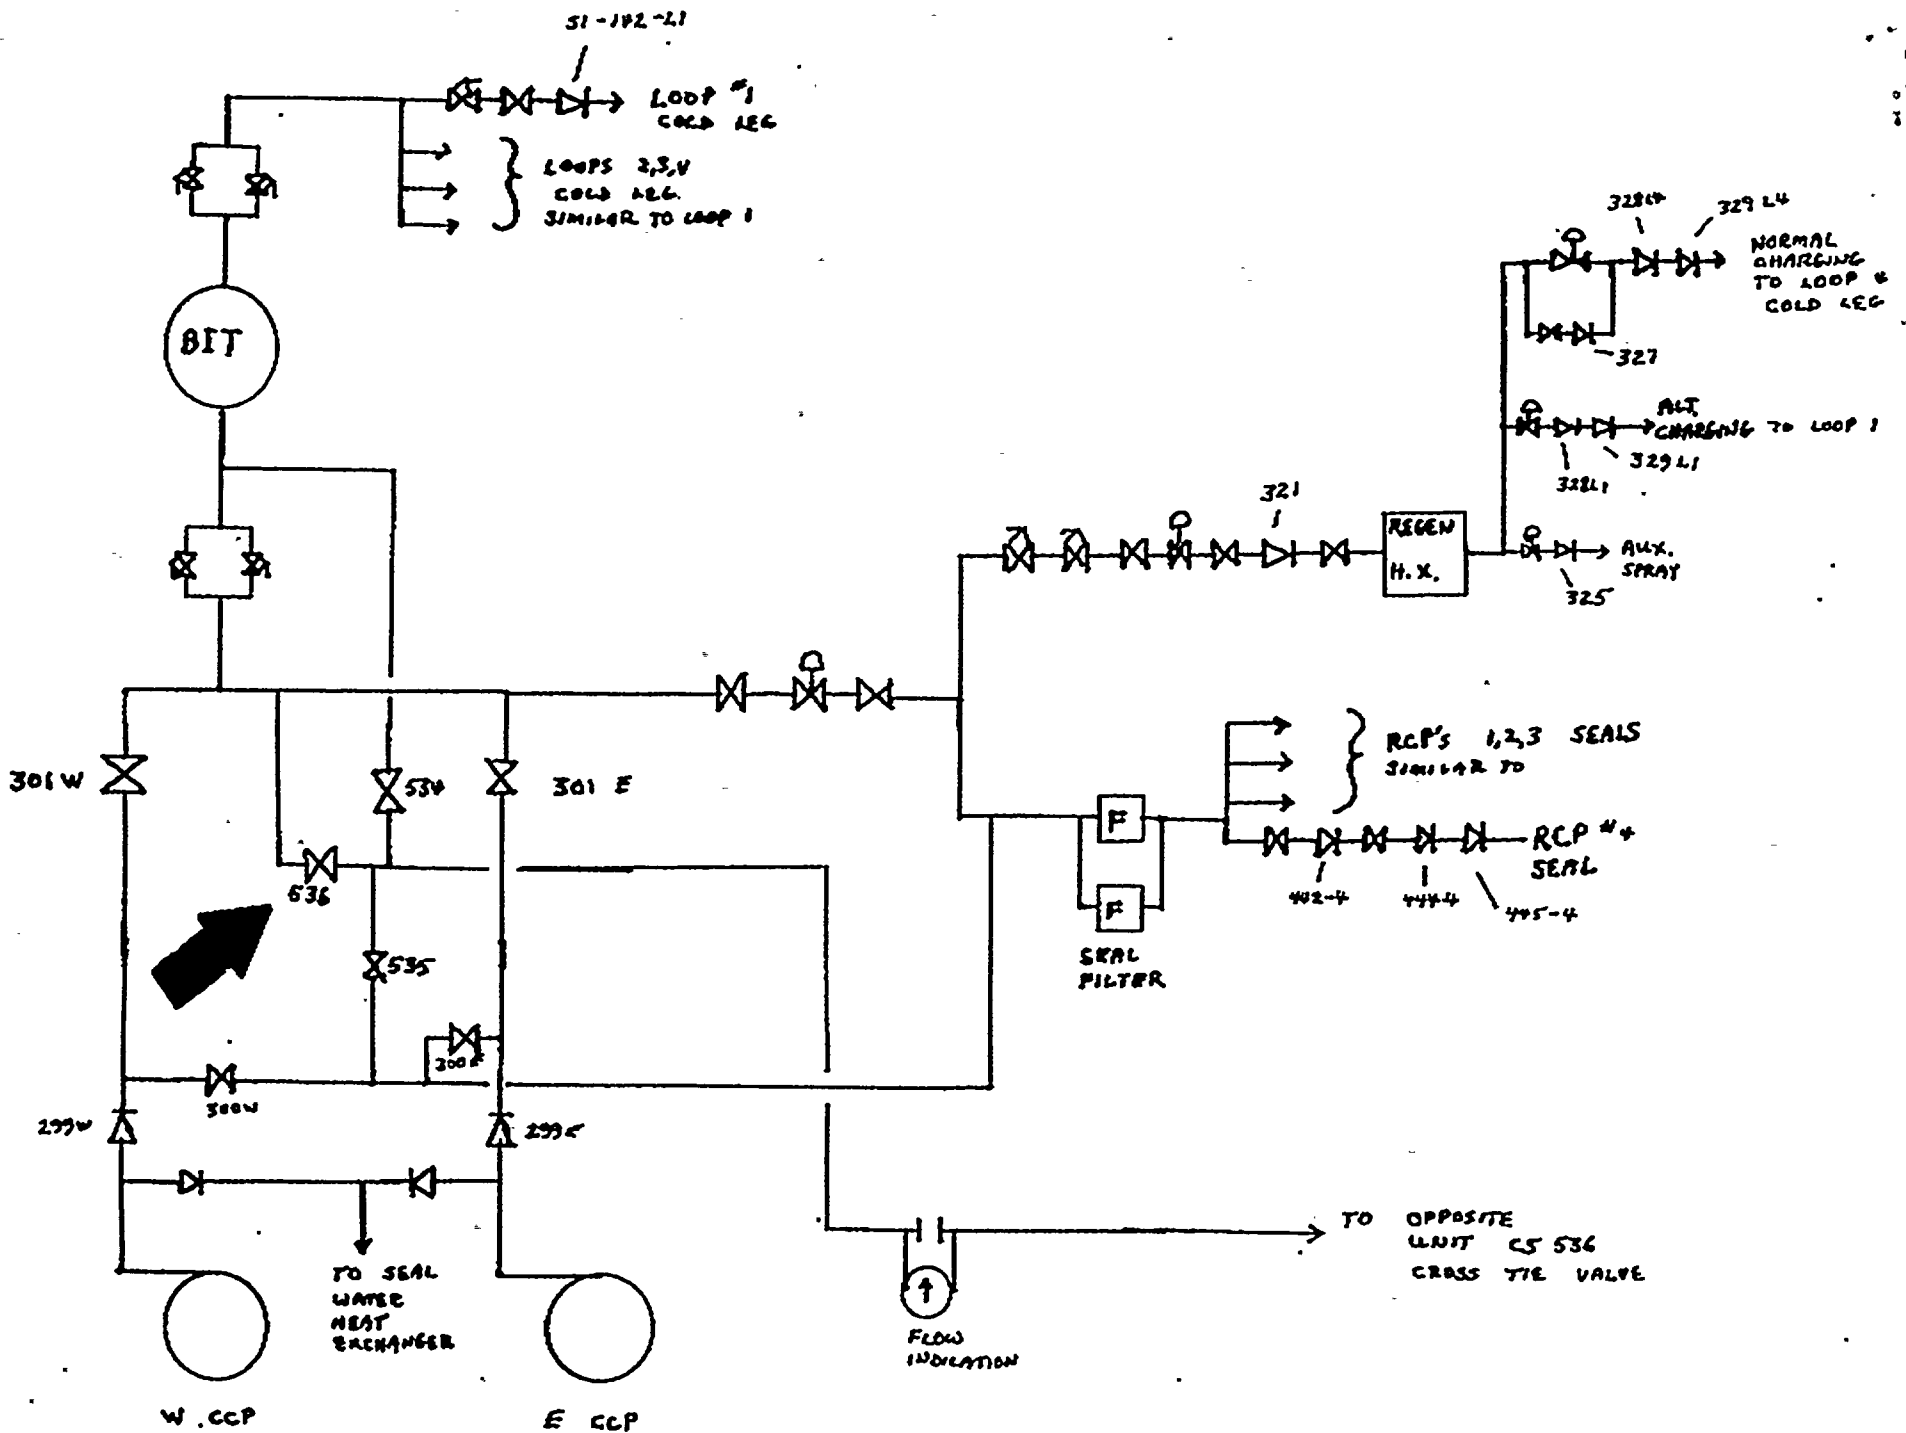
This waiver of compliance is necessary in order to repair a body-to-bonnet leak in valve No. 1-CS-536, installed in the Cook Nuclear Plant Unit 1 chemical and volume control system (CVCS). Valve 1-CS-536 is a normally closed valve located in the charging pump cross-tie between Units 1 and 2.

event of an Appendix R fire. Subsequent to the last Unit 1 refueling outage, a leak of an estimated 30 gpm was discovered developed in valve 1-CS-536 installed in the Unit 1 charging flow cross-tie line. In the event of a fire in Unit 1, current procedures would require valve 2-CS-536 to be opened in order to provide seal water injection and RCS volume control to Unit 1 from the Unit 2 charging system. Although the charging system is of sufficient capacity to provide the necessary seal injection flow and RCS volume control even with the existence of the identified leak, the magnitude of the leak cannot be exactly quantified. This reduces our ability to confirm that charging flow from the unaffected to the affected unit during a fire is adequate using our existing emergency and safe shutdown procedures. This is because existing safe shutdown procedures require verification of adequate seal injection flow using a flow indicating device which, when providing flow to Unit 1 from the Unit 2 charging system, would be upstream of 1-CS-536 (and therefore upstream of the leak). As a result when Unit 1 is the affected unit and is being supplied from Unit 2 the total cross-tie flow can be measured; but since the exact leak rate from valve 1-CS-536 cannot be determined, the actual seal water injection flow to Unit 1 cannot be verified. When supplying Unit 2 from Unit 1 the actual flow to Unit 2 can be verified, however, containing the leakage water becomes both a containment problem and a radiological problem. (This problem, in fact, would exist regardless of which unit is the fire affected unit.) The leak, therefore, must be repaired. Our intent is to repair valve 1-CS-536 during power operation in order to avoid an unnecessary shutdown of Unit 1 with the consequent thermal cycling of the RCS and reactor vessel. A simplified flow diagram of the affected portion of the CVCS is provided in the attachment to this letter.

Our method for repairing valve 1-CS-536 during power operation is to establish a freeze seal in the four-inch line upstream of the valve, then, once the freeze seal is in place disassemble the valve, replace the valve bonnet, trim assembly and packing cartridges, reassemble the valve and return the system to its normal configuration. It is expected that the time during which we will need to rely on the freeze seal for pressure boundary retention will be less than four hours, with the repair activity itself expected to require less than one hour.
