SUBJECT: LER 93-003-00: on 921016, discovered that charcoal filter face dampers were closed instead of open as indicated. Caused by incorrect solenoid installation. Procedures revised & dampers verified to be installed correctly. W/930408 ltr.

FACILITY NAME (1) D. C. COOK PLANT - UNIT 2		DOCKET NUMBER (2) 0   5   0   0   0   3   1   6   1	PAGE (3) 1 OF 05
--	--	--	---------------------

TITLE (4) ESF Ventilation System Filter Train Damper Control Malfunction Due to Incorrect Solenoid Installation

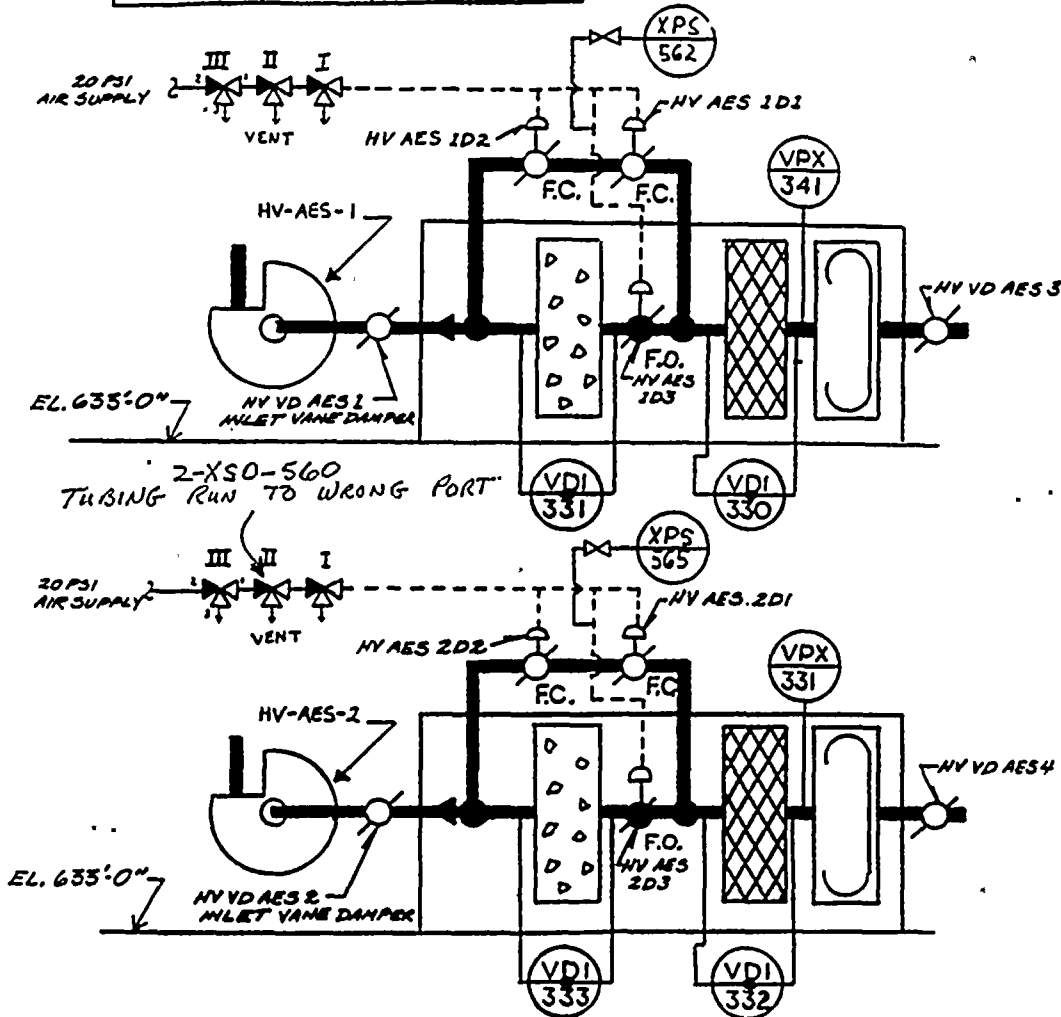
An investigation revealed that the incorrect position of the 2-HV-AES-2 face and bypass dampers was caused by an incorrect piping configuration (air supply piped to wrong solenoid part) of the instrument air supply to solenoid valve (2-XSO-560) (EIIS/LF-SOL) which provides the control air for the damper operation (see attached drawing). Upon actuation of a Containment Isolation Phase B (CI-B) signal, both ESF Ventilation Trains start with flow going through the associated charcoal filters. Solenoid Valve 2-XSO-560 actuates from a Train-A CI-B signal, or from the Train A fan being out of service and provides a cross-train feature to reposition the Train-B ESF Ventilation Filter Dampers. Solenoid 2-XSO-560 ensures cross-train backup for Solenoid Valve 2-XSO-564, which actuates on a Train-B, CI-B signal. If solenoid 2-XSO-564 would have failed during an accident, the supply air piping error would have prevented solenoid 2-XSO-560 from performing its backup design function for the Train-B ESF Ventilation Filter dampers and prevented use of the manually actuated Solenoid Valve 2-XSO-565 to correctly position the dampers.

This event was the result of a print error. It could not be determined when the solenoid had been installed incorrectly since a review of the design change test data indicates that the solenoid valve was successfully tested in 1977. The Design Change Test included the following steps:

This drawing shows the correct solenoid installation.

To ensure that the system continues to operate as designed, procedure change requests have been issued for surveillance procedures which test these systems. Revisions to the ESF time response Train-A and Train-B Procedures will include verification that each AES fan's dampers will move to the charcoal filtration mode when the opposite Train receives a Safety Injection signal. These procedure revisions are scheduled to be completed by December 15, 1993 (prior to the next scheduled test). The drawing has been revised to show the correct piping configuration.
