UNITED STATES
NUCLEAR REGULATORY COMMISSION
OFFICE OF INSPECTION AND ENFORCEMENT
WASHINGTON, D.C. 20555

October 30, 1980

IE Information Notice No. 80-38: CRACKING IN CHARGING PUMP CASING CLADDING

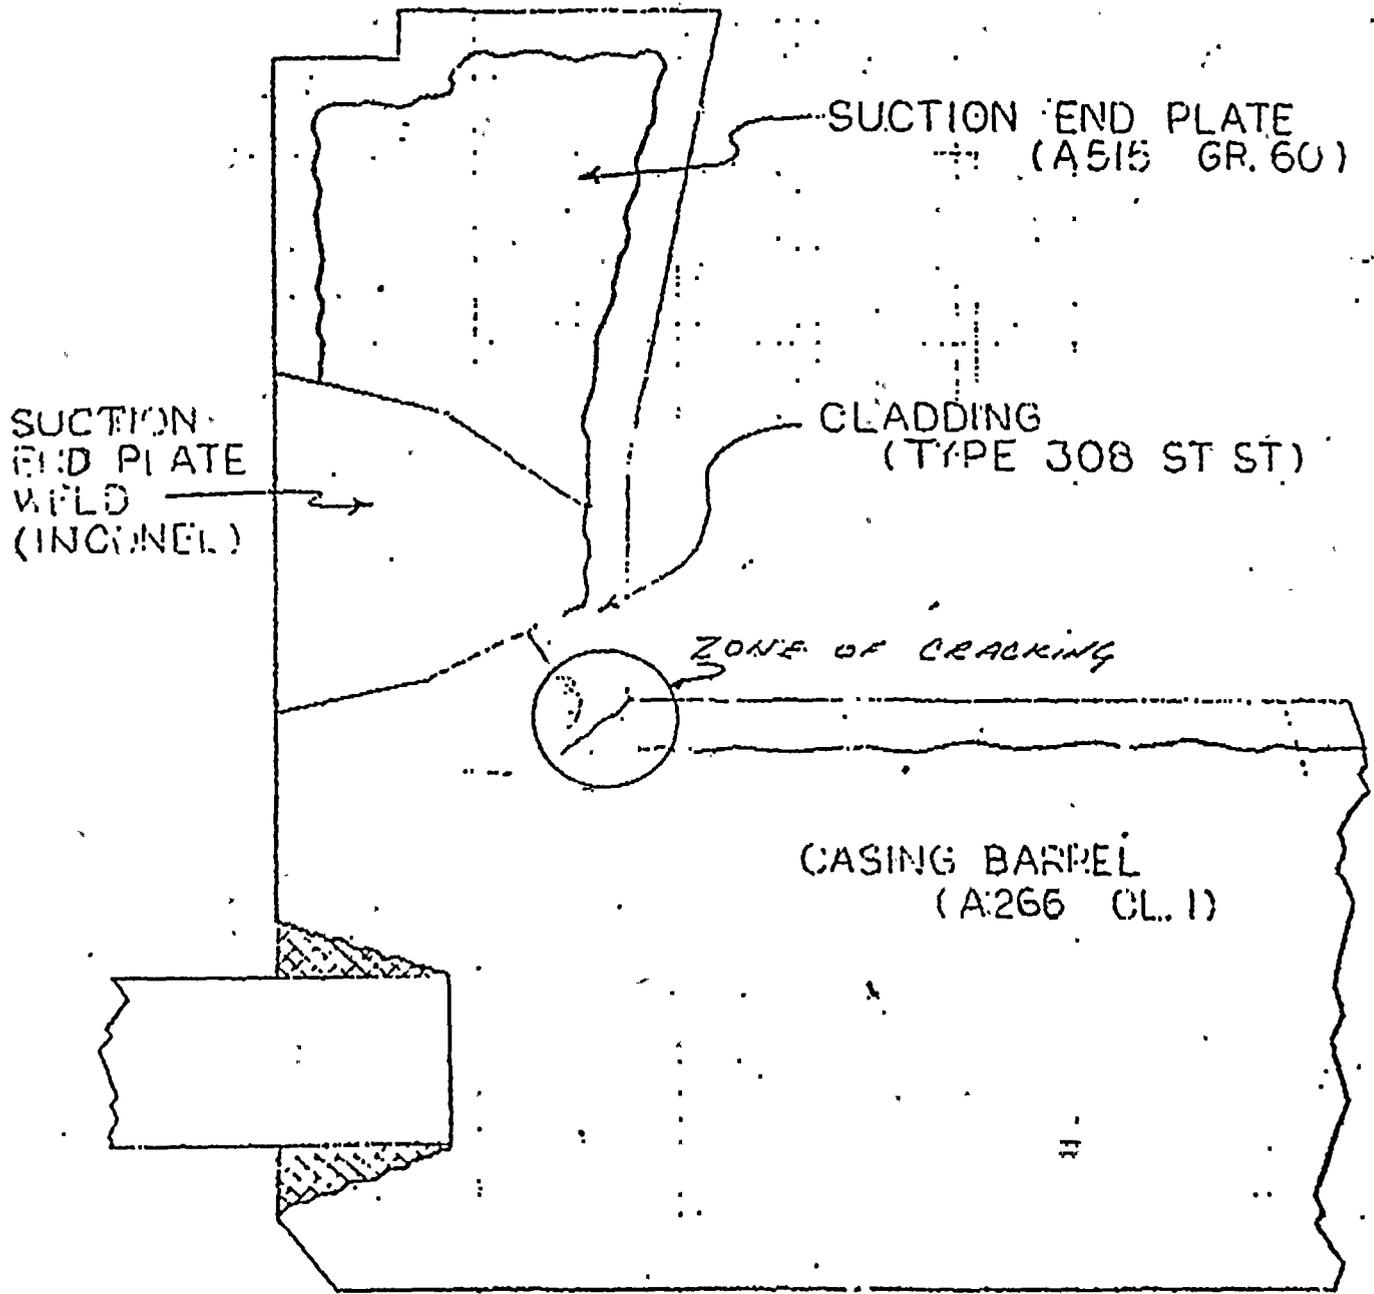
FIGURE 1

The pumps are 2-1/2 inch, 11 stage, Type IJ manufactured by the Pacific Pumps Division of Dresser Industries. The pump casing end assembly in the area of interest, Figure 1, consists of a suction end plate of A515 grade 60 carbon steel plate welded to the casing barrel forging of A266 class 1 carbon steel using an Inconel weldment. The entire inner surface is clad with type 308 stainless steel applied by submerged arc welding.

An in-situ ultrasonic examination conducted in late April confirmed clad cracking indications at the barrel case to end plate inner radius for approximately 330 degrees around the circumference and that the cracking possibly extended into the pump base material in the bottom 180 degrees of the assembly. A review of the original radiographs revealed crack like indications in the clad overlay, however, not to the extent observed during this examination.

Subsequently, the entire suction end of the pump was removed and cross sections metallographically examined to further evaluate the nature and extent of the cracking. It was determined that initiation and propagation of the clad cracks probably resulted from stress concentration and dilution effects in the initial corner bead pass due to the difficult access and bead sequencing required by the fairly sharp corner geometry. Extension of the cracks at the base metal-clad interface ranged to a depth of 1/16 inch maximum in the 1-1/2 inch thick base material. These crack tip areas were well blunted and slightly cavitaded from corrosion effects due lengthy exposure to the localized boric acid attack. Examination of the crack morphology revealed that the clad cracking essentially arrested at the base metal-clad interface and that base metal corrosion progressed at a relatively slow rate.

The 1A charging pump was replaced with a new pump provided with a casing constructed entirely of stainless steel. The licensee is currently developing improved NDE procedures for examination of the three remaining pumps at the next refueling outage. Further, the licensee and pump manufacturer are developing repair procedures in the event cracks are discovered in the remaining pumps.

Based on the available information no immediate safety concern is indicated. However, the observed conditions reveal a potential source of pump degradation over long term operations. Therefore, to assure maximum availability, it appears prudent to perform a nondestructive examination of this pump type at the earliest practical time during the first code required in-service inspection interval and if cracking is confirmed, take appropriate corrective actions per the rules of ASME Section XI BP&V Code.
