UNITED STATES  
NUCLEAR REGULATORY COMMISSION  
OFFICE OF NUCLEAR REACTOR REGULATION  
OFFICE OF NEW REACTORS  
WASHINGTON, DC 20555

June 13, 2018

NRC INFORMATION NOTICE 2018-07: PUMP/TURBINE BEARING OIL SIGHT GLASS  
PROBLEMS

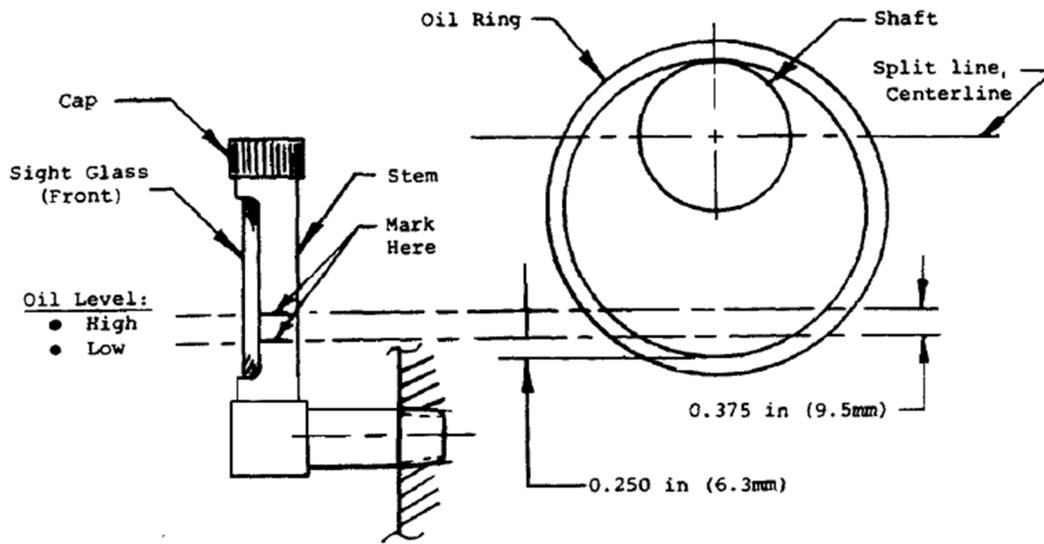
The licensee performed an investigation and identified the apparent cause for the bearing damage was a failure to replenish the oil reservoir after removal of a 10- to 11-ounce oil sample following the last quarterly surveillance test on June 21, 2017. The technician did not replenish the oil reservoir because the vertical (columnar) sight glass indicated that the oil level was within the marked bands. The vendor manual states that the minimum proper oil level (in the reservoir) in slinger ring lubricated bearings is 0.250 ( $\frac{1}{4}$ ) inch above the bottom dead center of

the inside diameter of the oil slinger rings (see Figure 1). The vendor manual also states that the sight glass should have two marks that indicate the minimum and maximum oil levels. Although these marks should be approximately 0.375 (3/8) inch apart, the as-found marks were significantly wider than 3/8 inch. The licensee determined the as-found oil level after the September 13, 2017, event was below the minimum recommended level on the vendor drawing even though the oil level was observed to be within the normal range of the as-found scribe marks on the sight glass.

**Figure 1 Recommended oil level for ring oil lubricated bearings  
(Source: Davis-Besse Vendor Manual Guidance, Terry Corporation)**
