UNITED STATES
NUCLEAR REGULATORY COMMISSION
WASHINGTON, D.C. 20555-0001

December 4, 2017

SUBJECT: SALEM NUCLEAR GENERATING STATION, UNIT NO. 1 – SUMMARY OF
OCTOBER 27, 2017, CONFERENCE CALL WITH PSEG NUCLEAR LLC
RE: FALL 2017 STEAM GENERATOR INSPECTIONS (CAC NO. MG0215;
EPID L-2017-LRO-0028)

SALEM NUCLEAR GENERATING STATION, UNIT NO. 1
STEAM GENERATOR TUBE INSPECTION DISCUSSION POINTS
(DRAFT INFORMATION)

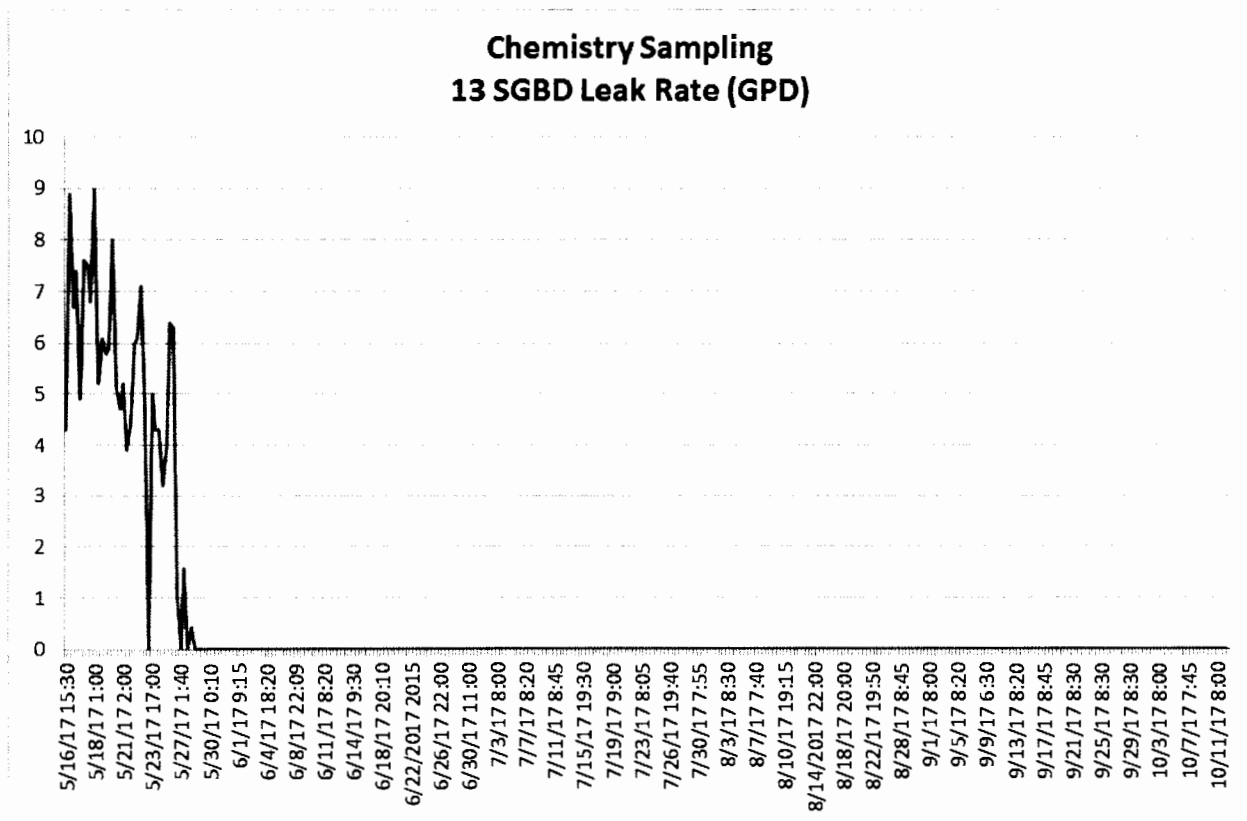
On Monday May 15, 2017 at approximately 1800, operators in the Salem-1 Control Room identified a rise in the primary-to-secondary leakage from radiation monitor indications. The small leak was identified in SG 13, and went below detection around May 28, 2017. Below is the chemistry grab sample results for the duration of the leak event, including up to the start of outage 1R25 (October 12, 2017). Subsequent to May 28, 2017, the leak remained below detection. Online radiation monitors provided similar trend.
