WCAP-14447

Repair Boundary for Parent Tube Indications  
Within the Upper Joint Zone of  
Hybrid Expansion Joint (HEJ) Sleeved Tubes

September 1995

WESTINGHOUSE ELECTRIC CORPORATION  
NUCLEAR SERVICES DIVISION  
P.O. BOX 158  
MADISON, PENNSYLVANIA 15663-0158

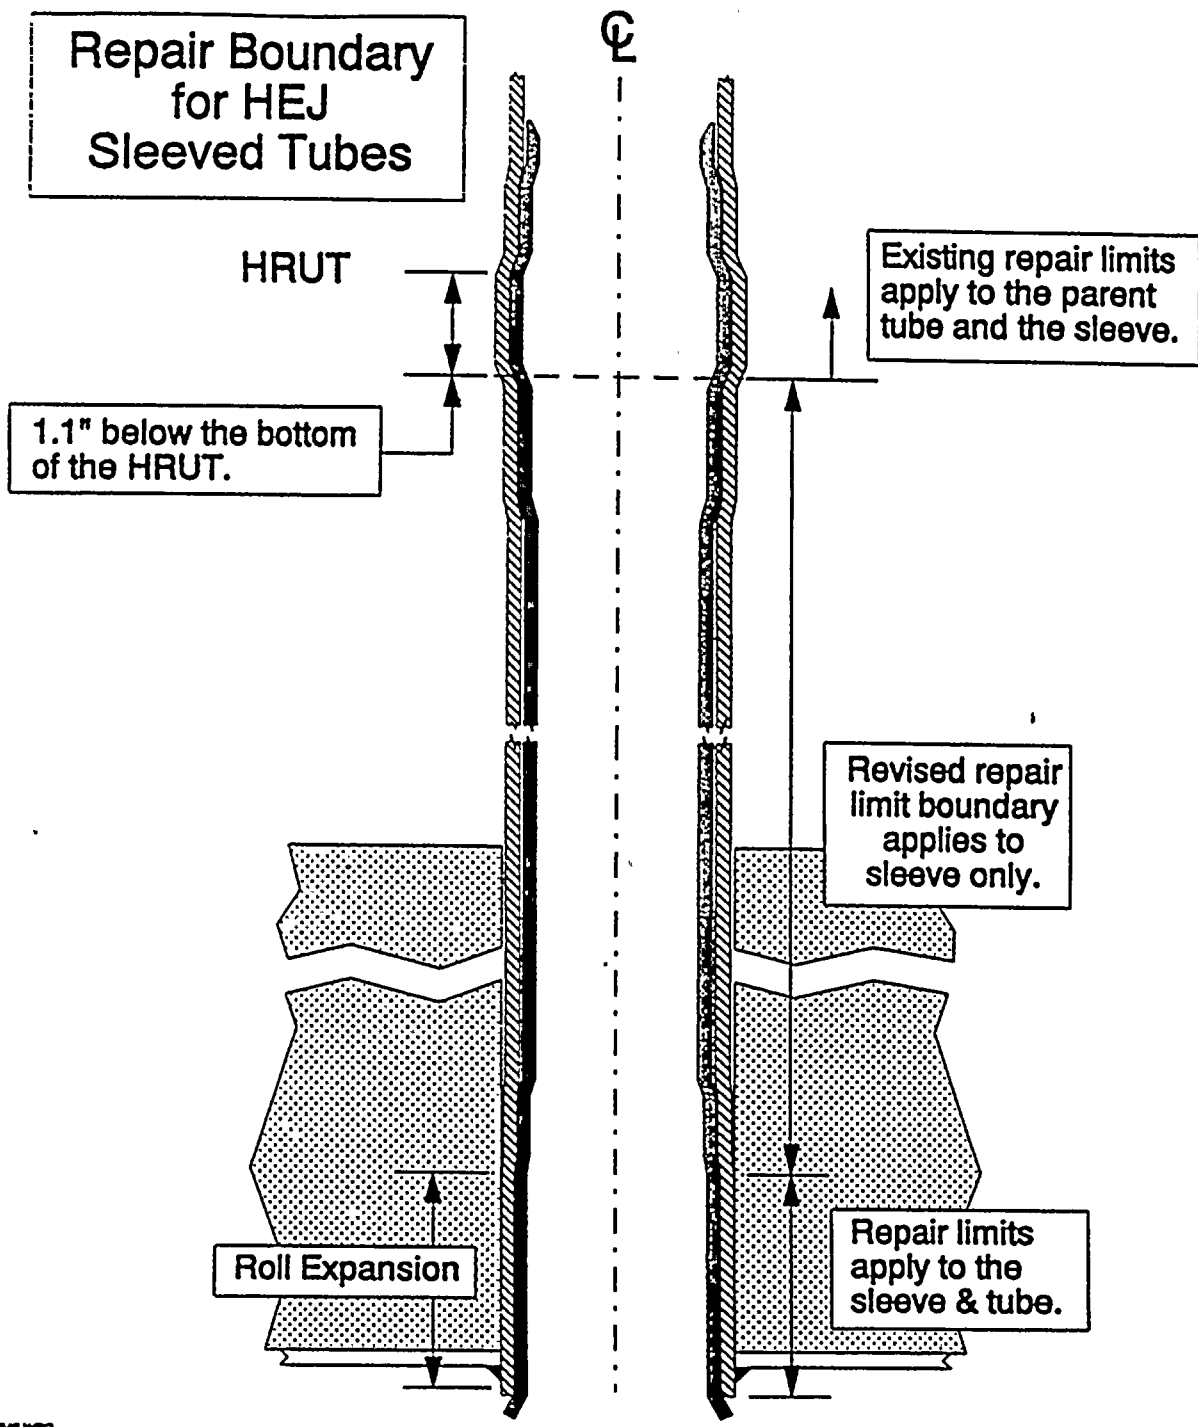
Figure 2-1: Revised Pressure Boundary Definition for HEJ Sleeved Tubes

The burst criteria of draft RG 1.121 were used to establish a repair boundary for HEJs with PTIs. The continued safe operation of the SGs is not compromised if the PTIs are located below the repair boundary, i.e., 1.1" downward from the bottom of the HRUT or lower, as illustrated on Figure 2-1.

Tests conducted in joints designed to simulate a 360° throughwall crack have shown that the upper hardroll must have additional axial load carrying capability to supplement the radial contact pressure of the sleeve-to-tube interface. To comply with this condition, PTIs in the sleeve/tube joint, i.e., the HEJ, must be limited to 1.1" and lower as reckoned downward from the bottom of the HRUT.

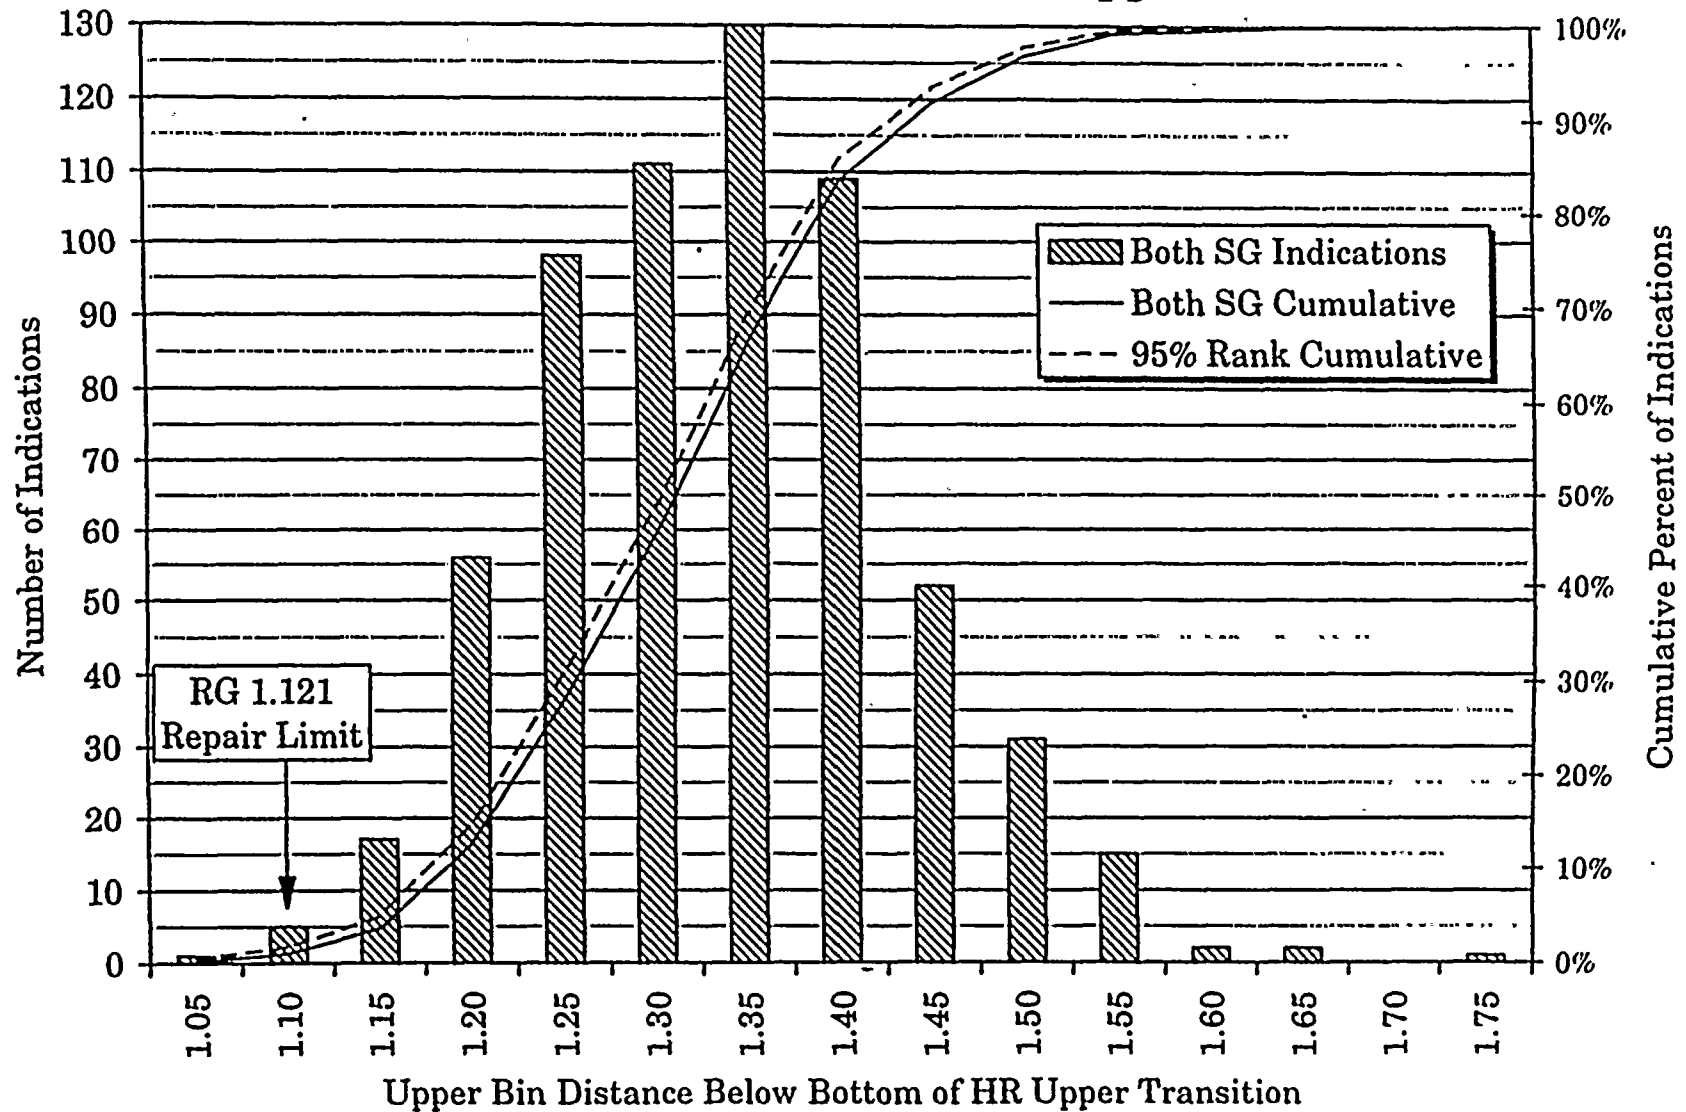
# **Kewaunee SGs "A" & "B" HEJ PTIs vs. Distance Below the Bottom of the HR Upper Transition**

Approximately 75% of the known PTIs have been found in tubes in the Kewaunee SGs. Hence, it would be expected that the distribution of indications relative to elevation can be characterized by the distribution found at Kewaunee. Figure 4-3 illustrates the distributions of PTIs at the last inspection outage at Kewaunee.<sup>1</sup> Approximately 1% of the indications were judged to be located within 1.1" of the bottom of the HRUT. If an eddy current positioning error of 1/16" is assumed, the number of indications above the repair boundary would be on the order of 4%.

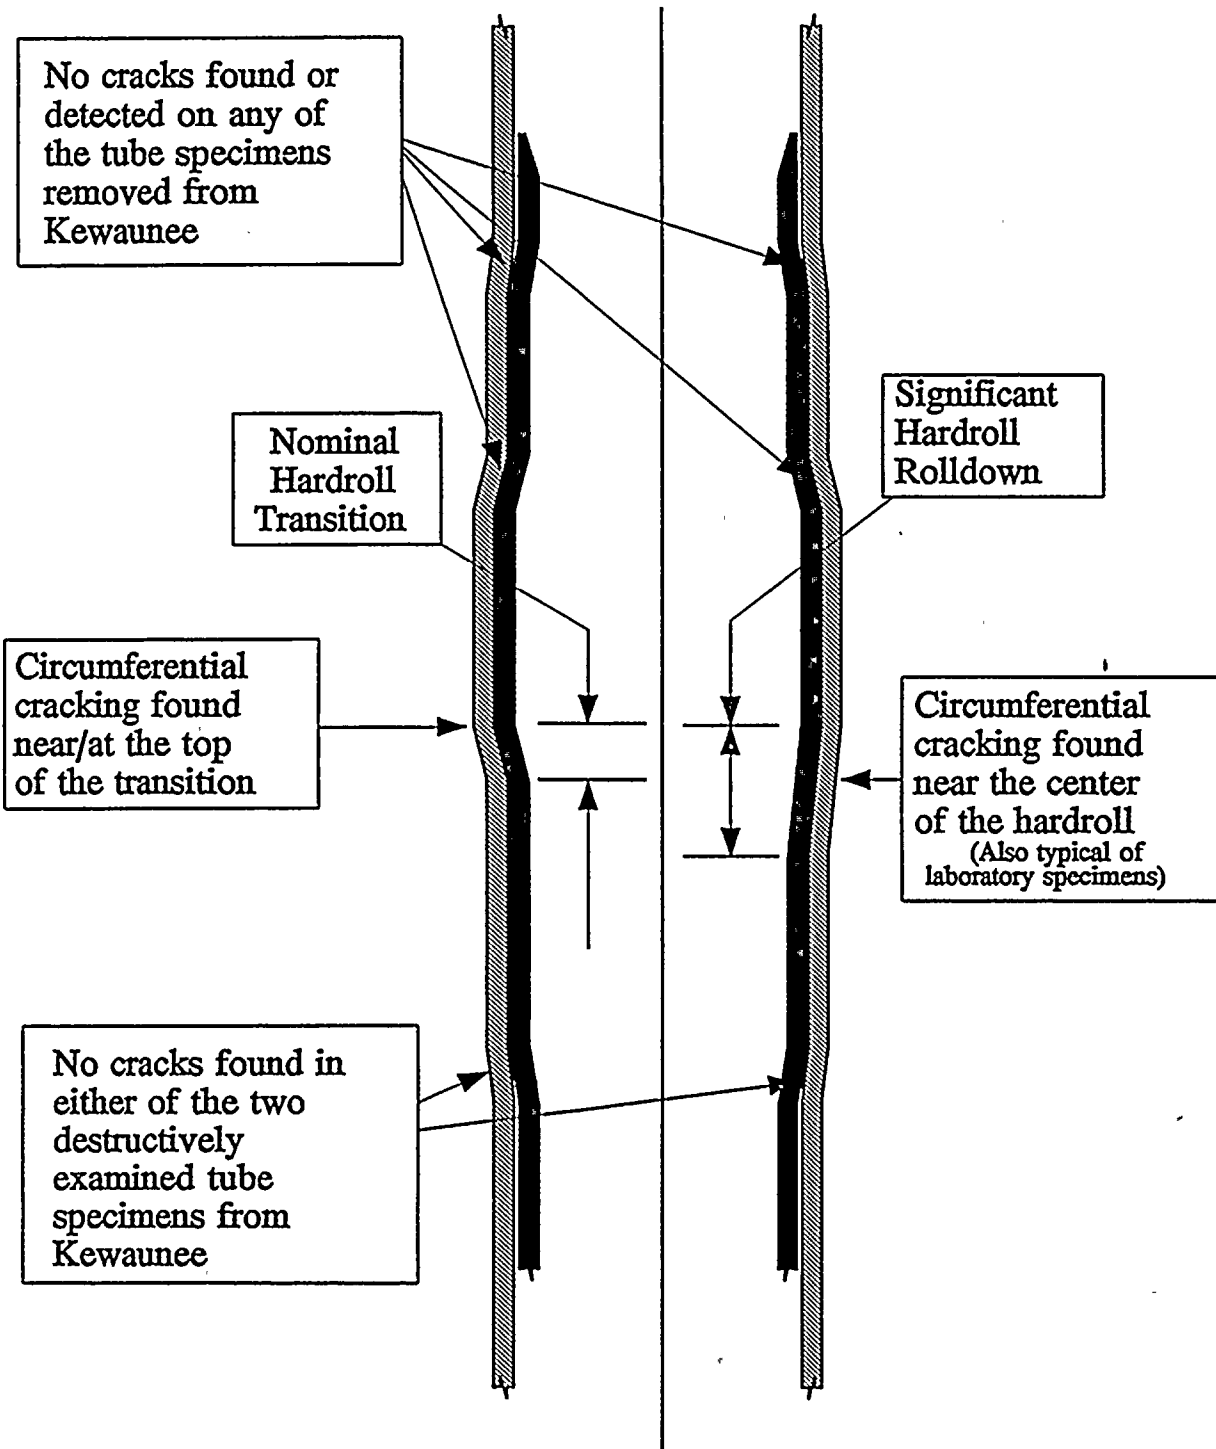
Figure 5-1

The radiographic laboratory examination detected a 270 to 360° circumferential band of short semi-continuous circumferential indications in the upper portion of the HRLT of the tube, just below the HR region in tube R2C32. These cracks were confined to a very narrow zone, less than 0.05" high, such that the individual cracks appeared to occur head-to-toe. In addition, a shorter (approximately 300° long) band of cracks was observed approximately 0.1" below the main band of cracks. tube R2C54 had two to three similar bands of short semi-continuous circumferential cracks that occurred over 350° from the mid- to upper portion of the HRLT. Tube R2C61 had one band of short semi-continuous circumferential cracks that occurred over 360° in the mid-portion of the HRLT.

All intergranular corrosion was confined to and located in the HRLT regions. In the case of tube R2C32 the cracking was at the upper portion of the HRLT and in the case of tube R2C54 the cracking was located from the mid-portion of the HRLT to the upper portion of the HRLT. The fracture faces both had a maximum depth of 92% throughwall, with average depths ranging from 61% (tube R2C32) to 60% (R2C34) throughwall and with microcrack lengths that were 360° long. At some ID locations adjacent to the fracture faces, a few short circumferential microcracks were observed parallel to the fracture face. These microcracks appeared to be simple cracks, morphologically speaking, in that the near absence of oblique angle cracks and blunting was noted. This morphology is more typical of PWSCC than of secondary side corrosion that typically occurs in caustic crevices.

## Location of Cracks in HEJ Sleeved Tubes Removed from Kewaunee
