LICENSEE EVENT REPORT (LER)

FACILITY NAME (1) D. C. Cook Nuclear Plant - Unit Two	DOCKET NUMBER (2) 0 5 0 0 0 3 1 1 6	PAGE (3) 1 OF 0 4
---	---	-----------------------------

TITLE (4)
Lack of Specificity in Technical Specification Requirements Resulted in Operation With Unanalyzed Emergency Core Cooling System Configuration

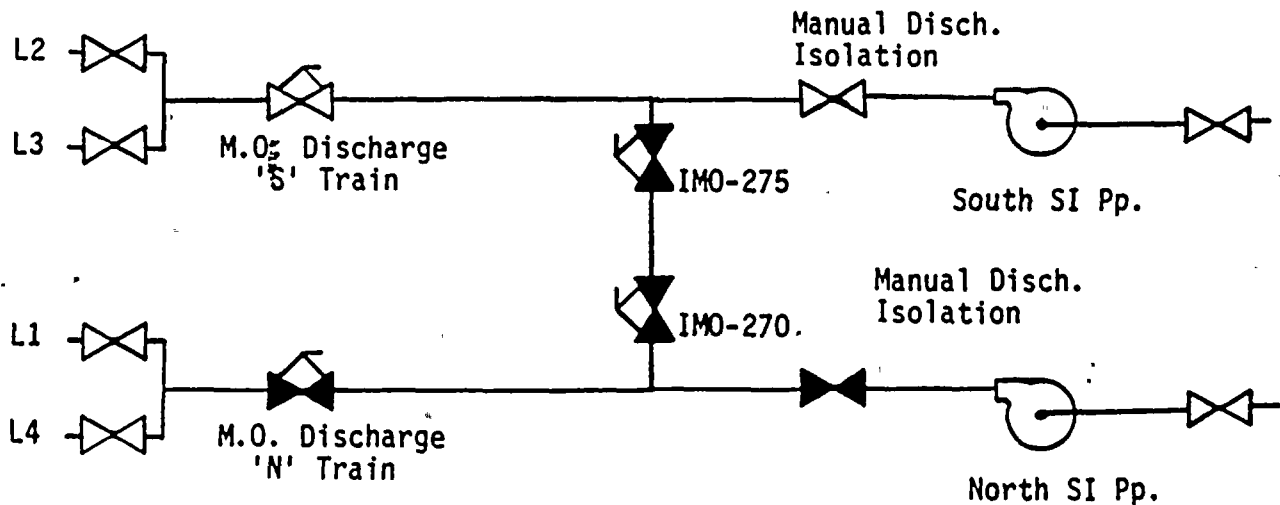
The intermediate head Safety Injection system outage began on September 4, 1986, at 0645 hours and lasted for a period of 18 hours and 53 minutes. At that time Unit Two was in Mode 1 (power operation) operating at 80 percent reactor thermal power. The purpose of this outage was to repair a body to bonnet leak on IMO-270, one of the two Safety Injection discharge cross-tie valves (EIIS-MOV). This required the isolation of both the motor operated (EIIS-MOV) and manual discharge isolation valves (EIIS-ISV) for the North Safety Injection Pump (EIIS-BQP) and the remaining discharge cross-tie (IMO-275). As a result the injection points to two of the four loops were lost.

As a result of the isolation boundary established for required maintenance being performed on one of the intermediate head Safety Injection system cross-tie valves, the North Safety Injection pump was not available for service and the South Safety Injection pump was only capable of delivering flow to two, rather than four injection points. This condition lasted for approximately 19 hours while the valve was being repaired.

Administrative controls have been placed on the cross-tie valves and other identified Emergency Core Cooling System valves on both Units to prevent isolation. In addition, operational and Technical Specification direction has been sought to ensure compliance with the surveillance requirements for this system.
