ENVIRONMENTAL IMPACT APPRAISAL  
BY THE OFFICE OF NUCLEAR REACTOR REGULATION  
LICENSE NOS. DPR-31 AND DPR-41  
FLORIDA POWER AND LIGHT COMPANY  
TURKEY POINT PLANT UNITS 3 AND 4  
DOCKET NOS. 50-250 AND 50-251

JUNE 29, 1979

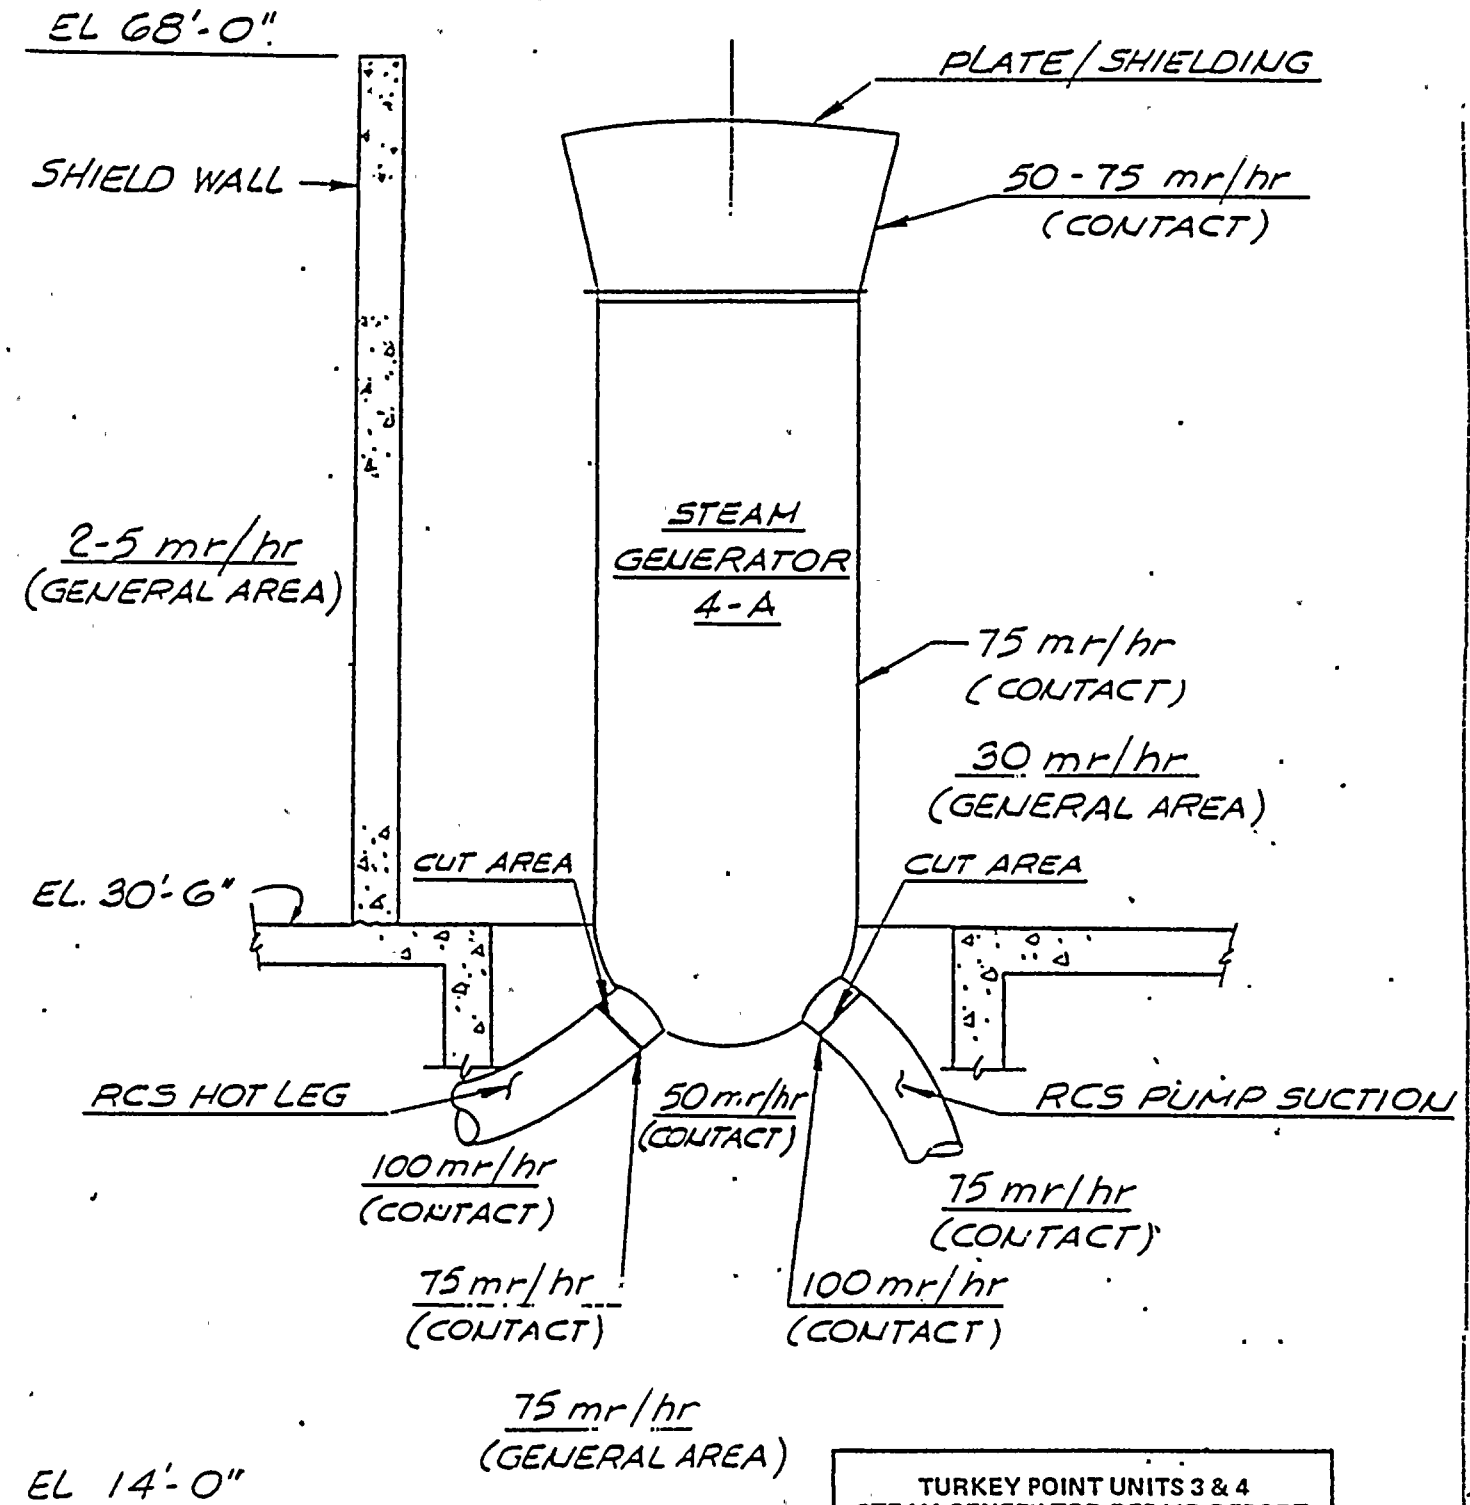
**Figure 3.2**

A drawing showing the principal parts of a typical steam generator is presented in Figure 3.1. Figure 3.2 shows the regions where the main cuts are proposed to remove the degraded steam generator. It shows also the radiation levels in these regions. A brief description of the FPL proposed repair procedure follows.

**DOSE RATES AROUND STEAM  
GENERATOR 4A**
