TURKEY POINT 3 STEAM GENERATOR  
INSPECTION PROGRAM

I. Introduction

An extensive inspection program for the Turkey Point Unit 3 steam generators was conducted in October, 1980. The following items were accomplished:

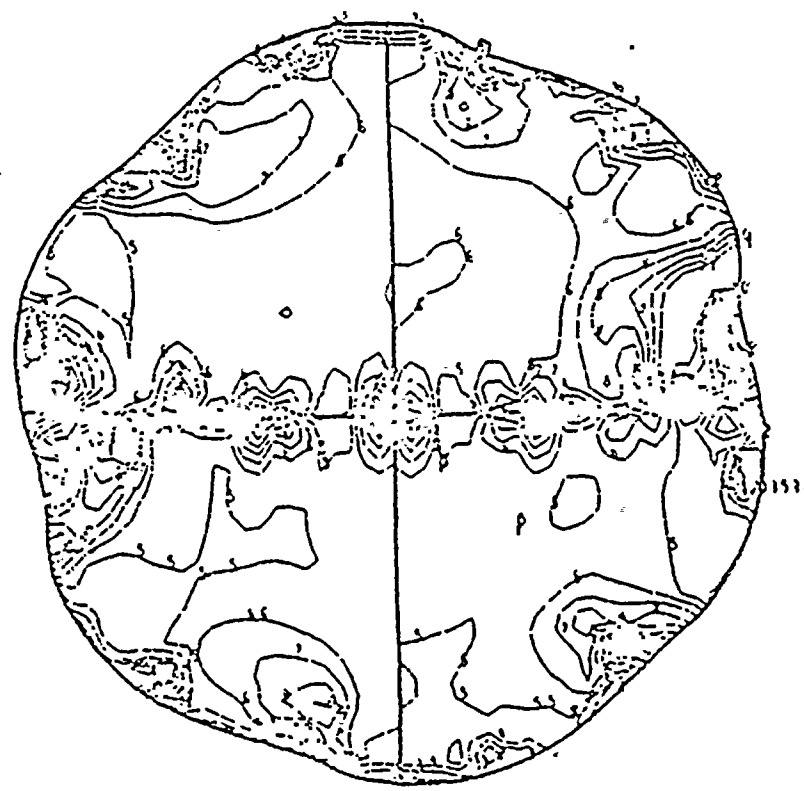
FIGURE 1 - TUBE HOOP STRAIN AT  
24 EFPM's BEYOND FULL CLOSURE

expectations as to the position of a strain boundary which might be linked to location of the most severely restricted tubes. The 17.5% strain contour utilized in the 12/79 inspection would encompass most of the hot leg tube bundle at 24 effective full power months beyond closure of the support plate flow slots, which is regarded as having occurred as of the 12/77 inspection. (The tube hoop strain at 24 effective full power months beyond full closure is given for reference purposes in Figure 1). Therefore, the gauging program, based on the program used in 12/79, has been adjusted to reflect prior experience at the Surry and Turkey Point plants. Additional inspection programs were defined for the periphery, wedge, and patch plate regions. These programs were based on previous tube leakage histories at the Turkey Point and Surry plant sites, as well as previous gauging results at the Surry and Turkey Point sites, as deemed appropriate. Due to the current awareness of the potential for tube deformation on the cold leg side, inspections of all three steam generator cold legs were performed.

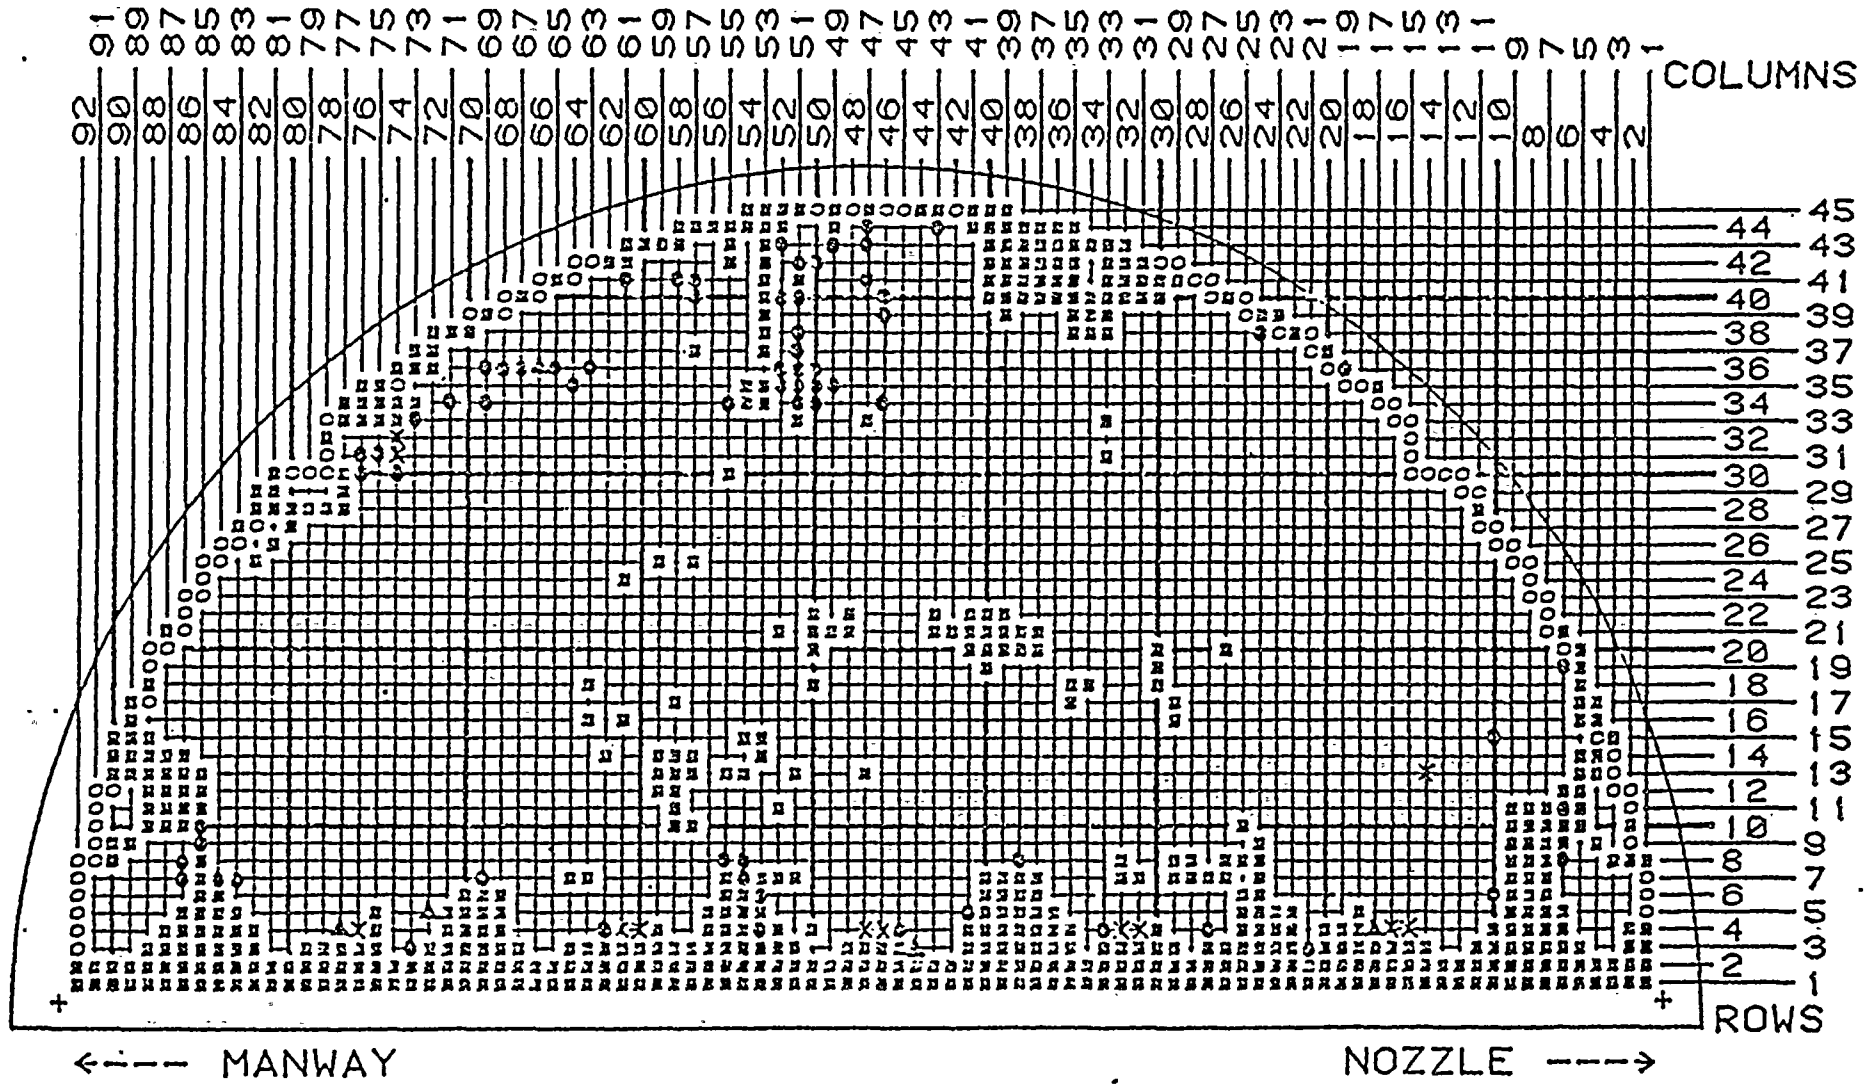
Turkey Point Unit 3  
 Steam Generator A - Inlet  
 Gauging Results - October, 1980

1. In steam generators A, B, and C, restricted tubes generally developed adjacent to previous activity or clustered together with other new activity. This was particularly true of tubes that restricted the 0.610" and 0.540" probes. Areas of activity were consistent with past historical data for this and other plants.

69  
 5  
 12

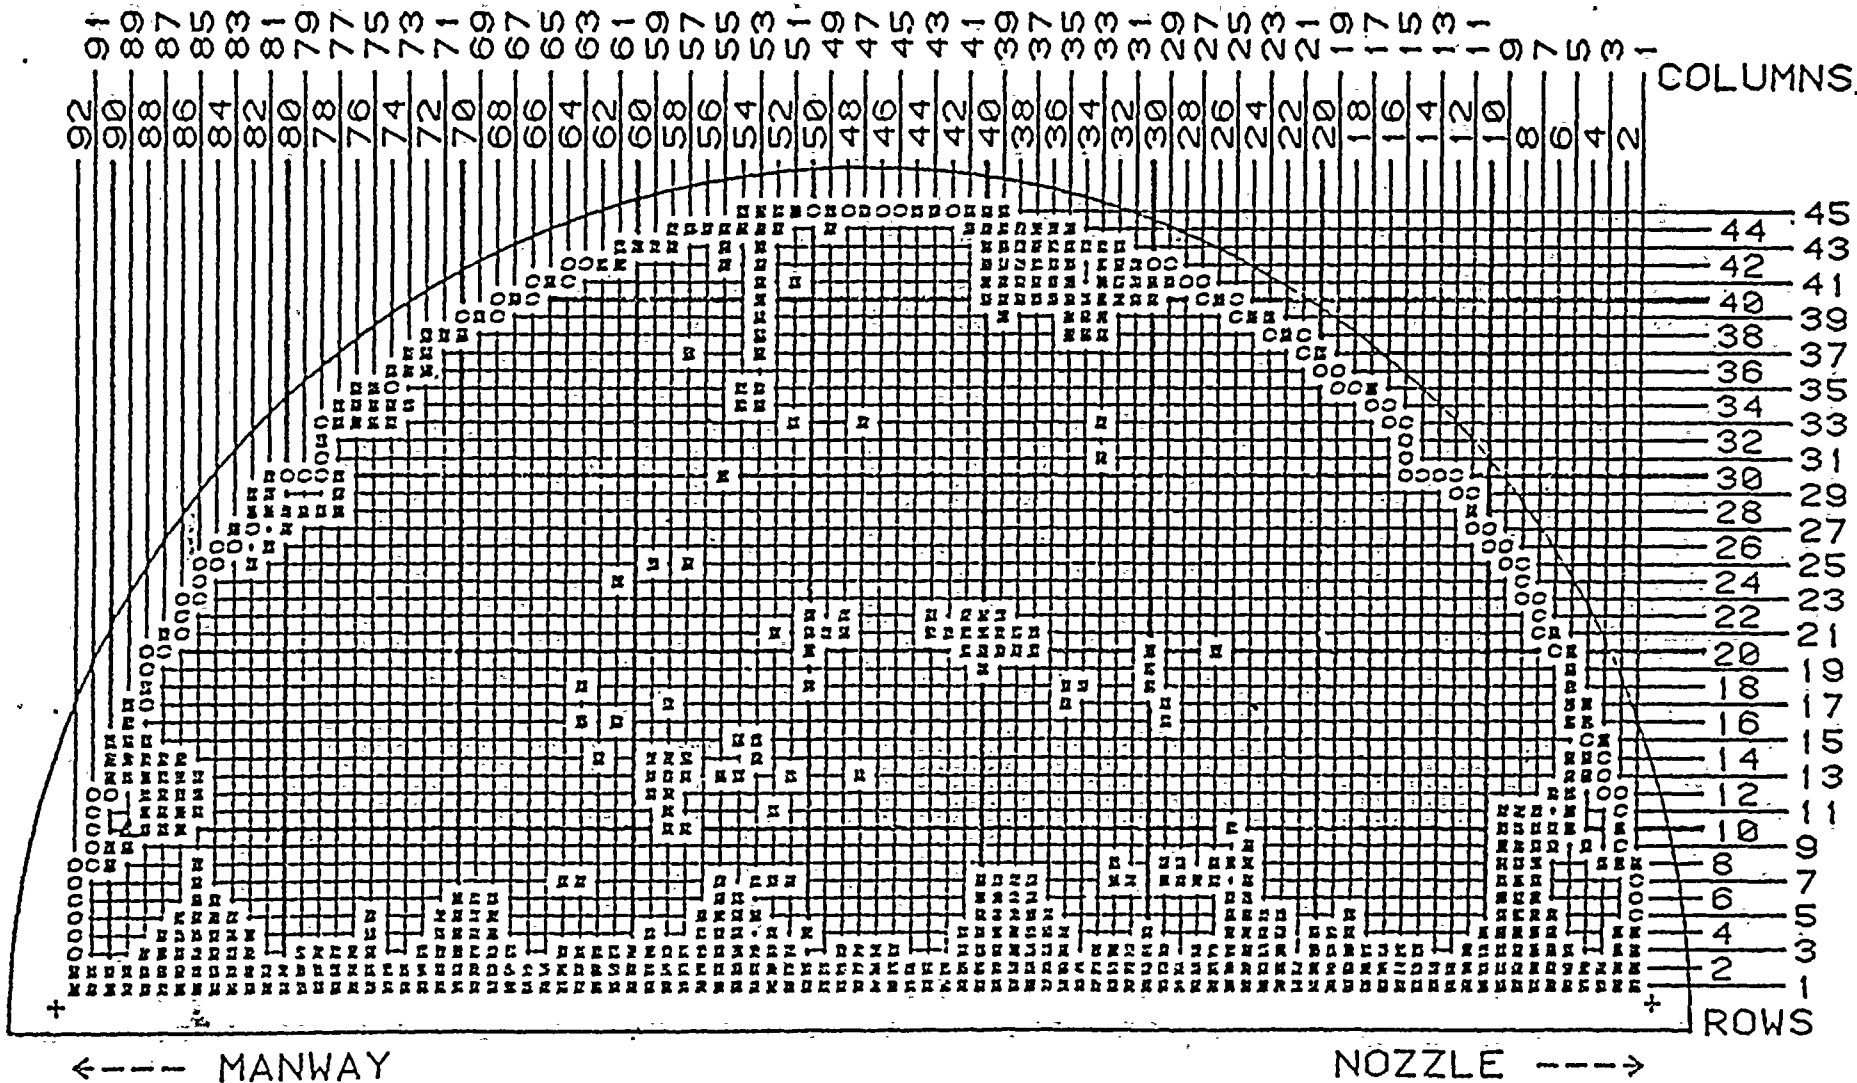
Turkey Point Unit 3  
 Steam Generator A - Outlet  
 Gauging Results - October, 1980

0  
 1  
 0

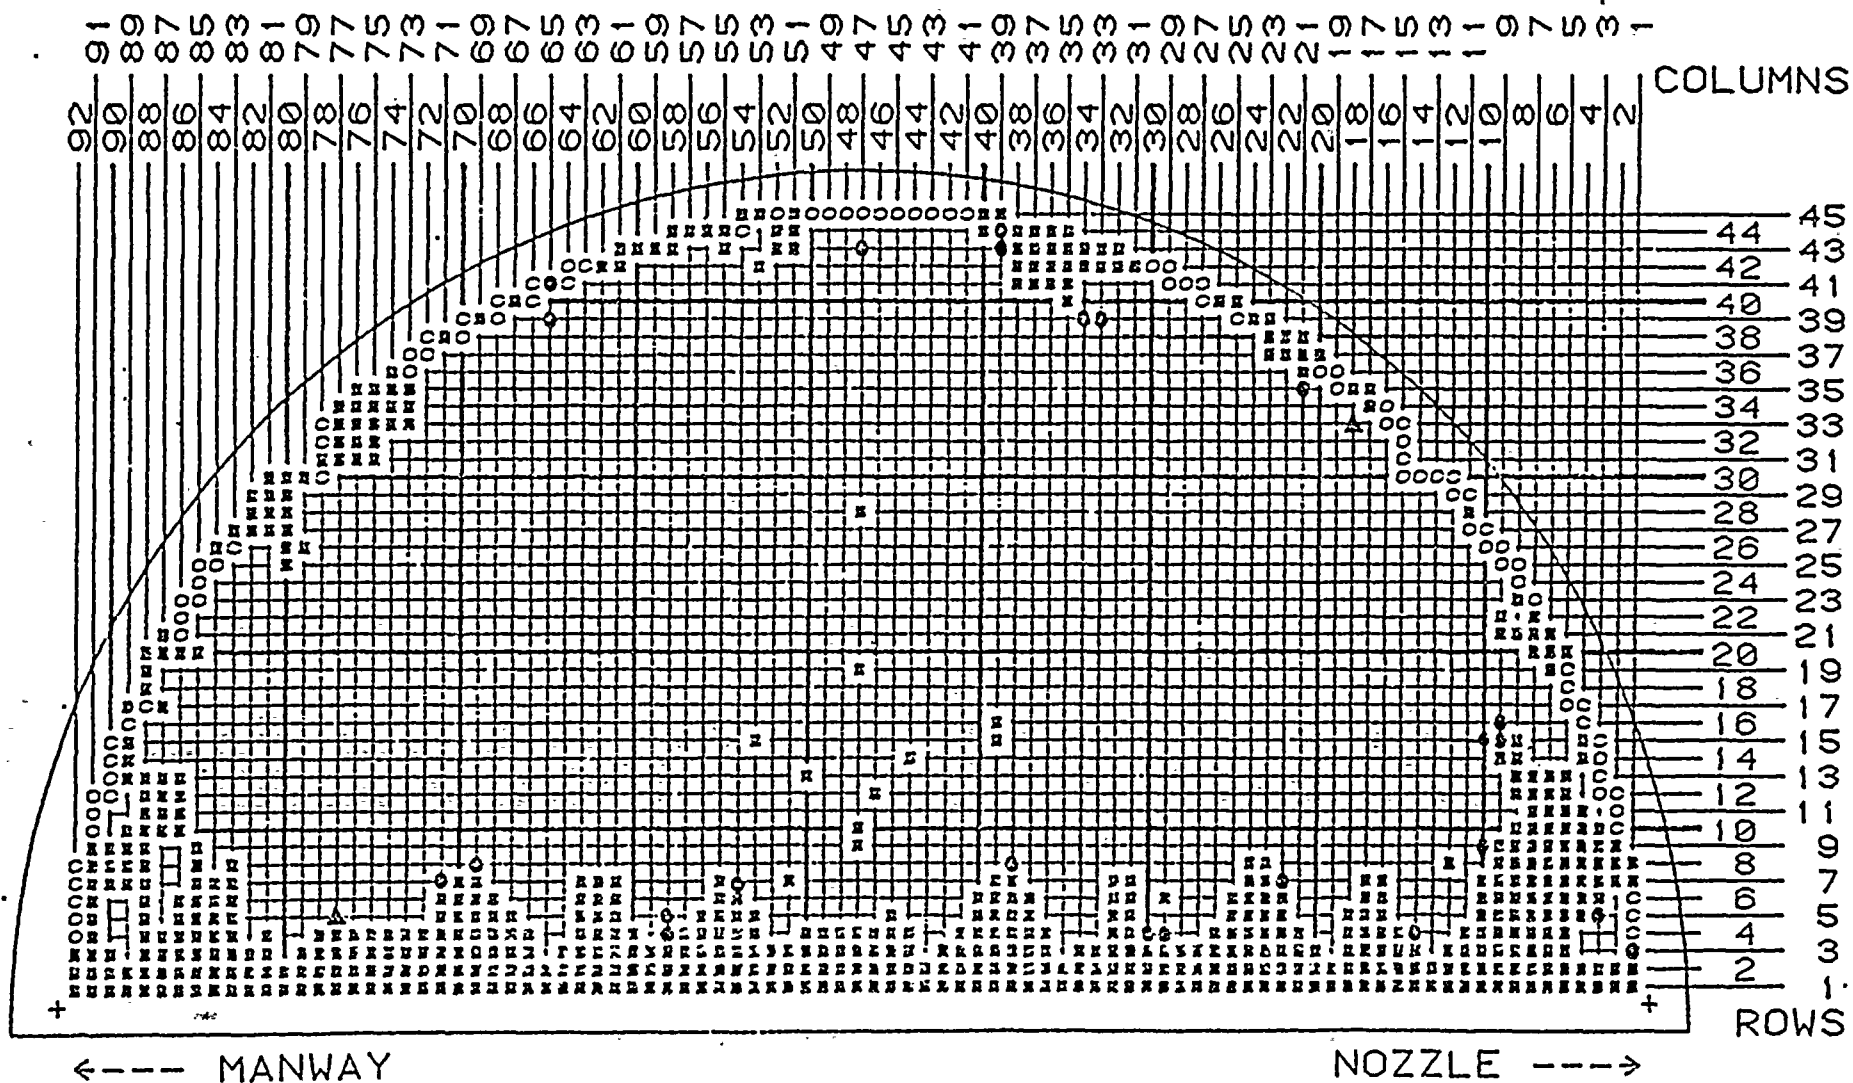
FIGURE 9

Turkey Point Unit 3  
 Steam Generator B - Inlet  
 Gauging Results - October, 1980

⊙ = .650"      24  
 △ = .610"      2  
 X = .540"      0

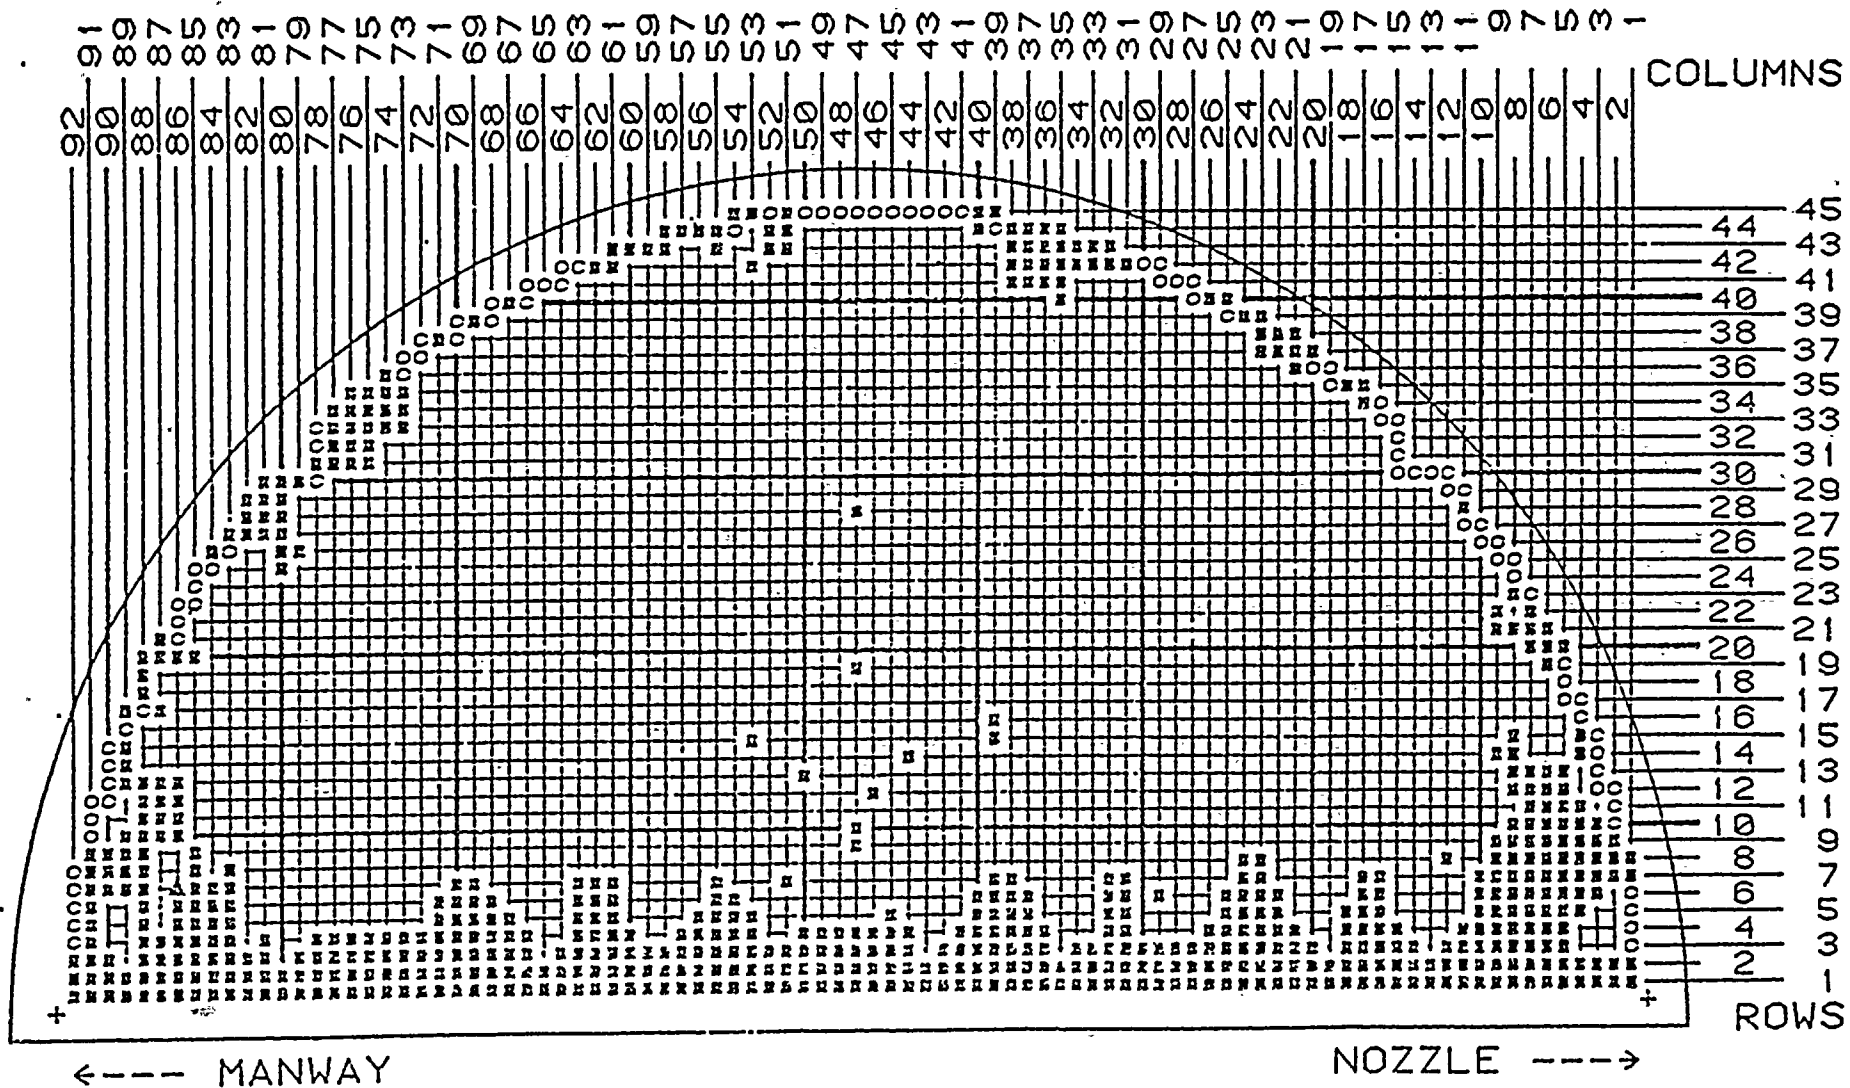
FIGURE 10

3. In this inspection of the cold leg areas, only one tube restriction was noted in the tubelane regions (SGB). No activity was noted in four of the six cold leg wedge areas inspected. Slight activity was noted adjacent to one of the inspected wedge areas in each of SG/A and SG/C. The level of activity is consistent with that noted in previous Turkey Point inspections. The overall level of activity continues to indicate a very low growth rate as compared to the hot leg.

Turkey Point Unit 3  
 Steam Generator B - Outlet  
 Gauging Results - October, 1980

0  
 1  
 0

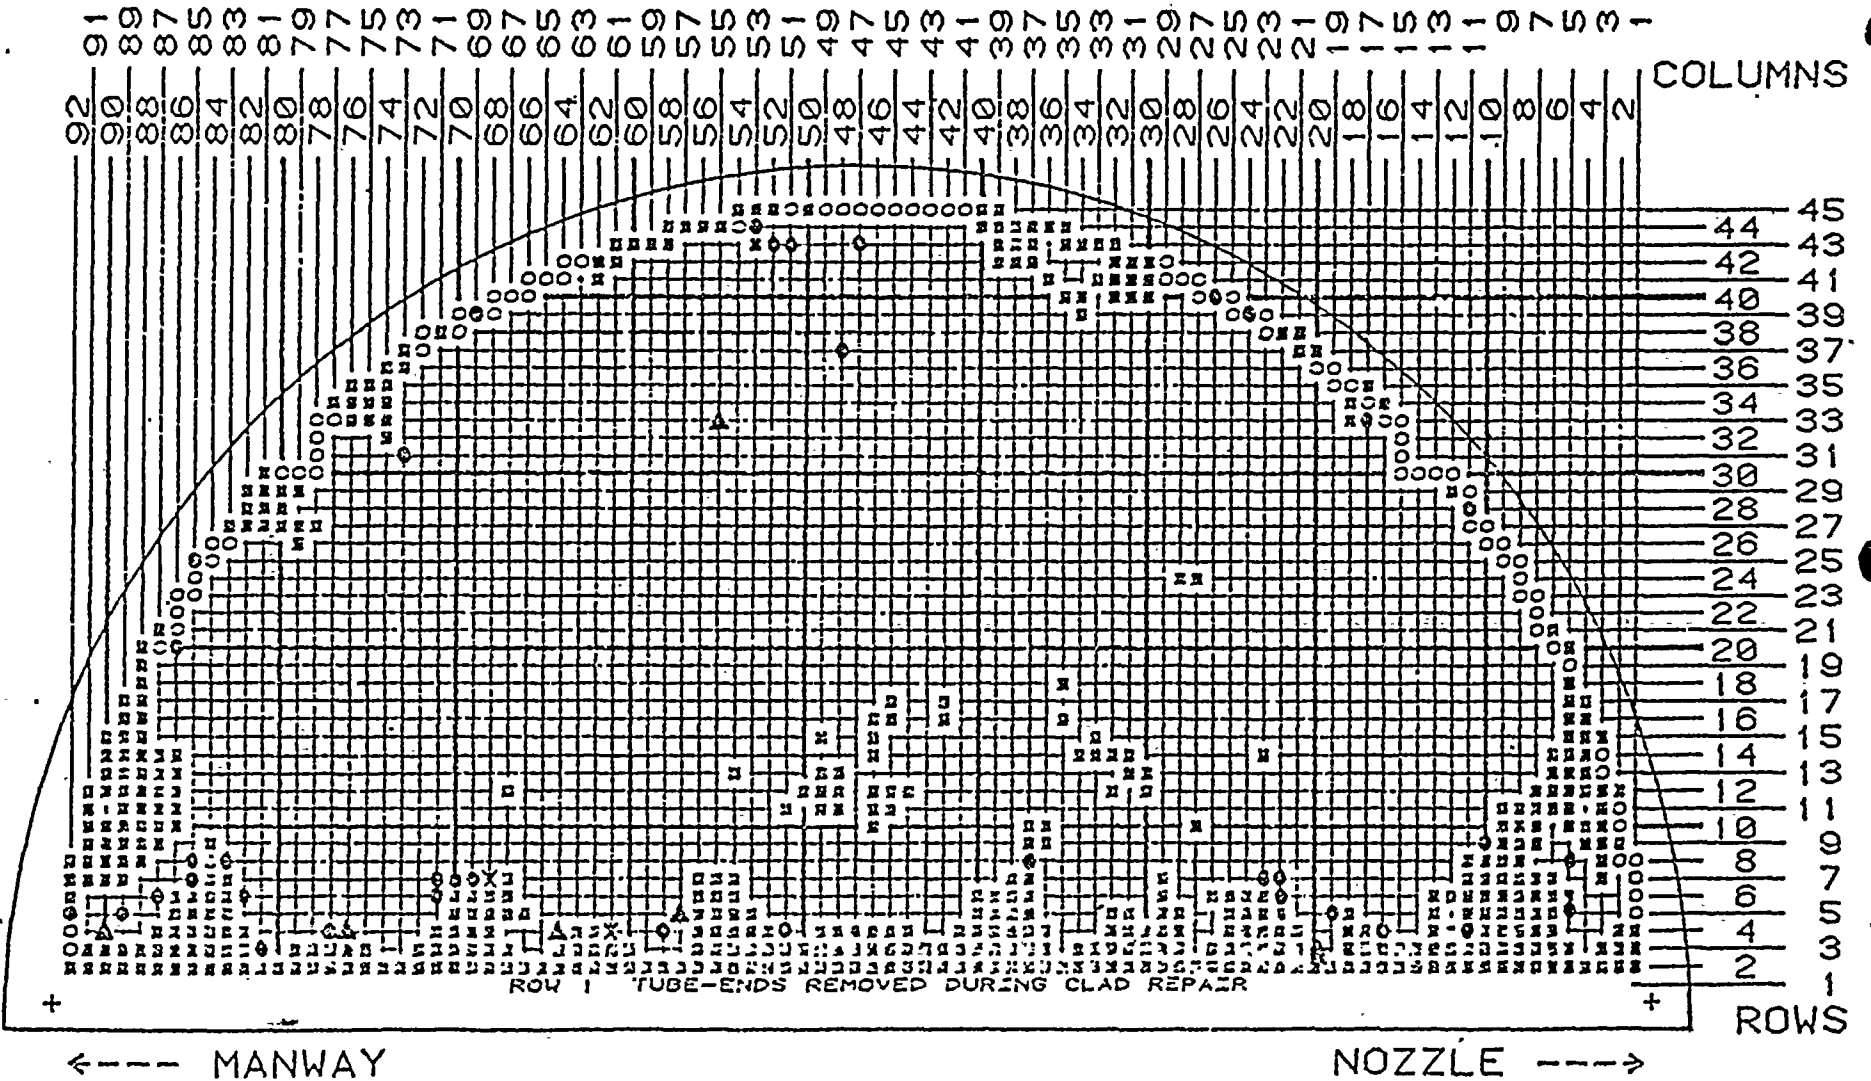
# FIGURE 1

Turkey Point Unit B  
Steam Generator C - Inlet  
Gauging Results - October, 1980

38  
5  
2

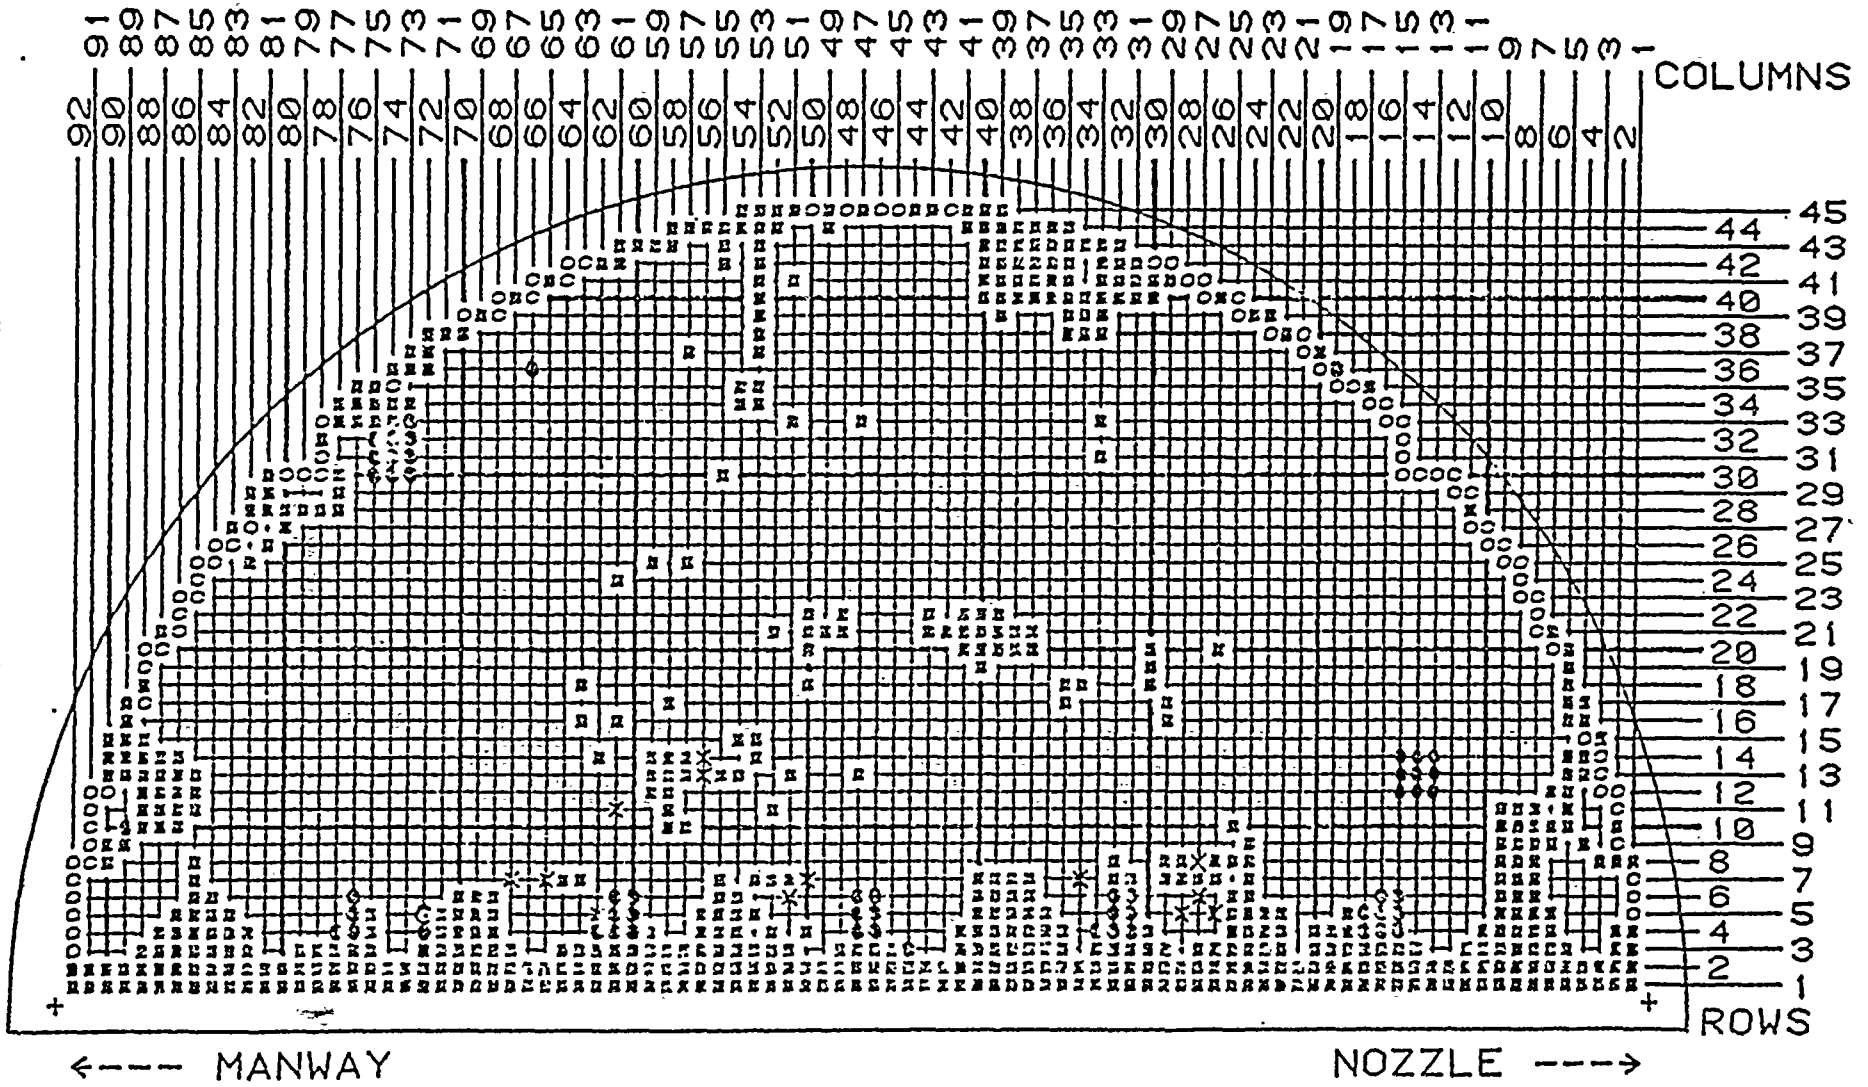
FIGURE 13

restriction. The pluggable tubes are generally located in rows 5 to 8, inclusive, with only a few in higher rows, as shown in Figures 13 and 15.

TURKEY POINT Unit #3  
STEAM GENERATOR A  
October, 1980

57  
13

The preventive plugging programs that were implemented are indicated in Figures 13, 14 and 15. Both gauging and Regulatory Guide 1.83 program plugging are indicated. Table 4 summarizes this plugging.

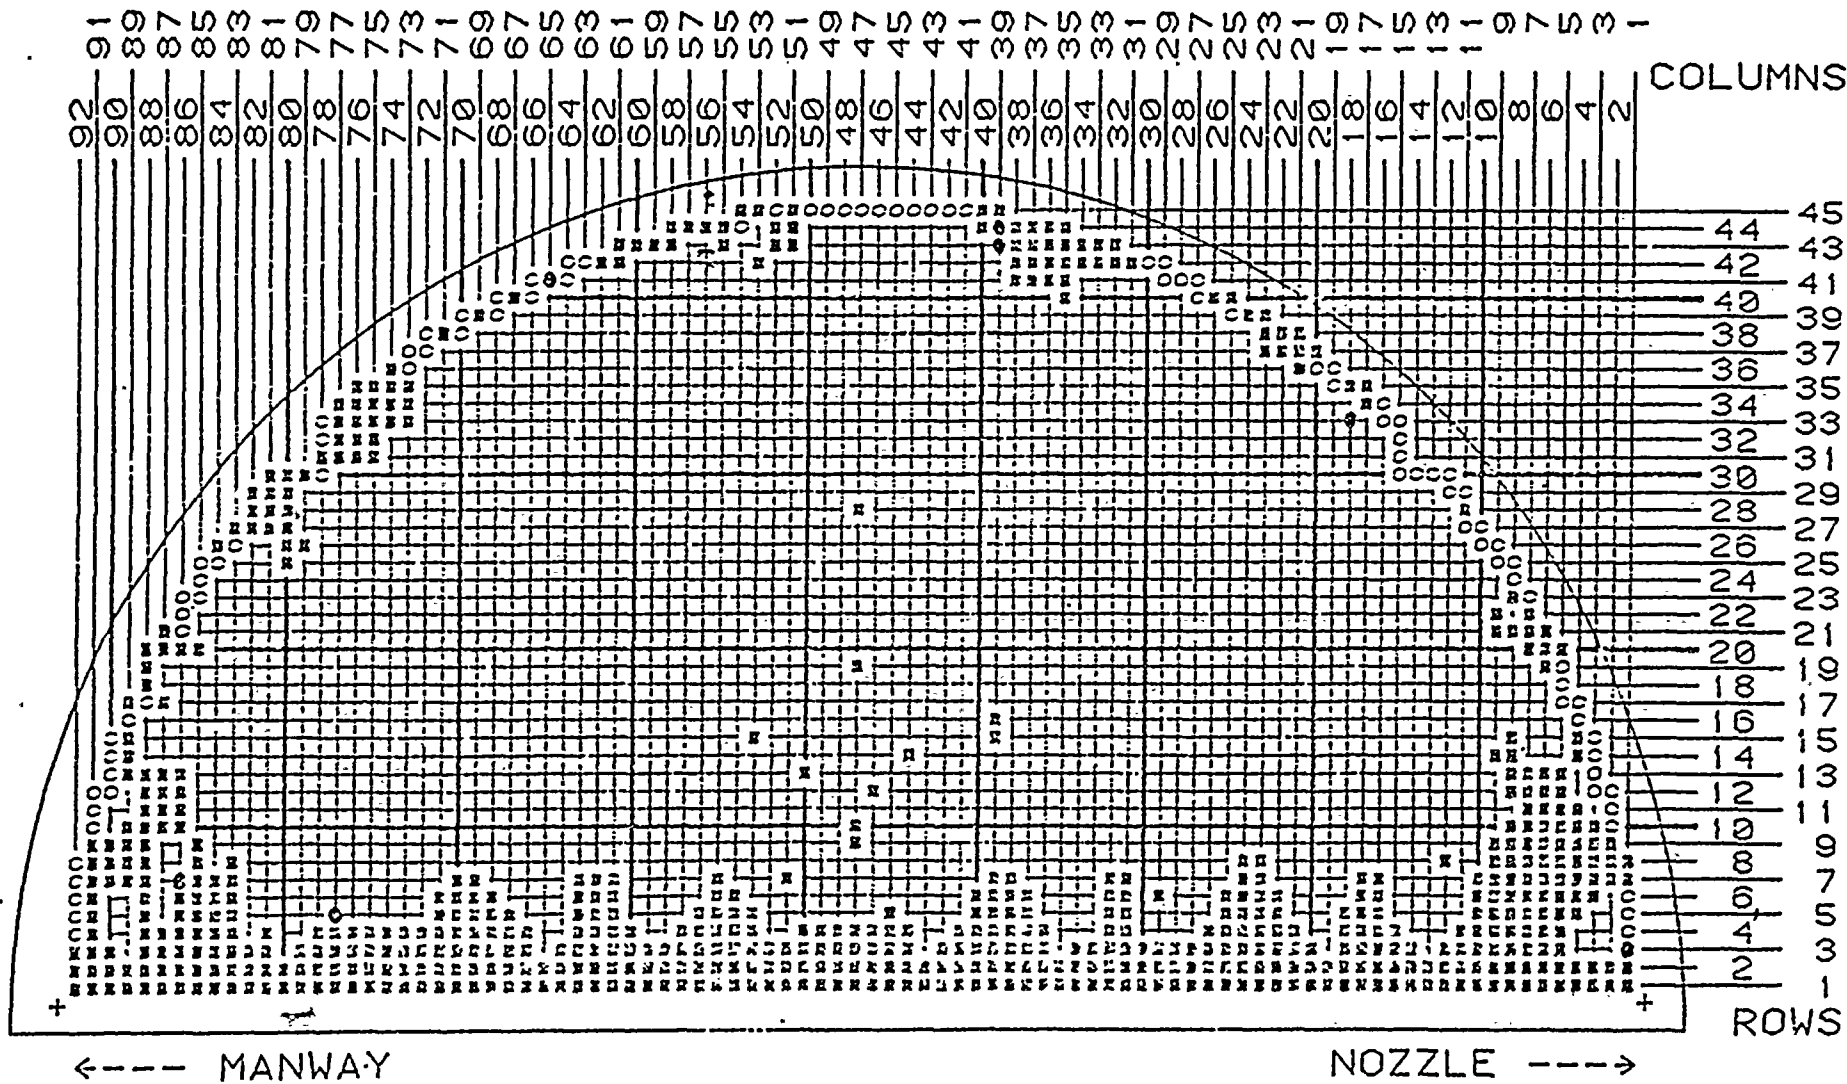
FIGURE 14

TURKEY POINT UNIT #3  
 STEAM GENERATOR B  
 October, 1980

7  
 0

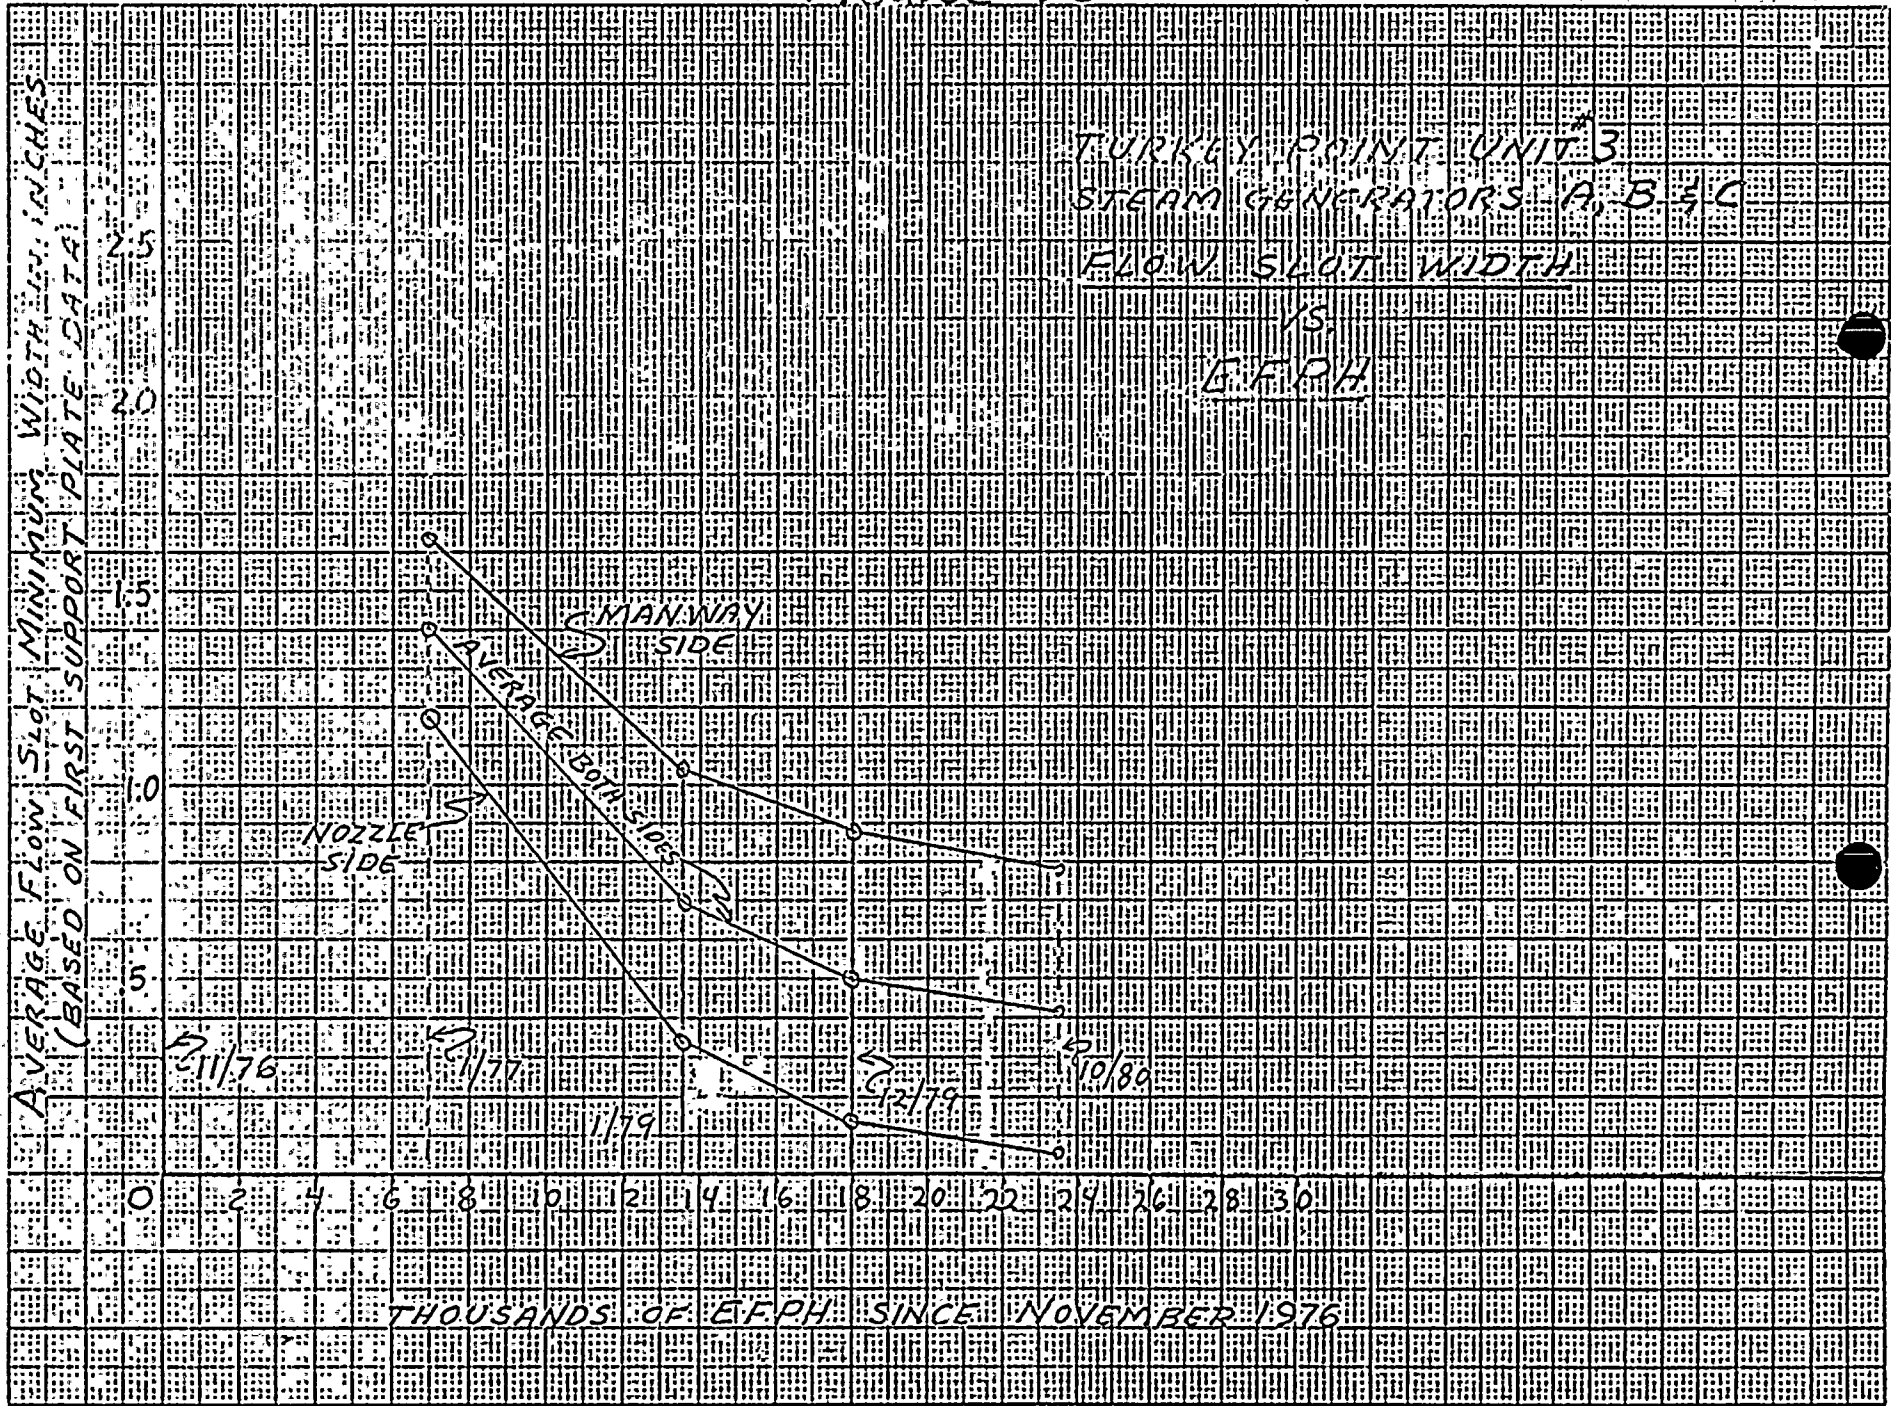
FIGURE 16

The results of the flow slot measurements are indicated in Figure 16. Only the lower support plates are clearly visible in each S/G. The results are consistent with previous behavior.
