ENGINEERING EVALUATION OF FEEDWATER TRANSIENT AND
SYSTEM PIPE BREAK AT TURKEY POINT UNIT 3
ON NOVEMBER 19, 1980

by the
Office for Analysis and Evaluation
of Operational Data
February 1981

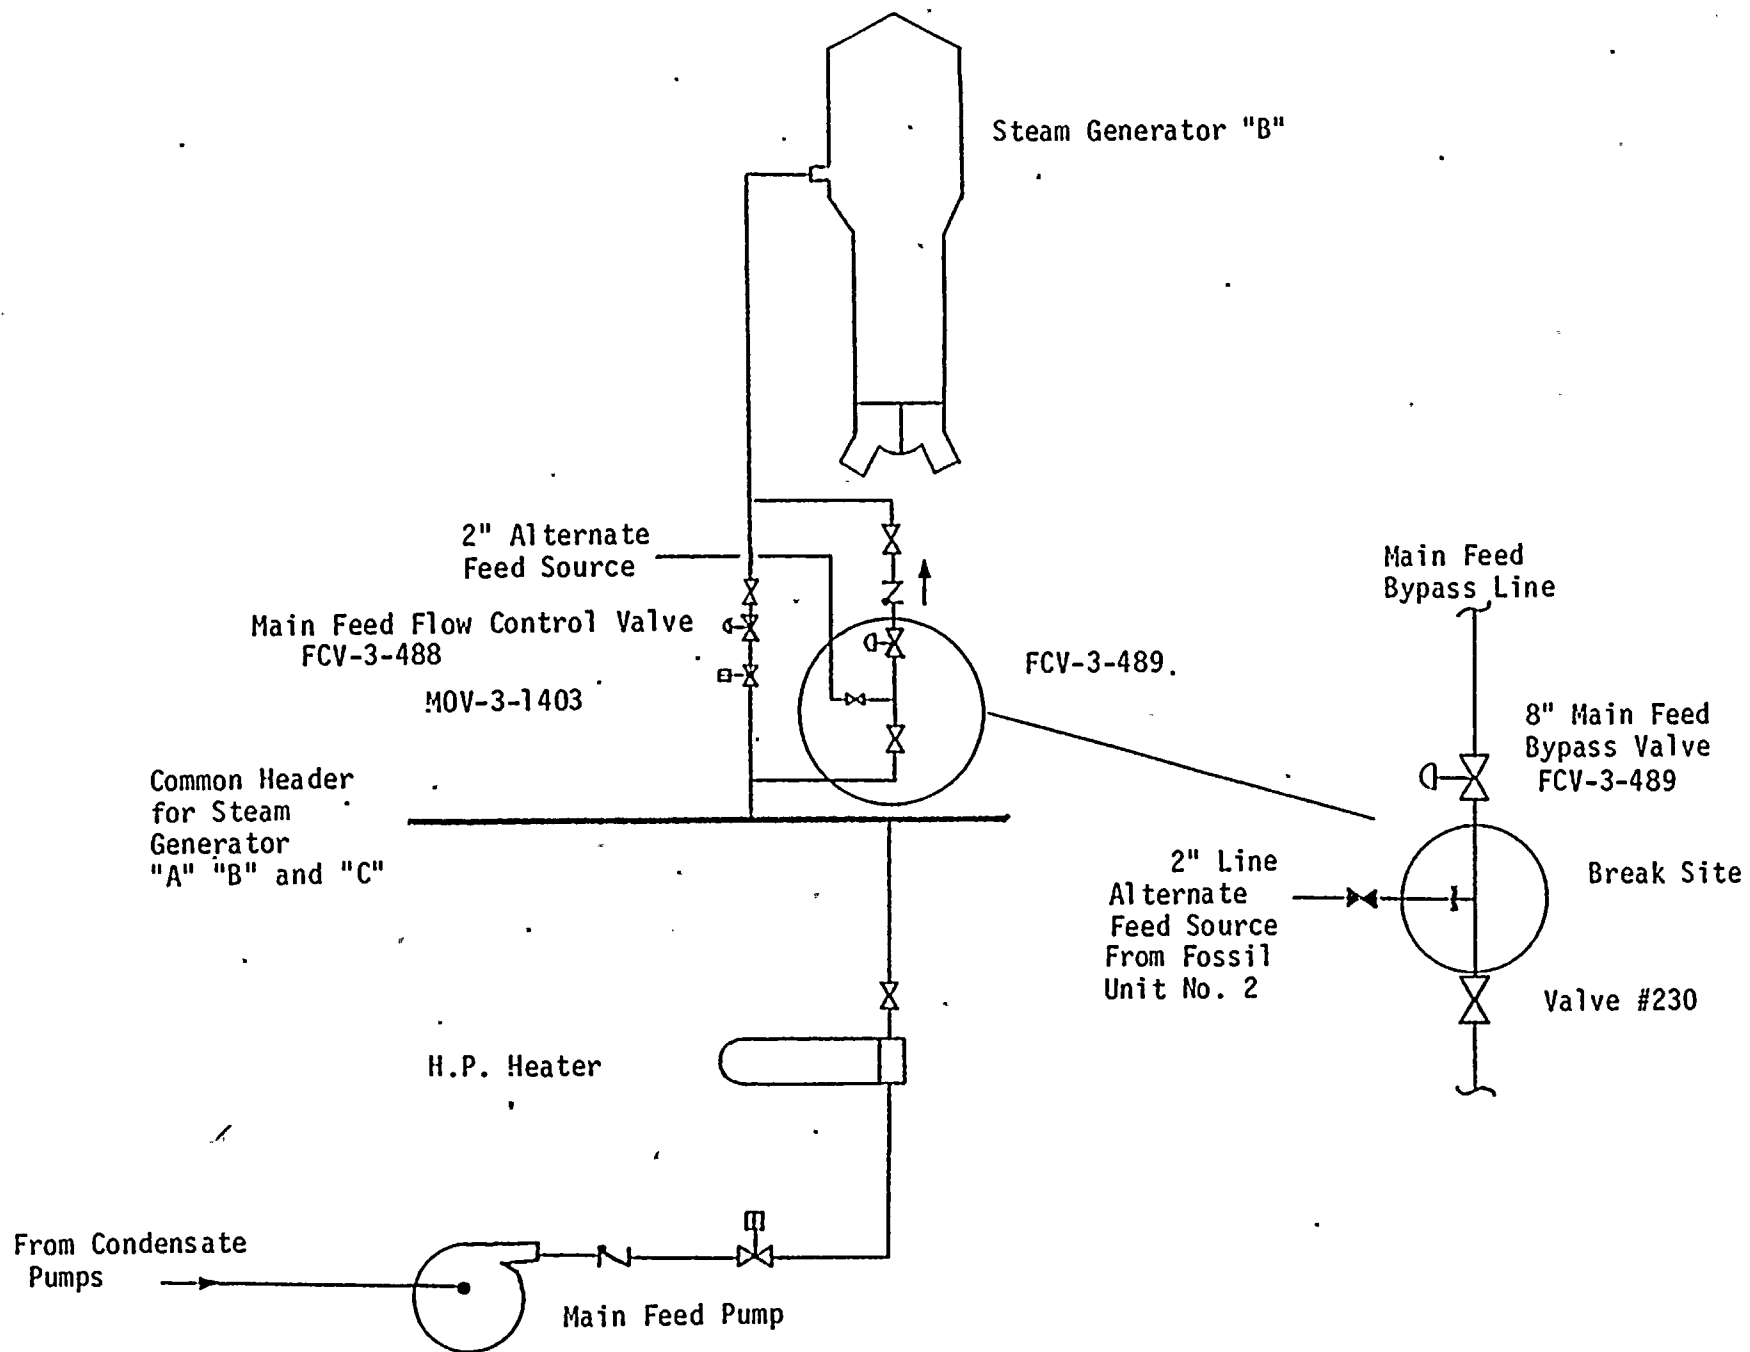
FIGURE 2 - TYPICAL FEEDWATER SYSTEM LAYOUT

isolated within thirty minutes. Investigation revealed that the plug had separated from the stem on valve FCV-3-489 (indicated on Figure 2), S/G "B" feedwater flow control bypass valve. Repairs to the flow control valve and the ruptured two-inch alternate feed line were completed and the unit was returned to power.

The underlying cause of the series of occurrences was the plug/stem separation of valve FCV-3-478, steam generator "A" main feedwater flow control valve. According to the licensee, the apparent cause of the stem failure was improper load distribution between the stem and plug due to the taper on the valve stem caused by improper manufacturing tolerances. This stem failure was the most probable cause of the flow oscillation and the feed control valve failing closed on the first reactor trip. When the unit tripped, the stem on the feed control valve was driven back into the plug on the feedwater isolation signal (reactor trip signal and low Tavg. < 554°F). There is evidence to support this in that three rows of threads above the break on the stem were damaged.
