SUBJECT: Proposes mod to turbine runback sys, deleting flux rat input.
 Sys prone to spurious runbacks due to single failure of
 single electrical component. Encl safety evaluation discusses
 consequences of single dropped rod control cluster assembly.

Re: Turkey Point Units 3 & 4
Docket No. 50-250 and 50-251
Turbine Runback System

MODIFICATION OF THE TURBINE RUNBACK SYSTEM

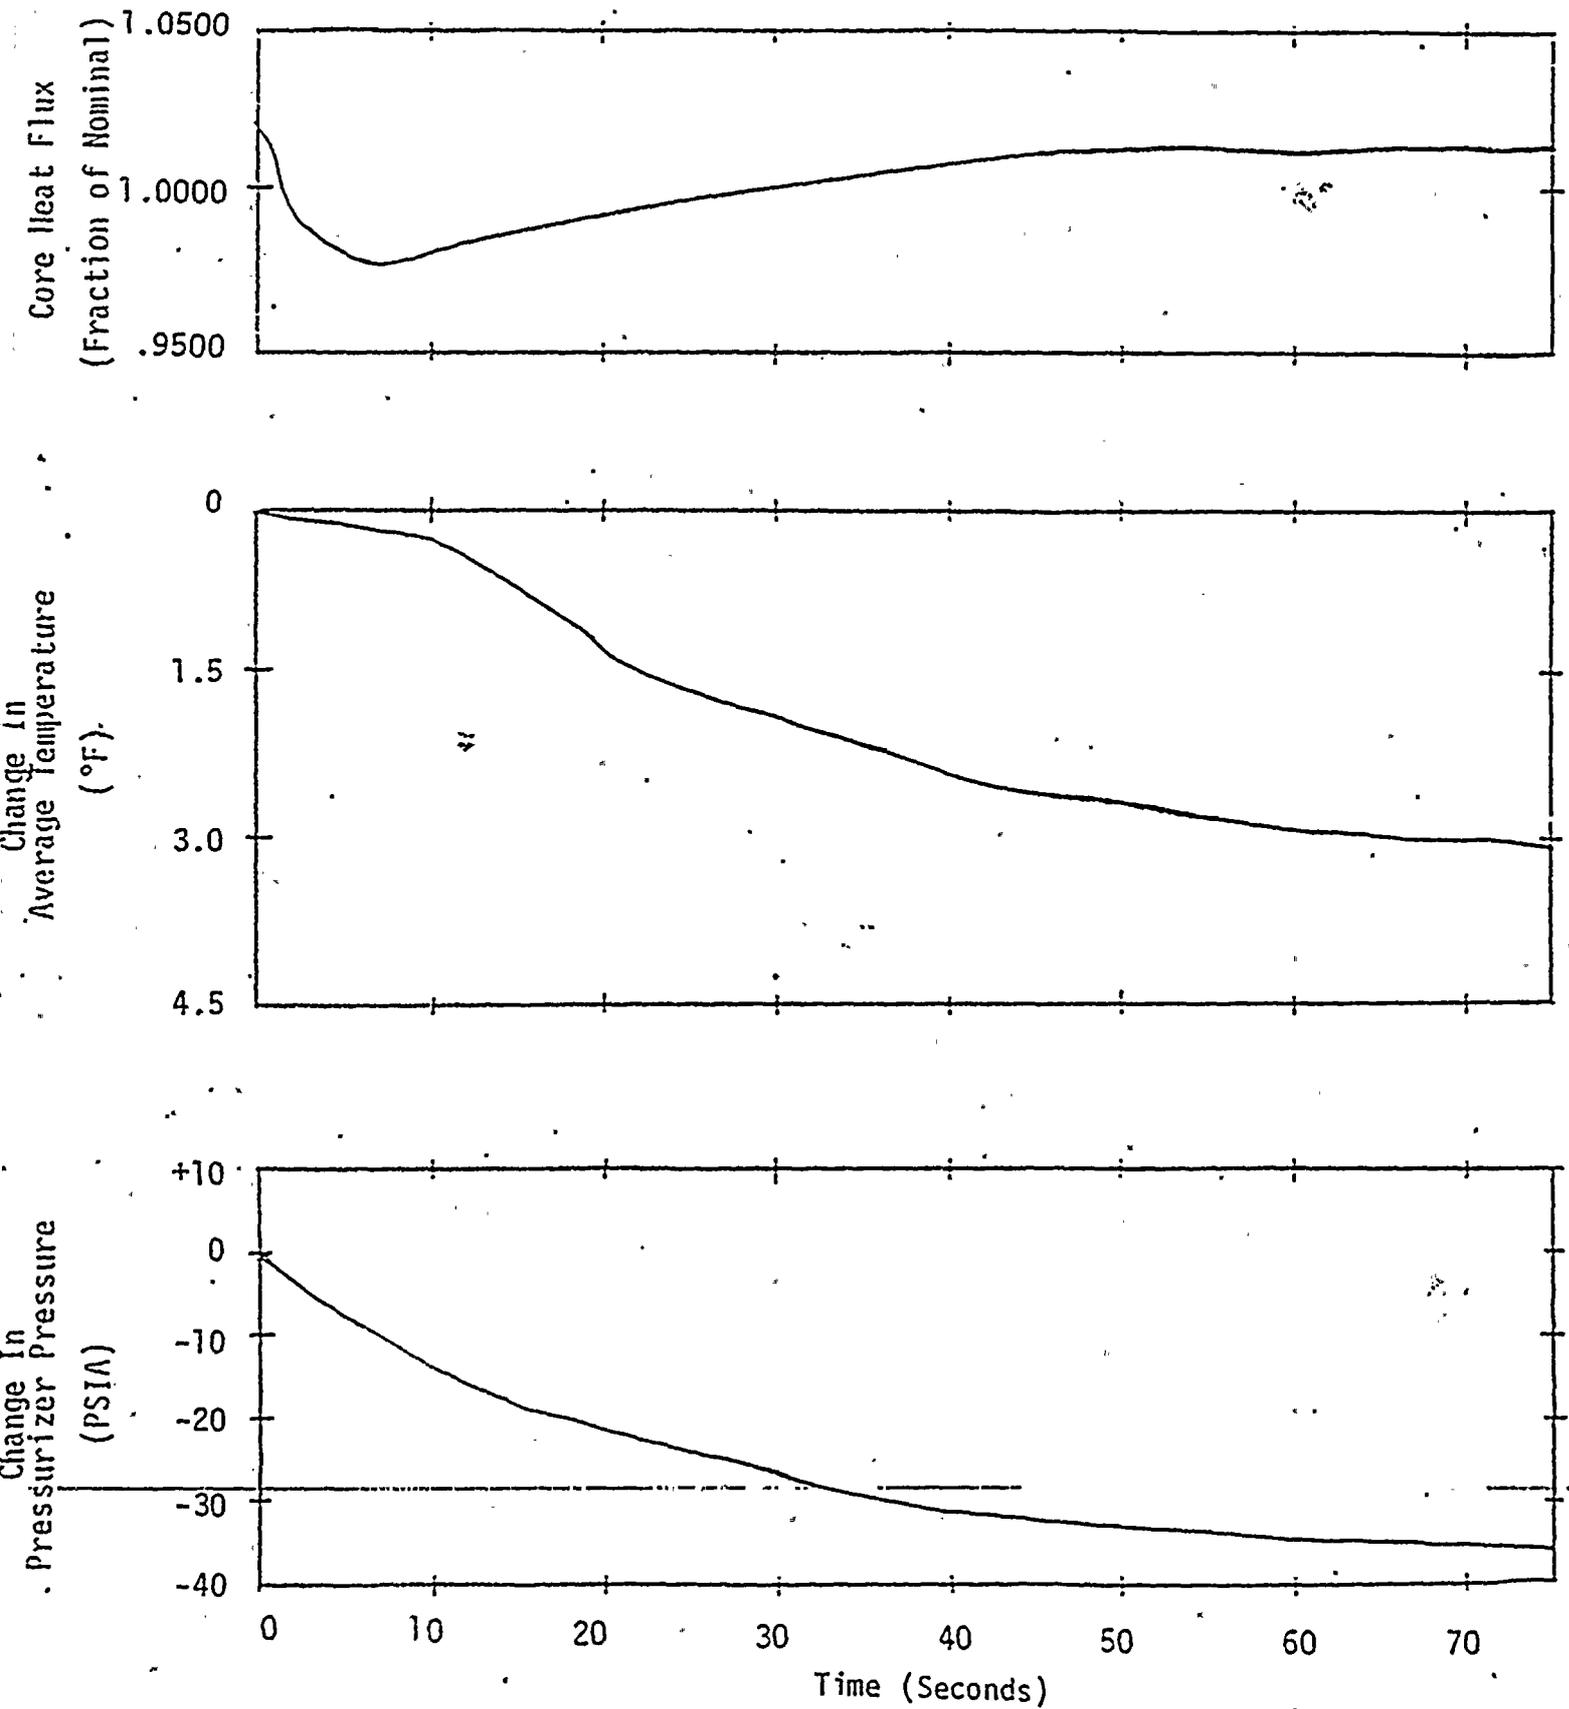
FIGURE 1

Figure 1 illustrates the transient for a typical dropped rod worth of 150 pcm in manual rod control. The core heat flux initially drops and then returns to the initial power level due to reactivity feedback. Temperature and pressure drop to a lower value. New equilibrium conditions are reached with the core at full power and reduced temperature and pressure. These conditions are less limiting than those for which the static full length misalignment of an RCCA is analyzed in the Reload Safety Evaluation for each cycle. In this analysis, the reactor is at full power with nominal temperature and pressure (including uncertainties). At the same power level, the DNBR benefit due to the reduction in temperature which occurs in the transient case more than compensates for the DNBR penalty caused by the transient drop in pressure. Thus, the single dropped RCCA analysis assuming manual rod control and no turbine runback is bounded by static RCCA misalignment. A dropped RCCA in automatic rod control is not bounded by this analysis since a power overshoot above 102% could occur.

DROPPED ROD MANUAL CONTROL
TURBINE RUNBACK
