TURKEY POINT UNIT 4
FLUX MAP THIMBLE TUBE
EDDY CURRENT TEST REPORT
FOR
NRC BULLETIN 88-09

Introduction

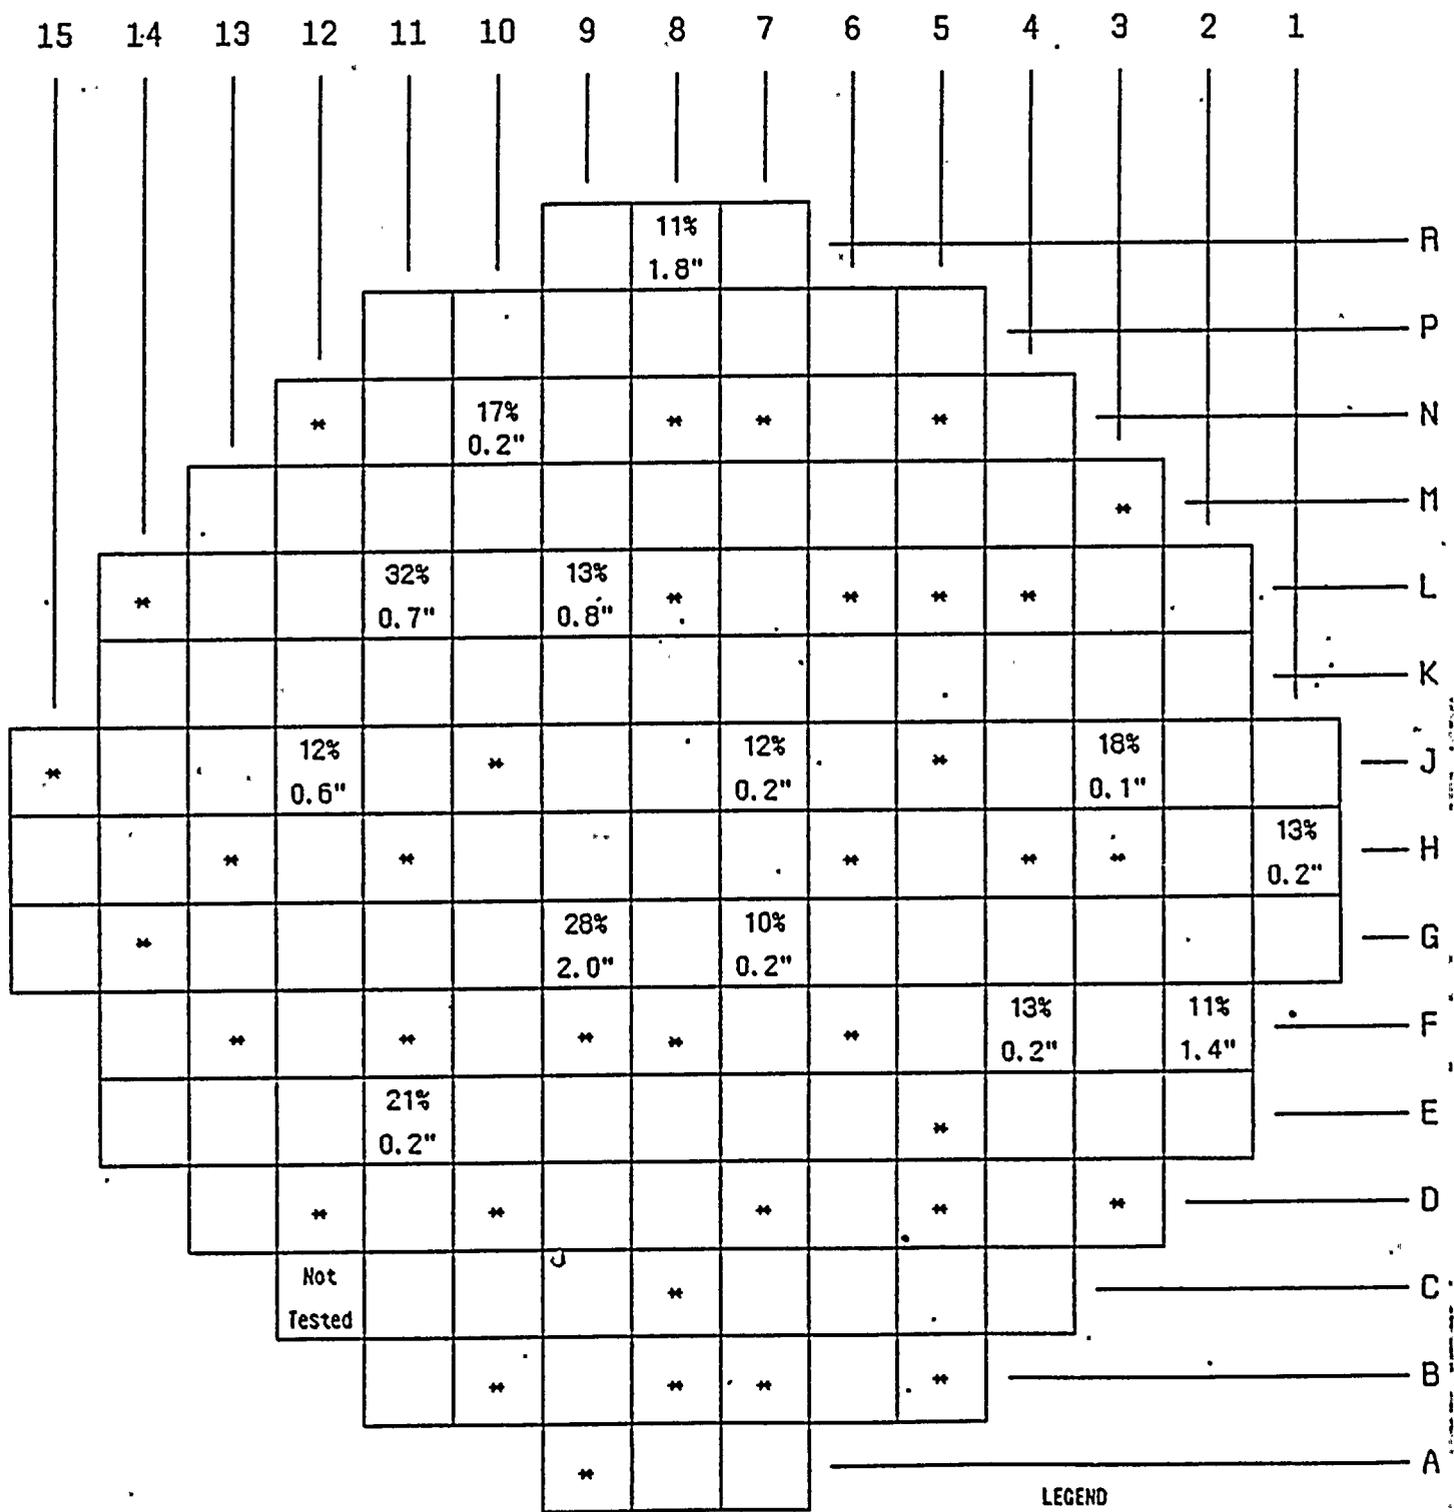
ATTACHMENT 1
REACTOR FUEL LOCATION
TURKEY POINT PLANT, UNIT NO. 4
CYCLE NO. XI to CYCLE XII
ECT RESULTS OF FLUX MAP THIMBLE TUBE INSPECTION

The ECT data was analyzed by the FPL Materials, Codes, and Inspections group to determine the percent wall loss and wear scar length for each thimble tube. The results from the data analysis identified the thimble tube locations with 10% or greater wall loss. A total of 13 thimble tubes showed a wall loss of 10% or more. Two of these thimble tubes showed a wall loss exceeding the test acceptance criteria of 23%, with the worst location indicating a 32% wall loss.

The ECT results were reviewed by Reactor Engineering to determine if there was any correlation between thimble tube wear and either core location or seal table location. The diagrams showing these locations are included with this report as Attachment 1 and Attachment 2. Several of the thimble tubes also showed measurable wear marks in more than one location. Attachment 3 is a chart of the wear mark locations relative to the lower core support plate. This part of the data analysis revealed no significant patterns in the occurrence of thimble tube wear that would indicate problems with either the RCS flow path or the reactor internals.
