L-PI-17-049
10 CFR 50.73

Prairie Island Nuclear Generating Plant, Unit 2
Docket No. 50-306
Renewed Facility Operating License No. DPR-60

LER 50-306/2017-002-00, Reactor Coolant System Shutdown Communication Line Vent Through Wall Defect

Licensee Event Report 50-306/2017-002-00

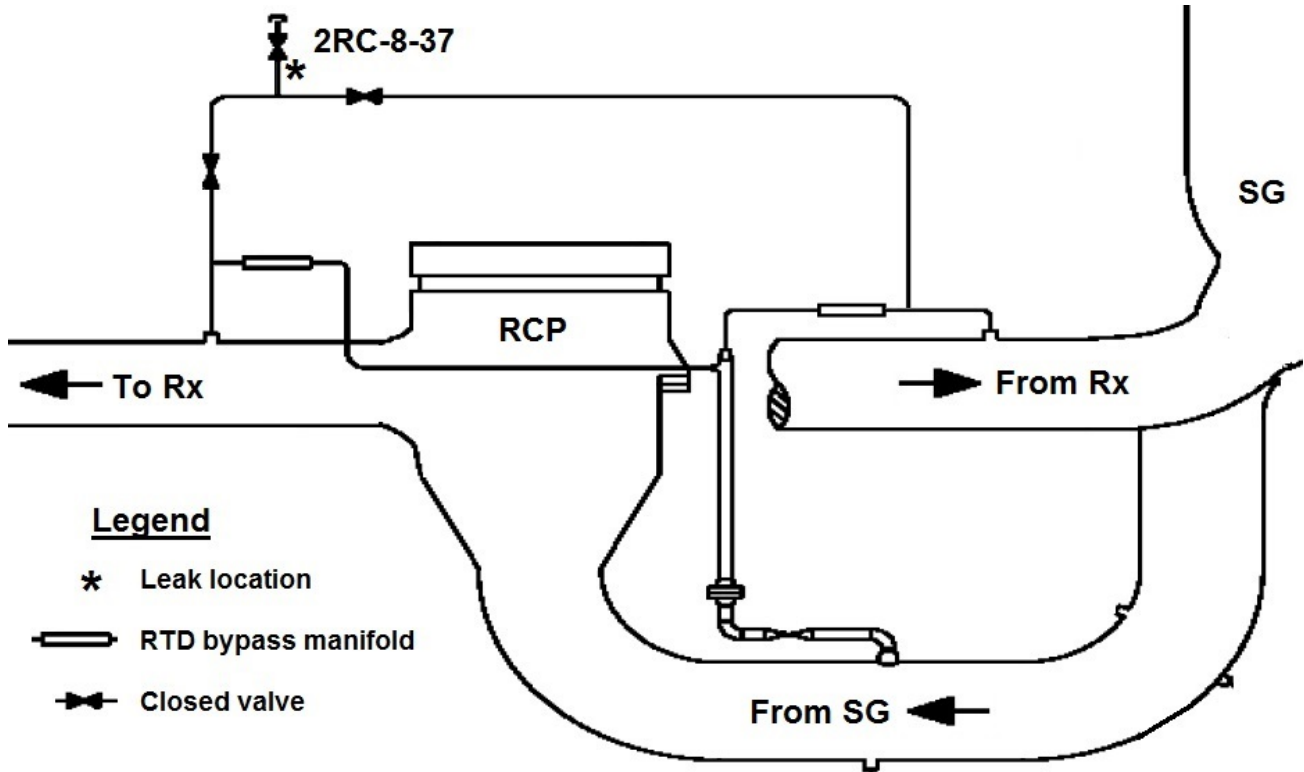
Figure

There was no actual safety consequence associated with this event. The quantity of dry boric acid at the location was small (estimated at 1/2 teaspoon in volume). Even if the weld had experienced a complete circumferential failure, the leak was isolated by closed valves that would have limited primary coolant leakage to within the capacity of the charging system when the reactor coolant system was pressurized (see figure next page).
