REPORT ON INSTRUMENTATION PORT

COLUMN ASSEMBLY LEAKAGE

FLORIDA POWER & LIGHT COMPANY

TURKEY POINT UNIT 4

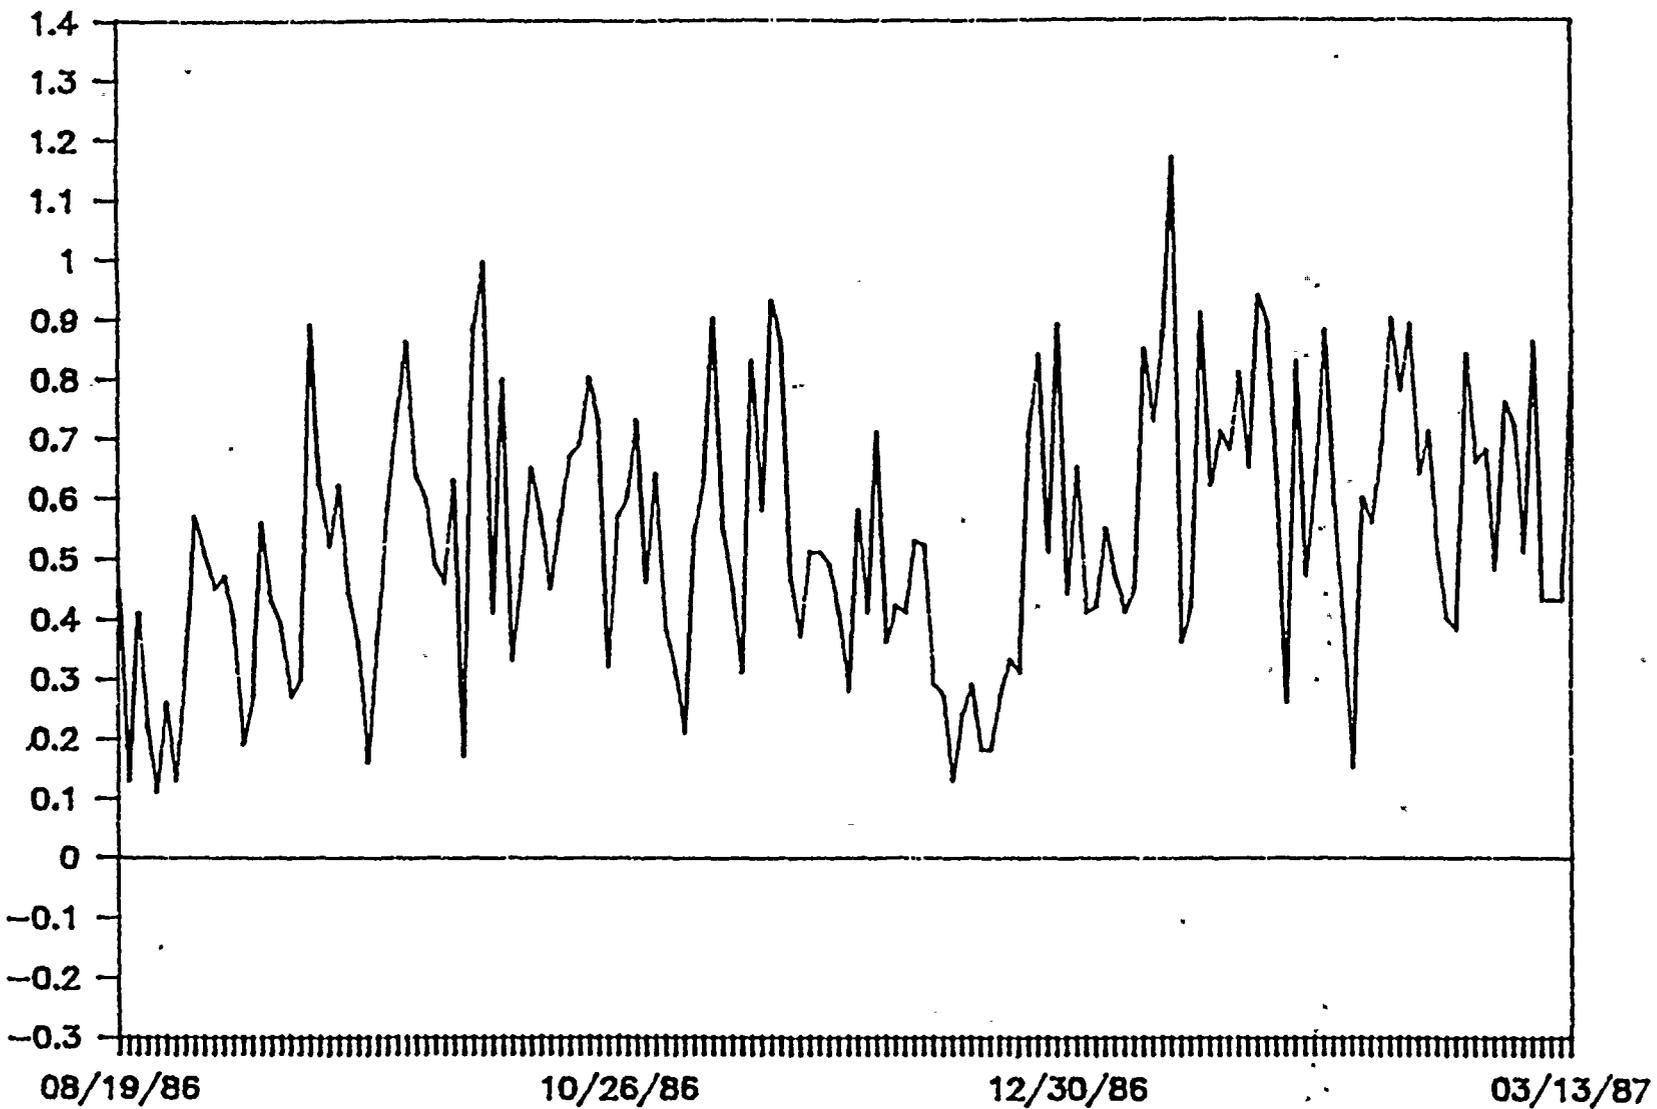
Figure 3-3: Unit 4 RCS Leakage

FPL continued to monitor RCS leakage in accordance with procedures. Figure 3-3 identifies the RCS leakage of Unit 4 from August 1986 to March 1987, calculated in accordance with the methods provided in NUREG-1107. As this figure indicates, the calculated leak rates were scattered during this period, primarily due to uncertainties in the calculational methods and changes in plant operating conditions. Of importance, Figure 3-3 shows that there was no evidence of an increasing trend in RCS leakage during this period. Although the calculated RCS leakage did exceed 1.0 gpm on several occasions during this period, in each case FPL evaluated the leakage as required by the Technical Specifications and determined that the specific occasional increases in the calculated leakage was attributed to causes other than the conoseal leakage (e.g., identified packing leakage, etc.).

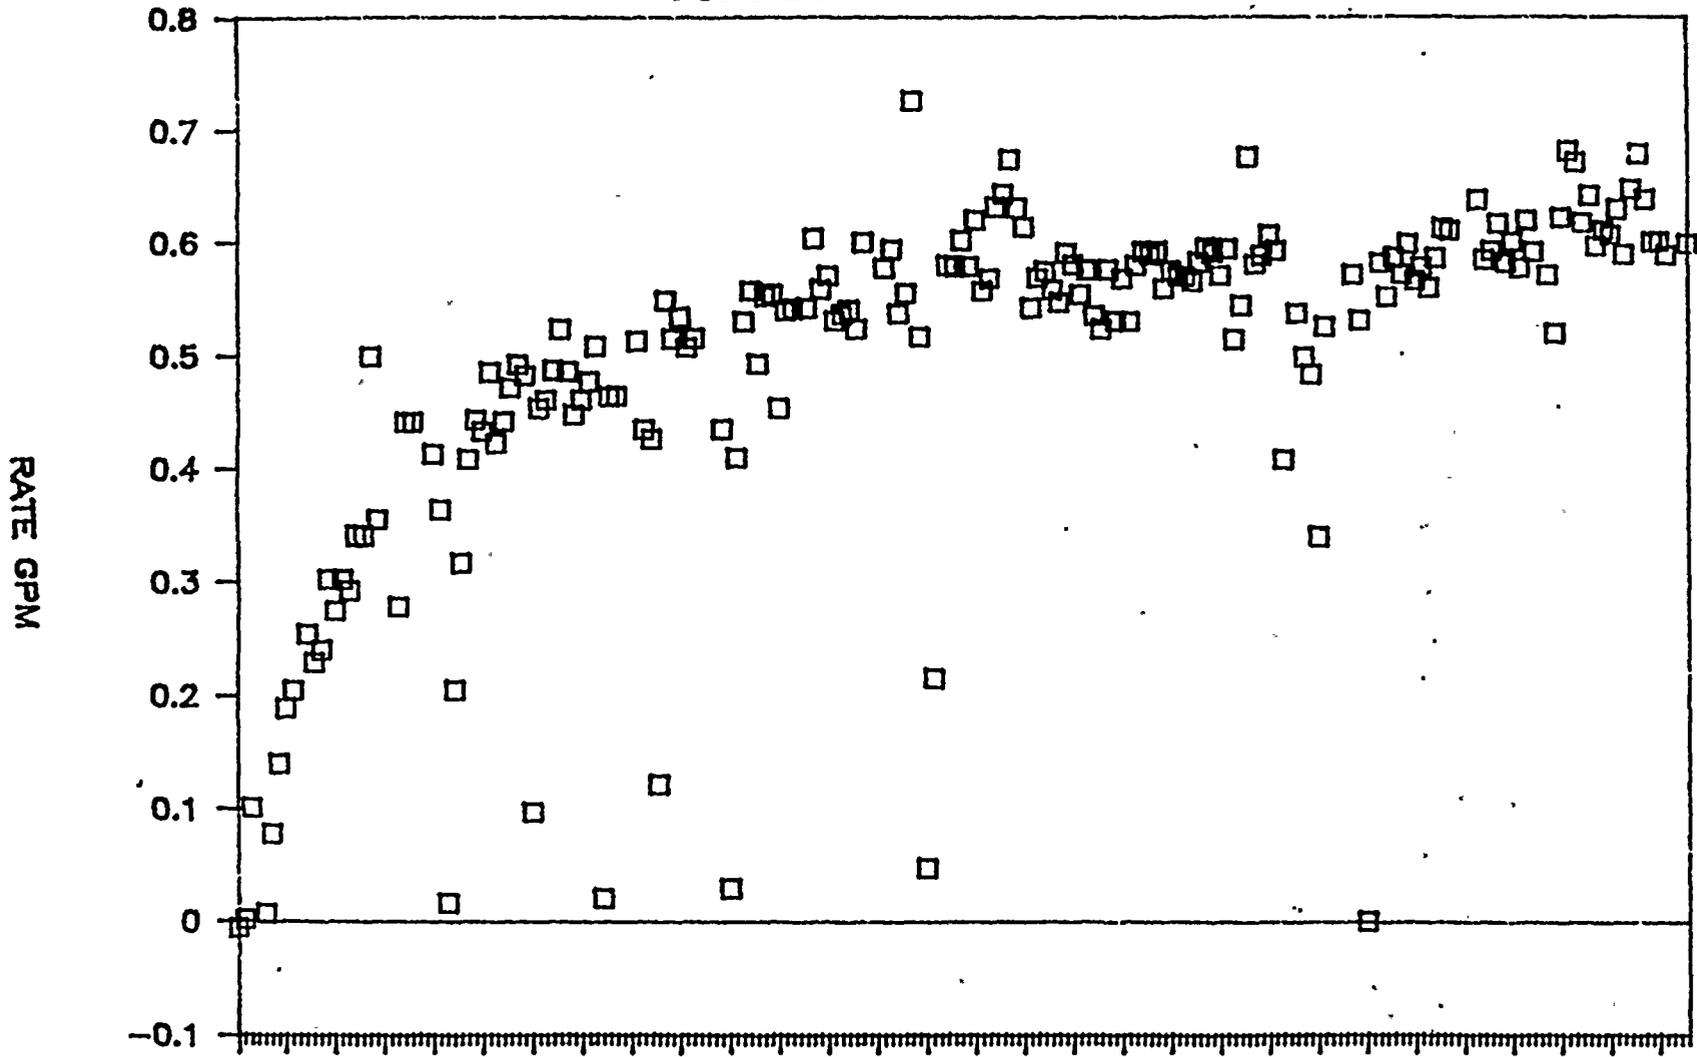
Figure 3-4: Unit 4 RCS Sump Change

Similarly, other plant indicators did not experience any unexplained increase during this period which could be attributed to conoseal leakage. For example, Figure 3-4 shows that the flow rates on the sump did not increase from November 1986 to March 1987. Although the sump flow rate did increase in September and October 1986, this increase was attributable to the fact that the containment atmosphere in the earlier months was not yet saturated and at equilibrium temperature (i.e. leakage would have a greater tendency to remain in the containment atmosphere rather than to condense as a liquid and flow to the sump). Additionally, as shown in Figure 3-5, the applicable radiation monitor did not register any increase in radiation levels, with the exception of an increase attributable to higher RCS activity. Therefore, plant personnel had no indication of any increase in the conoseal leakage prior to March 13, 1987.

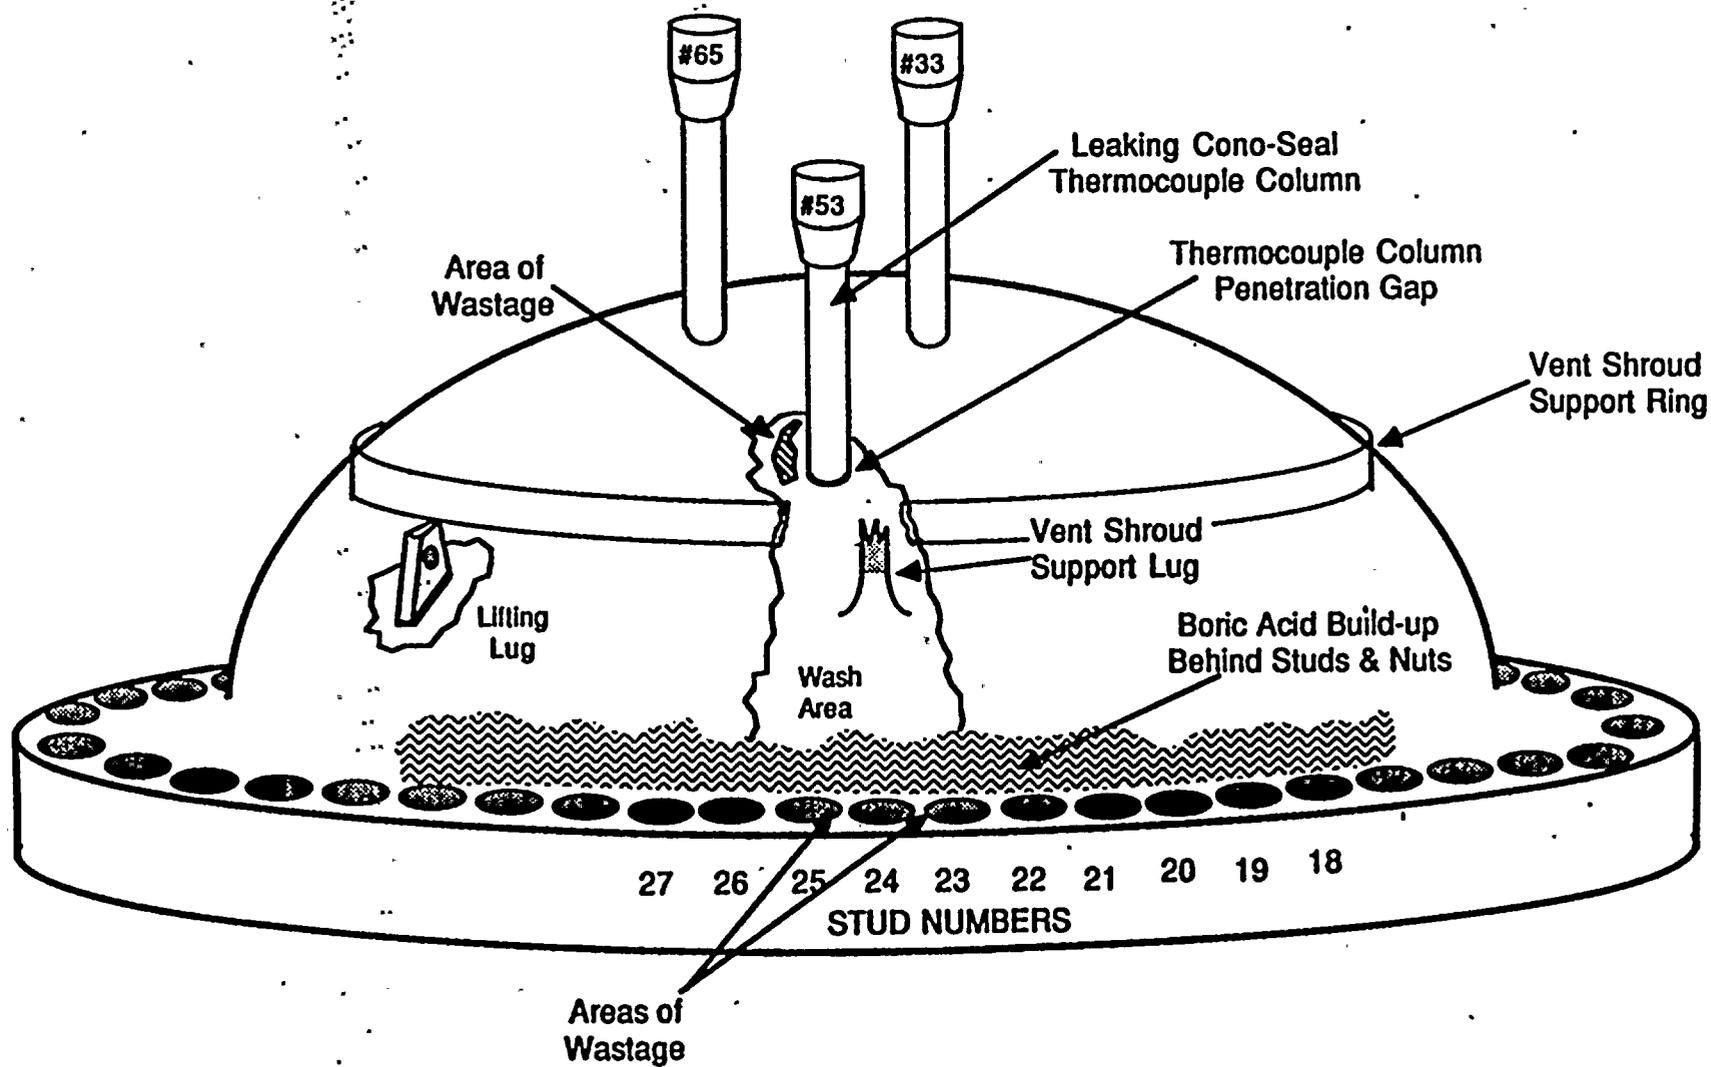
Figure 4-1: Identification of areas on the reactor vessel head affected by boric acid

Detectable wastage was observed in the instrumentation port column penetration counterbore (No. 53), a small area on the head base metal adjacent to the penetration, a three foot arc of vent shroud support, a vent shroud support lug, studs 24, 25 and 26, nuts 23 through 28, washers and small areas on the head flange ligament between the washers. (See Figure 4-1)

Two areas, each less than 4 square inches and located in the ligaments between studs 23 and 24 and between studs 24 and 25 on the top of the head flange, had wastage to a maximum depth of 1/16 inch. An evaluation of the two depressions in the ligament top surface region concluded that the condition is acceptable because the critical

flange region is beneath the stud nuts and washers and not at the top of the ligament region (which is not highly stressed). Since the boric acid accumulations have been removed, the remaining stains will have no adverse effect on continued operation.

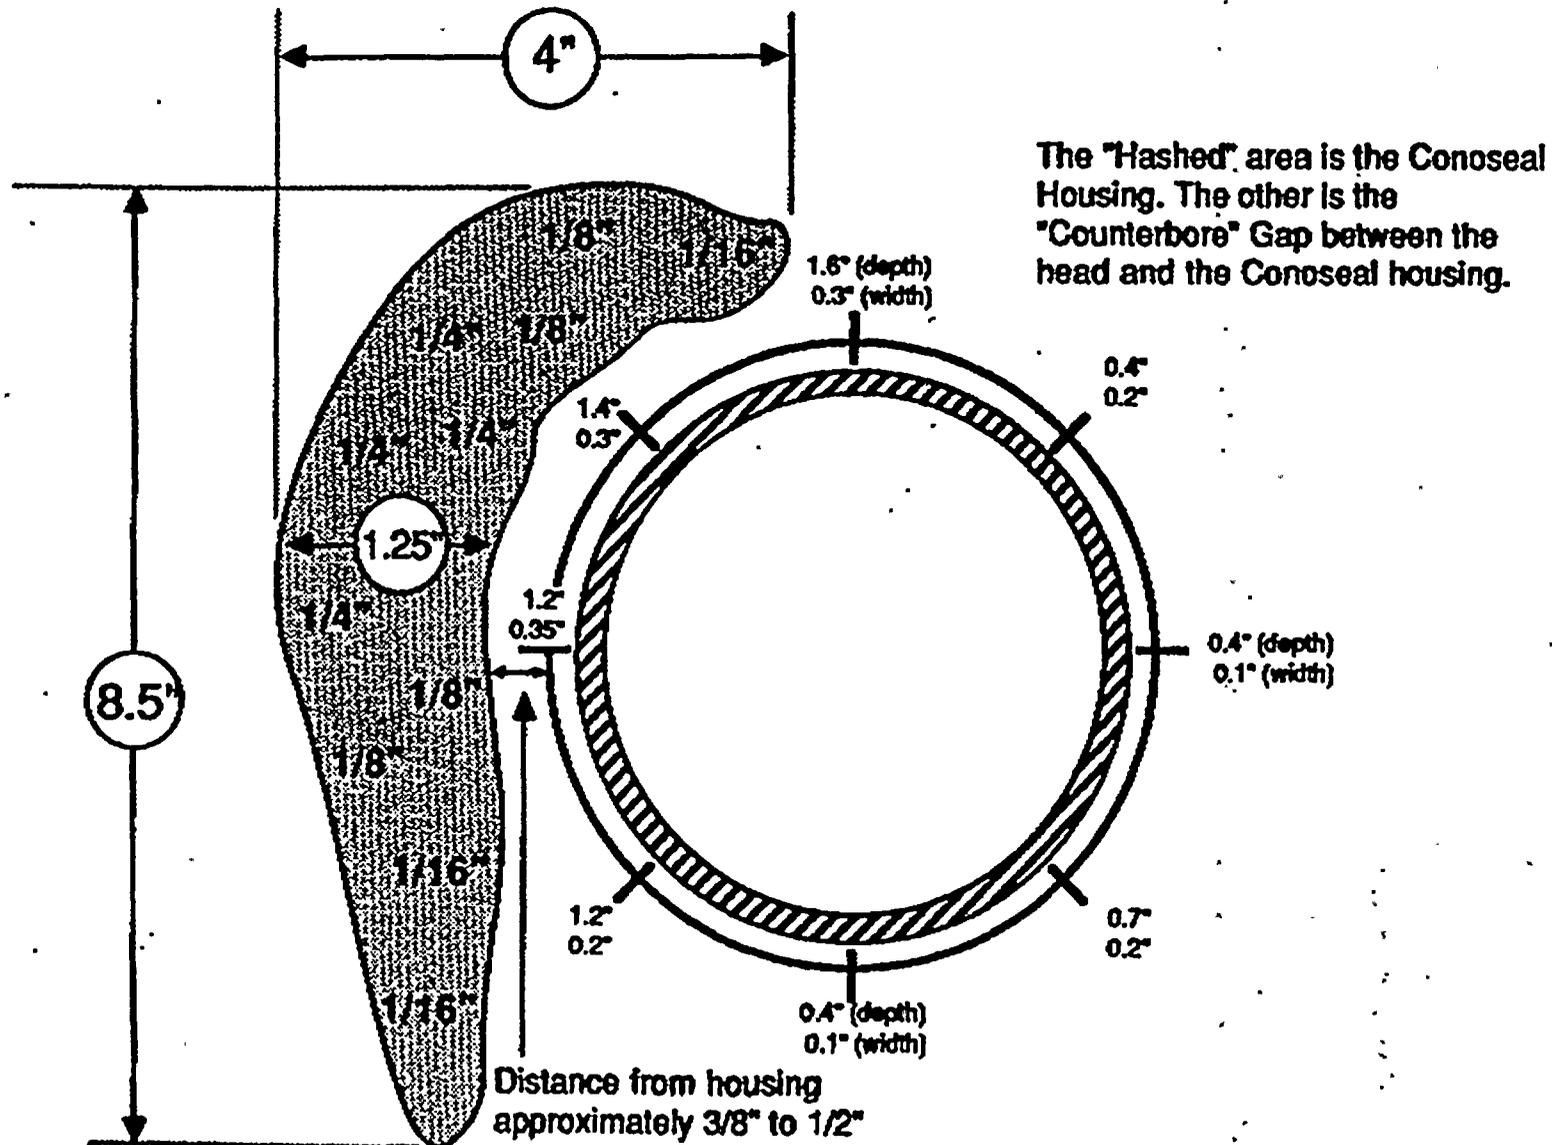
Figure 4-2: Detail of vessel head dome wastage and Penetration No. 53 counterbore corrosion

The instrumentation port, column Penetration No. 53 associated with the leaking conoseal was inspected. The counterbore of the penetration had been enlarged by wastage from 0.005 inches to a maximum of 0.35 inches at the top of the head. The maximum depth of the counterbore gap corrosion was measured to be 1.6 inches. (See Figure 4-2).

The sketch below is a plan view as looking down on the penetration.  
 The numbers circled are dimensions, the others are depth measurements.

A calculation was performed which verified the acceptability of this condition under the ASME Code Section III criteria for the head minimum thickness, ligament efficiency, and penetration reinforcement requirements.
