SUBJECT: Requests relief from visual (VT-2) exam required by  
 IWA-5246, "Repaired or Replaced Components & Alteration of  
 Sys." required by ASME Boiler & Pressure Vessel Code Section  
 XI. Basis for request encl. Fee paid.

Re: Turkey Point Unit 3  
Docket No. 50-250  
Request for Relief for the  
Second Inservice Inspection Interval

TURKEY POINT PLANT UNIT NO. 3  
SECOND INSPECTION INTERVAL  
INSERVICE INSPECTION

RELIEF REQUEST NO. 15

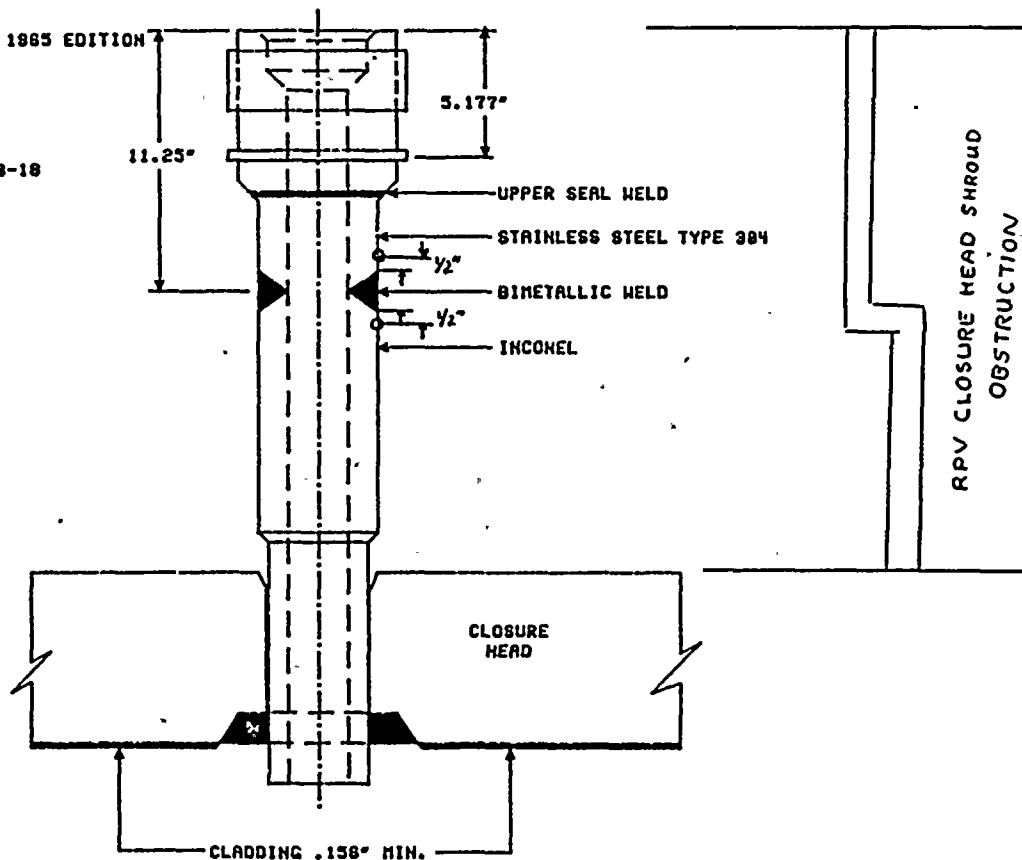
- IWB-2500-1, PERFORM VOLUMETRIC OR SURFACE EXAMINATIONS OF 10% OF THE PERIPHERAL CONTROL ROD DRIVE HOUSINGS DURING THE INSPECTION INTERVAL. DRAWING NO. CIS-V-02B PROVIDES THE EXAMINATION REQUIREMENTS FOR A TYPICAL CRDM HOUSING WELD.
- IWA-7530 AND IWA-4500, PRIOR TO RETURN OF THE PLANT TO SERVICE, AND FOLLOWING A REPAIR OR REPLACEMENT, A PRESERVICE INSPECTION SHALL BE PERFORMED.
- IWA-5000, AFTER REPAIRS BY WELDING ON THE PRESSURE RETAINING BOUNDARY, A SYSTEM HYDROSTATIC TEST SHALL BE PERFORMED.
- IWA-5246, THE VISUAL (VT-2) EXAMINATION FOLLOWING A REPAIR OR REPLACEMENT OF A COMPONENT; MAY BE LIMITED TO THE REPAIRED OR REPLACED COMPONENT, BUT SHALL INCLUDE ANY CONNECTION MADE TO THE EXISTING SYSTEM.

- a. THE RPV HEAD SHROUD OBSTRUCTS THE ENTIRE LENGTH OF THE CRDM HOUSINGS. SEE DRAWING NO. CIS-V-02B FOR AREA OF OBSTRUCTION.
- b. THE CRDM COIL STACKS AND RFI CABLES ARE INSTALLED ON THE INSTRUMENT PORTS.
- c. THE INSULATION SOCK IS INSTALLED ON THE REPAIRED DUMMIES. SEE DRAWING NO. CIS-V-02D FOR DETAILS.
- d. A BLANK COIL STACK IS INSTALLED OVER THE INSULATED SOCK, AND IS ATTACHED BY A CLAMP TO THE ADJACENT CRDM HOUSING. SEE DRAWING NO. CIS-V-02G FOR DETAILS.

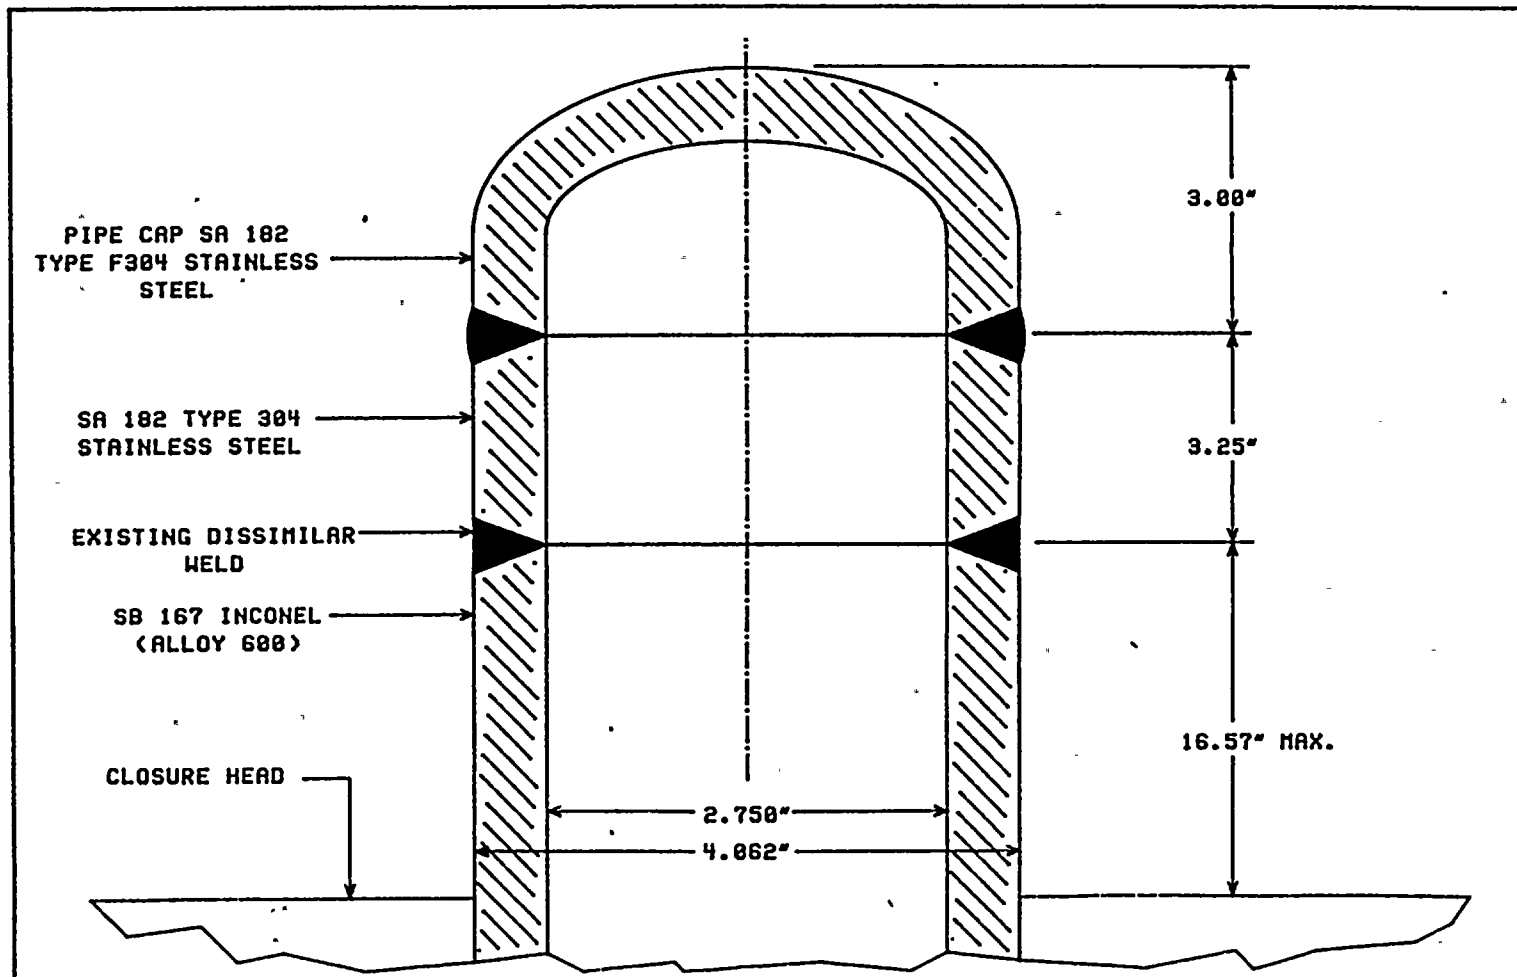
THE REPAIR OF THE LEAKING CRDM DUMMIES CONSISTED OF REMOVING THE EXISTING WELD AND REPLACING IT WITH A STAINLESS STEEL CAP WELDED BY A FULL PENETRATION BUTT WELD. DRAWING NUMBER CIS-V-02C PROVIDES A DETAIL OF THE REPAIR WELD AND CAP CONFIGURATION.

EXAMINATIONS PERFORMED DURING THE REPAIR ACTIVITY CONSISTED OF THE VISUAL, LIQUID PENETRANT AND RADIOGRAPHIC EXAMINATION METHODS. FOLLOWING THE REPAIR A FINAL VISUAL, LIQUID PENETRANT AND RADIOGRAPHIC EXAMINATION WAS PERFORMED THAT INCLUDED BOTH THE CONSTRUCTION AND SECTION XI EXAMINATION REQUIREMENTS.

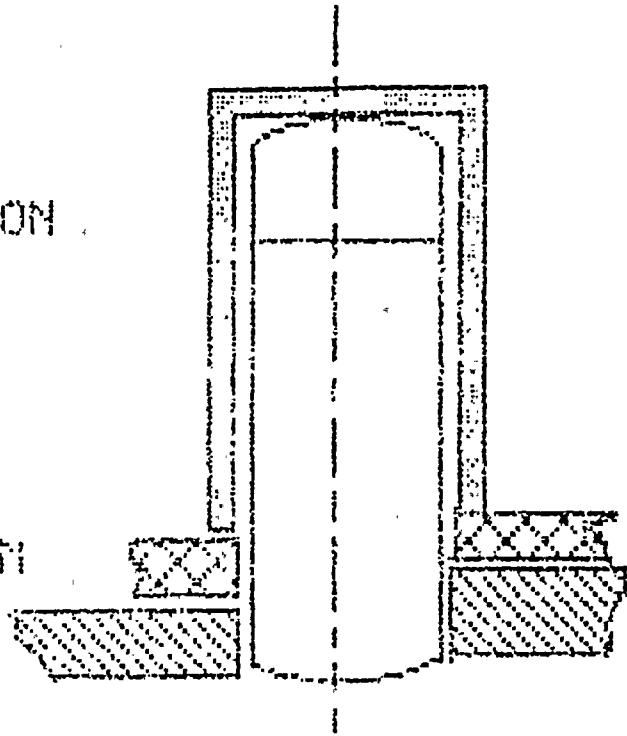
TURKEY POINT UNIT NO. 3  
RELIEF REQUEST NO. 15  
CIS-U-020  
CRDM INSULATION SOCK

THE CURRENT DESIGN CONFIGURATION OF THE REPAIR DUMMIES REQUIRE THE CRDM TO BE INSULATED WITH A SOCK. THE INSULATION SOCK AS IDENTIFIED IN ATTACHED DRAWING NO. CIS-V-02D RESTRICTS BOTH THE DIRECT OR REMOTE VISUAL EXAMINATION BY COMPLETELY COVERING THE ENTIRE CRDM HOUSING, THEREFORE OBSTRUCTING THE DIRECT OR REMOTE VISUAL EXAMINATION OF THE NEW WELD.

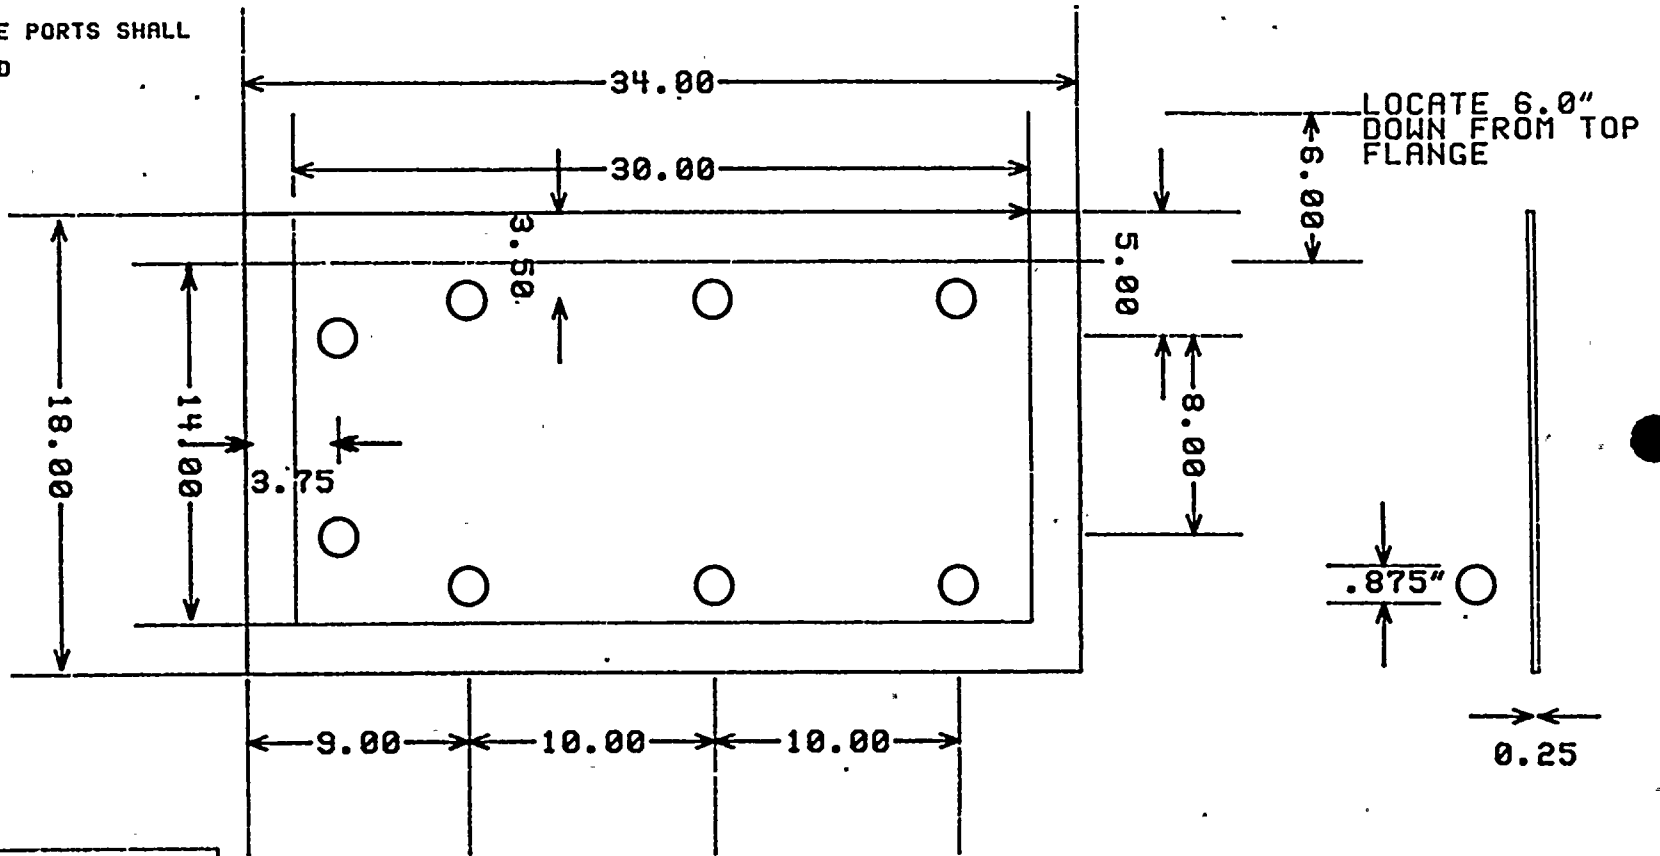
RELIEF REQUEST NO. 15  
 TURKEY POINT PLANT  
 UNIT 3 & 4  
 21 MAY 1987  
 CIS-V-02E

VISUAL EXAMINATION PORTS IN RPV SHROUD

- 1. (3) SEPERATE PORTS SHALL BE INSTALLED

1. PERFORM THE VISUAL (VT-2) EXAMINATION DURING THE REACTOR COOLANT SYSTEM OVERPRESSURE TEST TO THE EXTENT PRACTICAL WITHOUT THE REMOVAL OF THE INSULATION BY EXAMINING THE ACCESSIBLE PORTIONS AND EXPOSED SURFACES AND THE SURROUNDING AREAS LOCATED AROUND THE CLOSURE HEAD FLANGE SURFACE FOR EVIDENCE OF LEAKAGE.
2. FPL HAS INSTALLED WITHIN THE SHROUD, THREE (3) REMOVABLE INSPECTION/EXAMINATION PORTS AND WITH THE POSITION OF THE PORTS AND THE USE OF A HIGH INTENSITY LIGHT THESE VIEWING PORTS WILL PROVIDE THE EXAMINER WITH A MEANS OF LOCATING AND IDENTIFYING LEAKS THAT MAY BE PRESENT DURING THE OVERPRESSURE TEST.

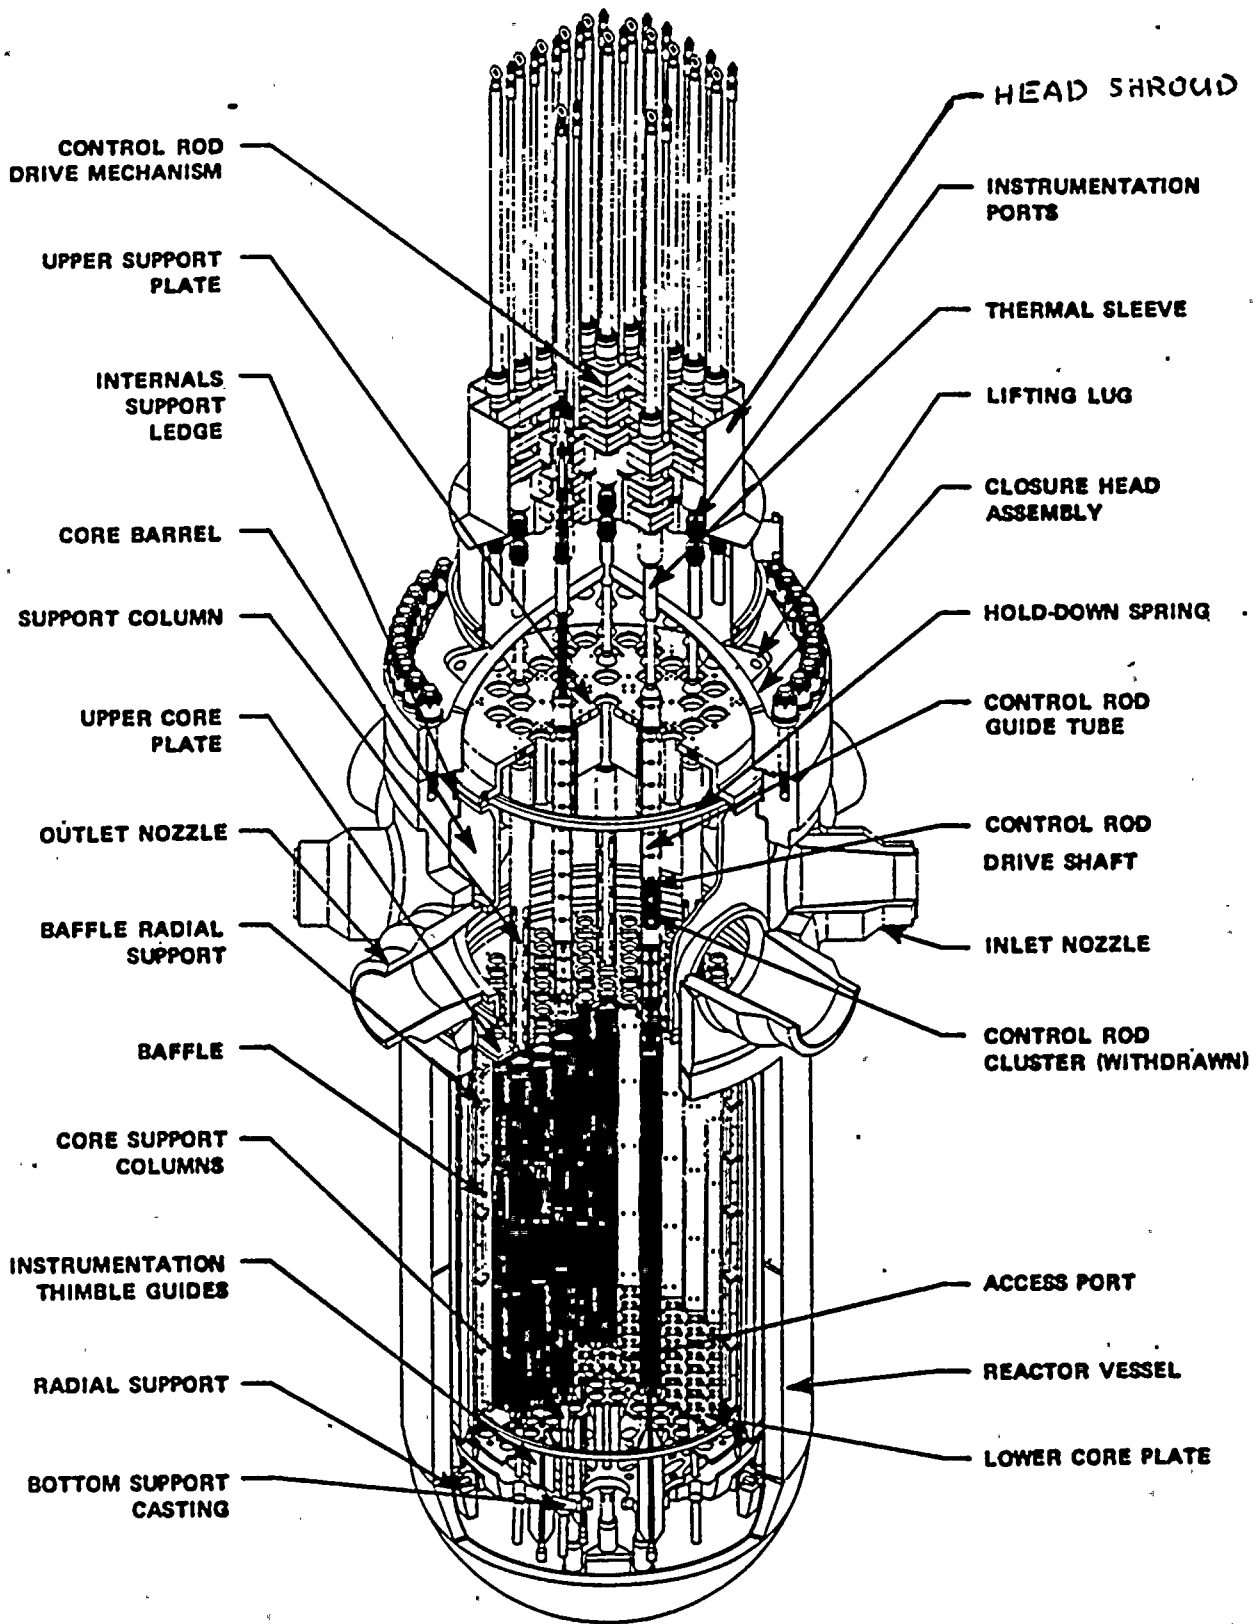
RELIEF REQUEST NO. 15  
CIS-V-02F

FOLLOWING THE REPAIR AND AFTER THE CLOSURE HEAD IS BACK ON THE VESSEL, THE FOLLOWING RESTRICTIONS PROHIBIT THE VT-2 EXAMINATION DURING THE RCS OVER PRESSURE TEST: SEE DRAWING NO. CIS-V-02F FOR GENERAL ARRANGEMENT DETAIL.

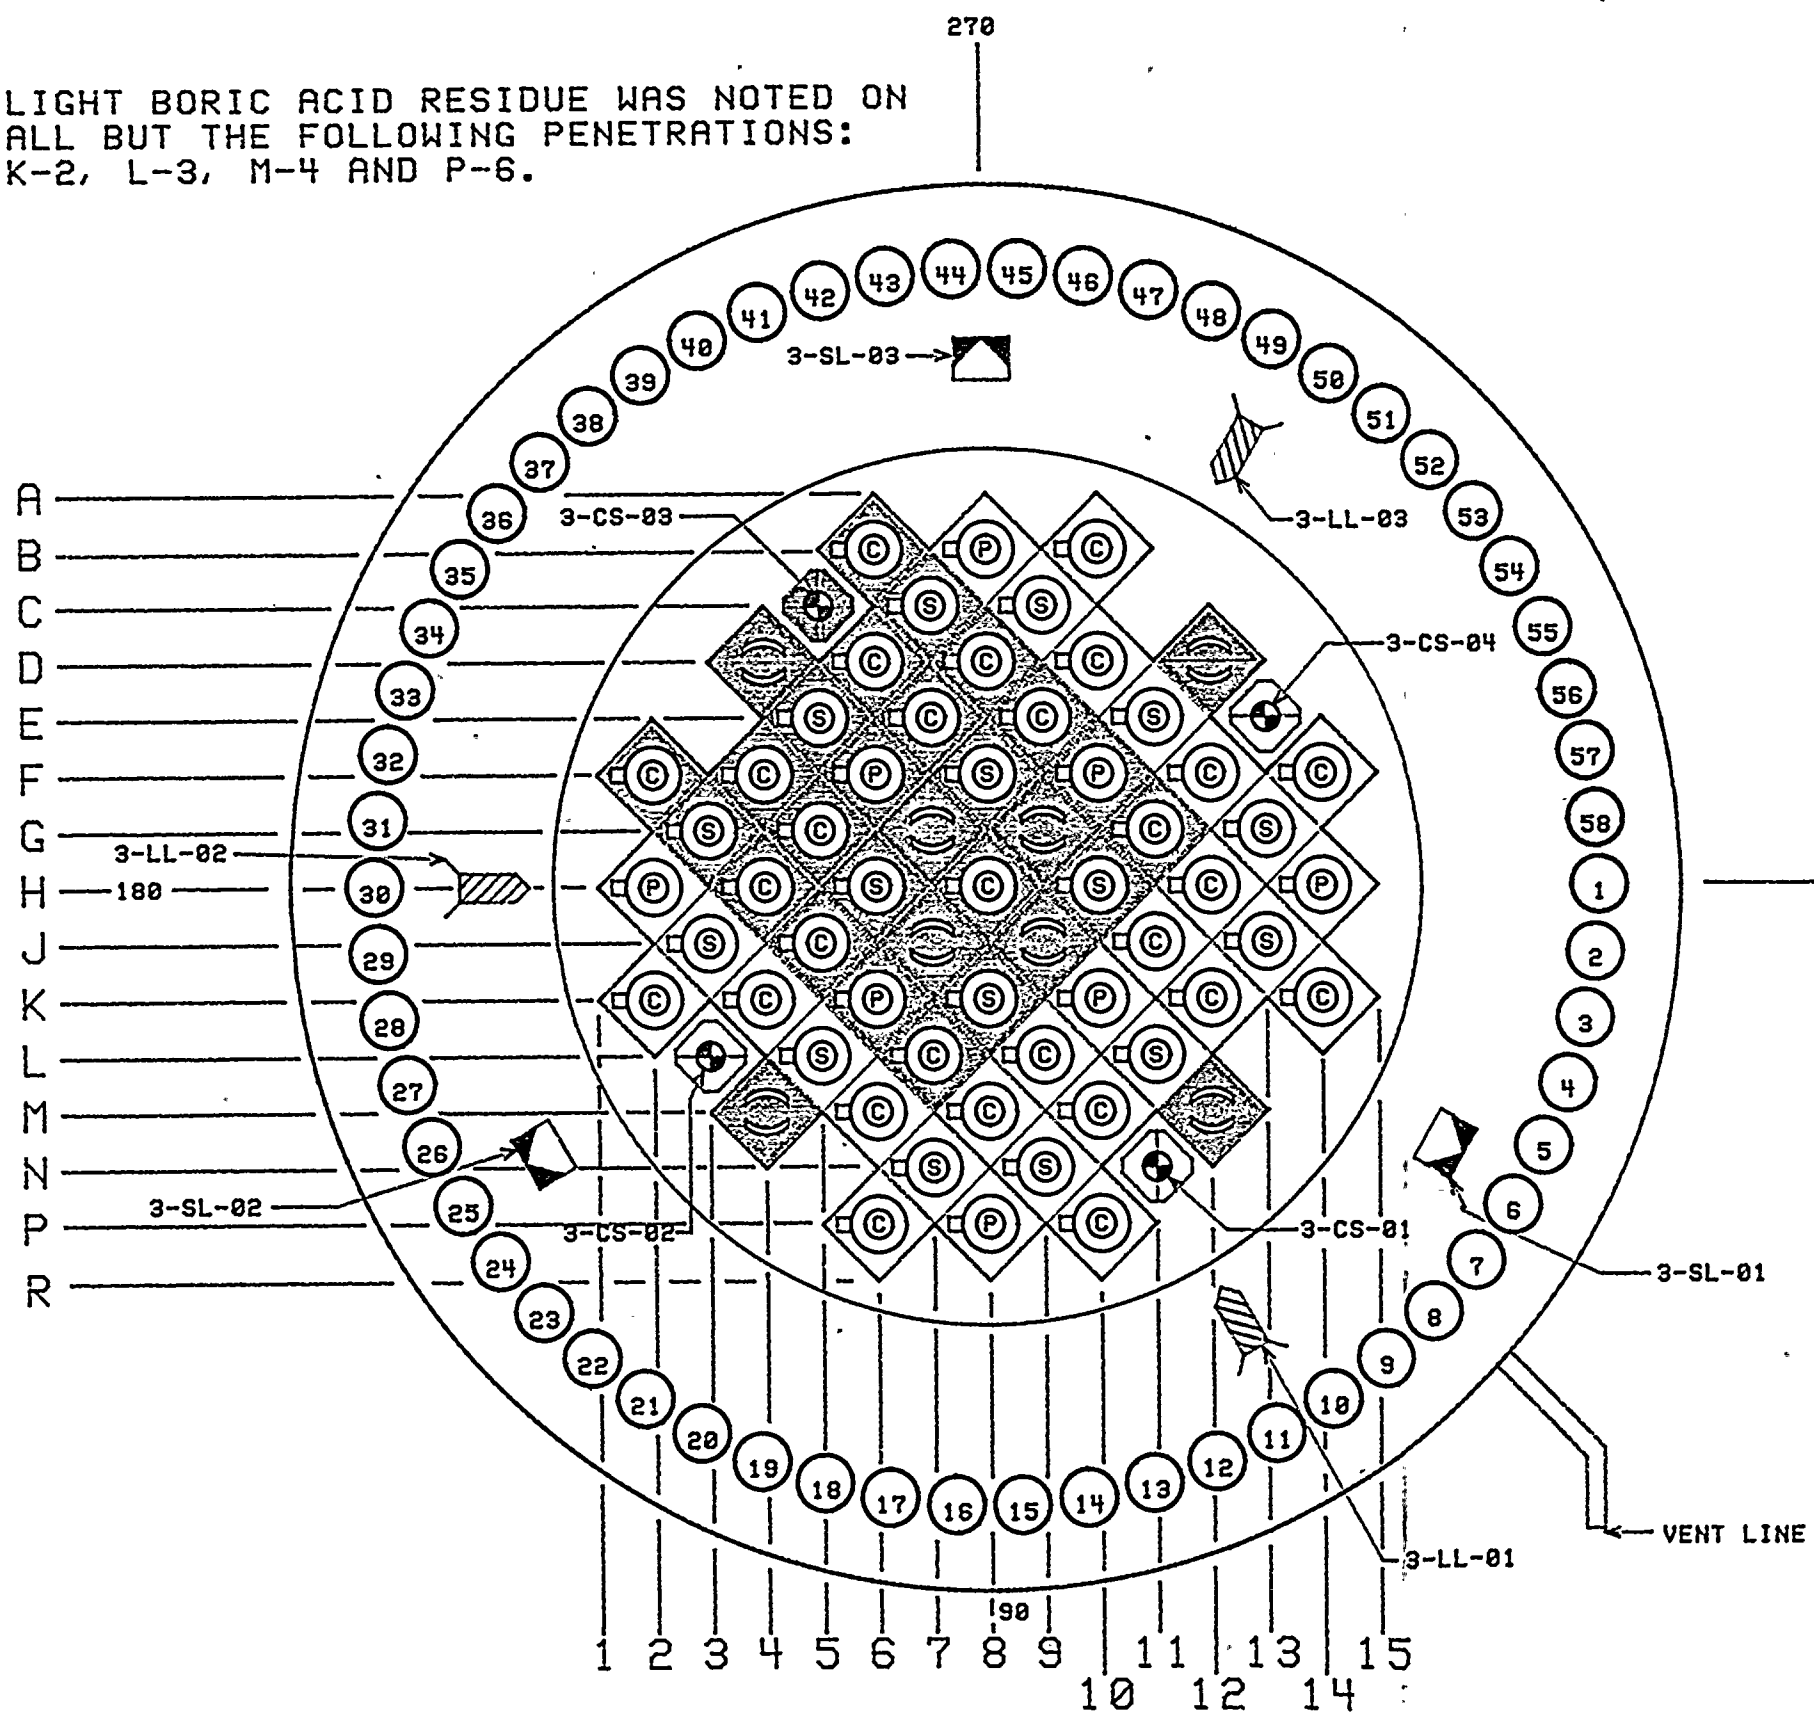
TURKEY POINT UNIT 3  
RPV CLOSURE HEAD LEAK DETAIL  
CIS-V-02A

THE (2) TWO REPAIRED CONTROL ROD DRIVE HOUSINGS (BOTH DUMMIES) ARE LOCATED IN THE CENTER OF THE REACTOR PRESSURE VESSEL HEAD. DRAWING NUMBER CIS-V-02A, COLOR CODED IN RED, PROVIDES THE LOCATION OF THE (2) TWO REPAIRED HOUSINGS WELDS NUMBERS G7 AND G9.

- c. FOLLOWING THE ABOVE EXAMINATIONS, A REMOTE VISUAL EXAMINATION WAS CONDUCTED AND RECORDED ON VIDEO TAPE. THE CRDM HOUSINGS EXAMINED ARE IDENTIFIED ON DRAWING NO. CIS-V-02A. THESE EXAMINATIONS INCLUDED THE TWO LEAKING DUMMIES (RED), THE FOUR ADJACENT CRDM WHICH HAD EVIDENCE OF RECEIVING THE MOST SPRAY (BLUE), THE SURROUNDING CRDMS IN WHICH TO BOUND IN THE LEAKERS (GREEN), THE ADDITIONAL THREE DUMMIES (TURQUOISE), AND THE TWO ADDITIONAL CRDMS CODED IN (PURPLE) RECEIVED A VISUAL AND LIQUID PENETRANT EXAMINATION IN ORDER TO SATISFY THE TEN-YEAR INSPECTION REQUIREMENTS.

NOTE: LIGHT BORIC ACID RESIDUE WAS NOTED ON ALL BUT THE FOLLOWING PENETRATIONS:  
K-2, L-3, M-4 AND P-6.

RED = LEAKERS G-7 INITIAL LEAKER CONFIRMED PT.  
G-9 SUSPECT LEAKER CONFIRMED PT.  
H-8 SUSPECT PT NRI. PLANT QC, VT-2 & PT.

BLUE = BORIC ACID ACCUMULATION  
GREEN = ISI VT-1 BOUNDARY TO INCLUDE CRDM AND BASEMETAL FOR EVIDENCE OF WASTAGE.  
PURPLE = 10 YEAR ISI, PT OF THE DISSIMILAR METAL WELD.  
TURQUOISE = ADDITIONAL SAMPLE TO INCLUDE ALL DUMMY PENETRATIONS.
