SUBJECT: Supplement to 910812 Part 21 rept re potential generic defects in ABB Type RHMH2 Model RK223068-EA & 069-EA relays. Caused by tape fold back condition. New method for installing insulation tape initiated.

UNITED CONTROLS

December 12, 1991

Subject: Investigation Results Of Potential Generic Defect Of
ABB Type RHM2 Model RK223068-EA and 069-EA Relays

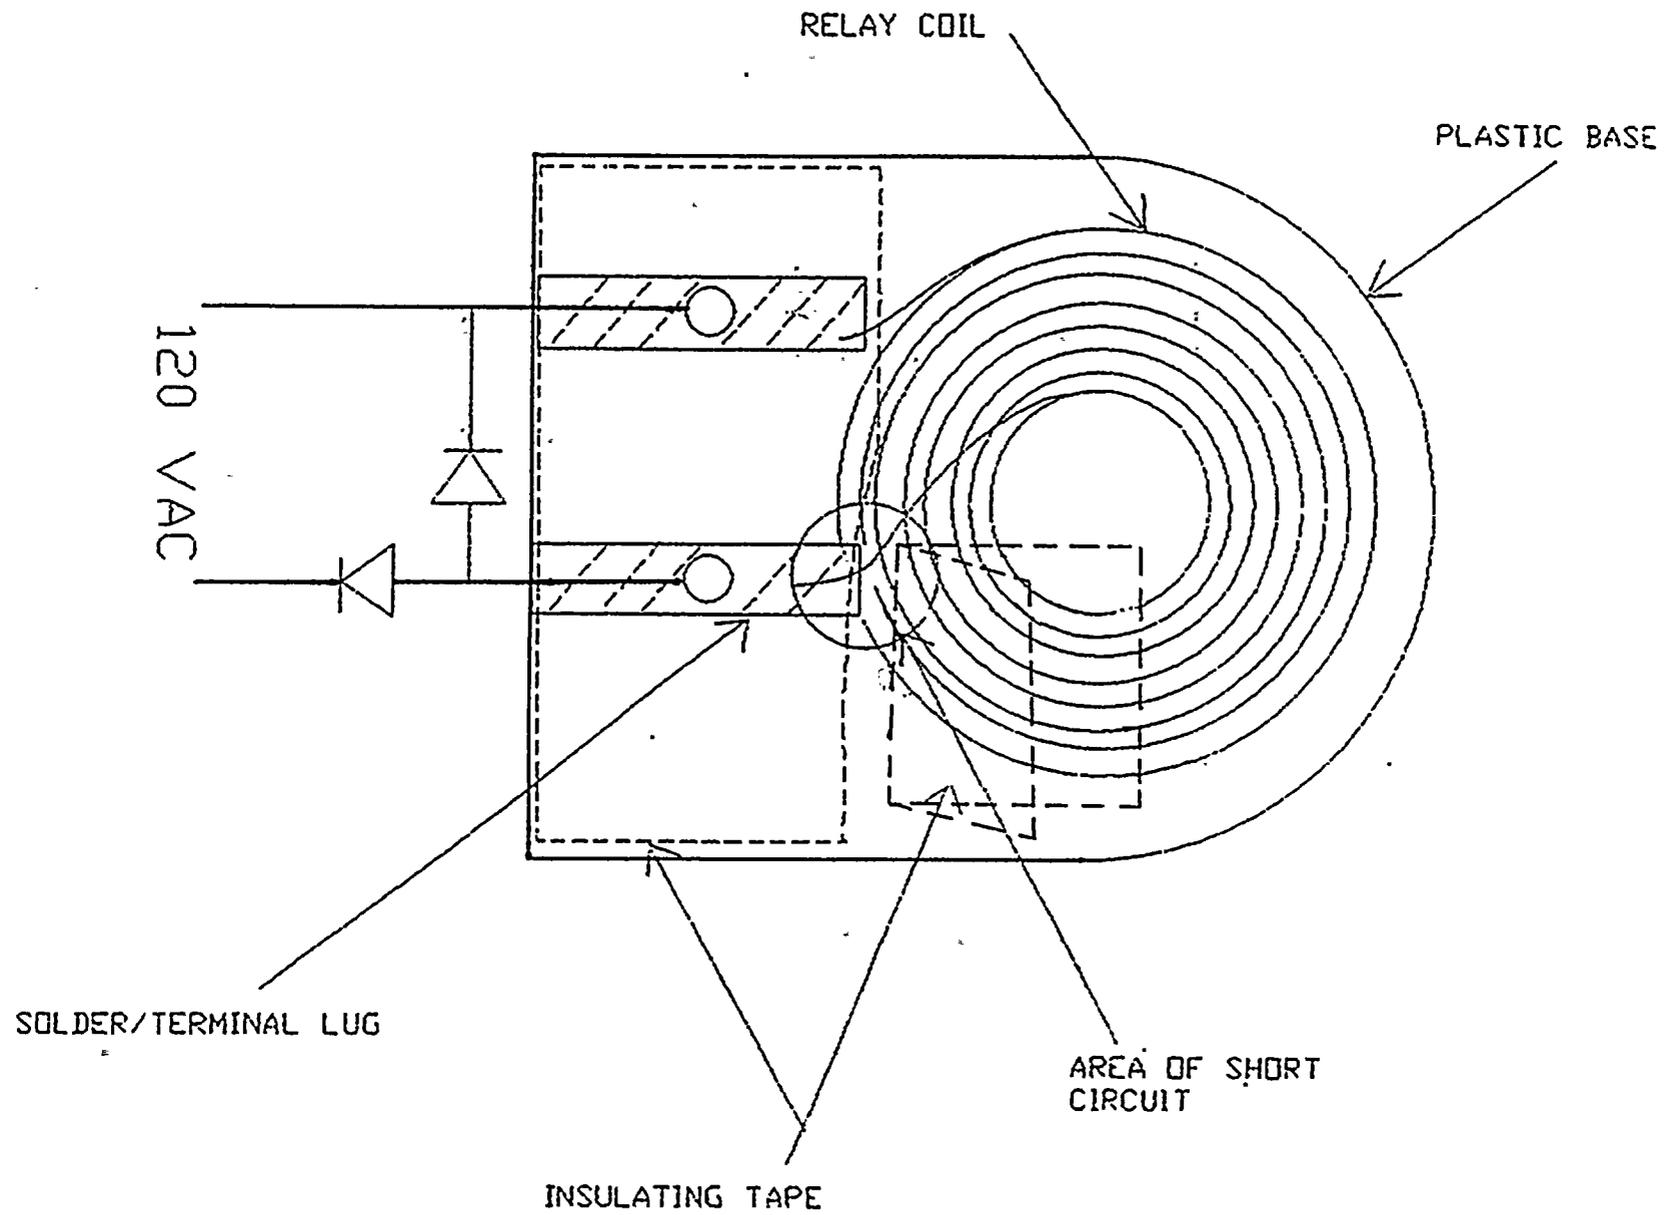
It was not until the last day of the audit that the UCI representatives were able to examine (for the first time) the actual Turkey Point failed relay coil. The coil exhibited a blackened burn area where the lead wire had shorted against the coil windings. This was clearly caused by a lack of the required insulation tape. However, the tape placement on the coil was not what caused this particular burnout. Rather the tape end had been folded back over its self (see attached drawing). This left about 3mm of the lead wire completely exposed to the windings. Even with this condition, the relay passed functional testing at the ABB factory and at United Controls, and several pre-operational tests at Turkey Point before failure occurred. The ABB Relays Manger of Protection Equipment was asked, if the failed coil may have had the tape folded back by the rotating wire on the winding machine. He thought this was a definite possibility.

Since it is evident that the only known failed coil suffered from an entirely different problem than the coils that were rejected by ABB from the sample checked at Turkey Point, there is the possibility that no generic defect exists. If only coils possessing a folded back condition on the insulating tape are subject to failure, then it may not be correct to define a lead wire in violation of the 1mm distance to the tape edge criteria, as a generic defect. To test this hypothesis, it was decided to run endurance cycling on a relay that fails the 1mm inspection criteria.

1. The new method of installing insulation tape nearly eliminates the possibility of inadequate lead wire coverage.
2. There is no conclusive evidence to define what time frame(s) may limit the relays that possess coils which violate the 1mm tape coverage inspection criteria.
3. The relay that actually failed was the result of a tape fold back condition that has not been found on any other coil.
4. The functional/endurance testing performed on a relay possessing a coil that violated the 1mm tape coverage criteria, significantly exceeded normal lifetime cycling expectations in the subject application.
5. There is no previously known pattern of failure for the Type RXMH relay.

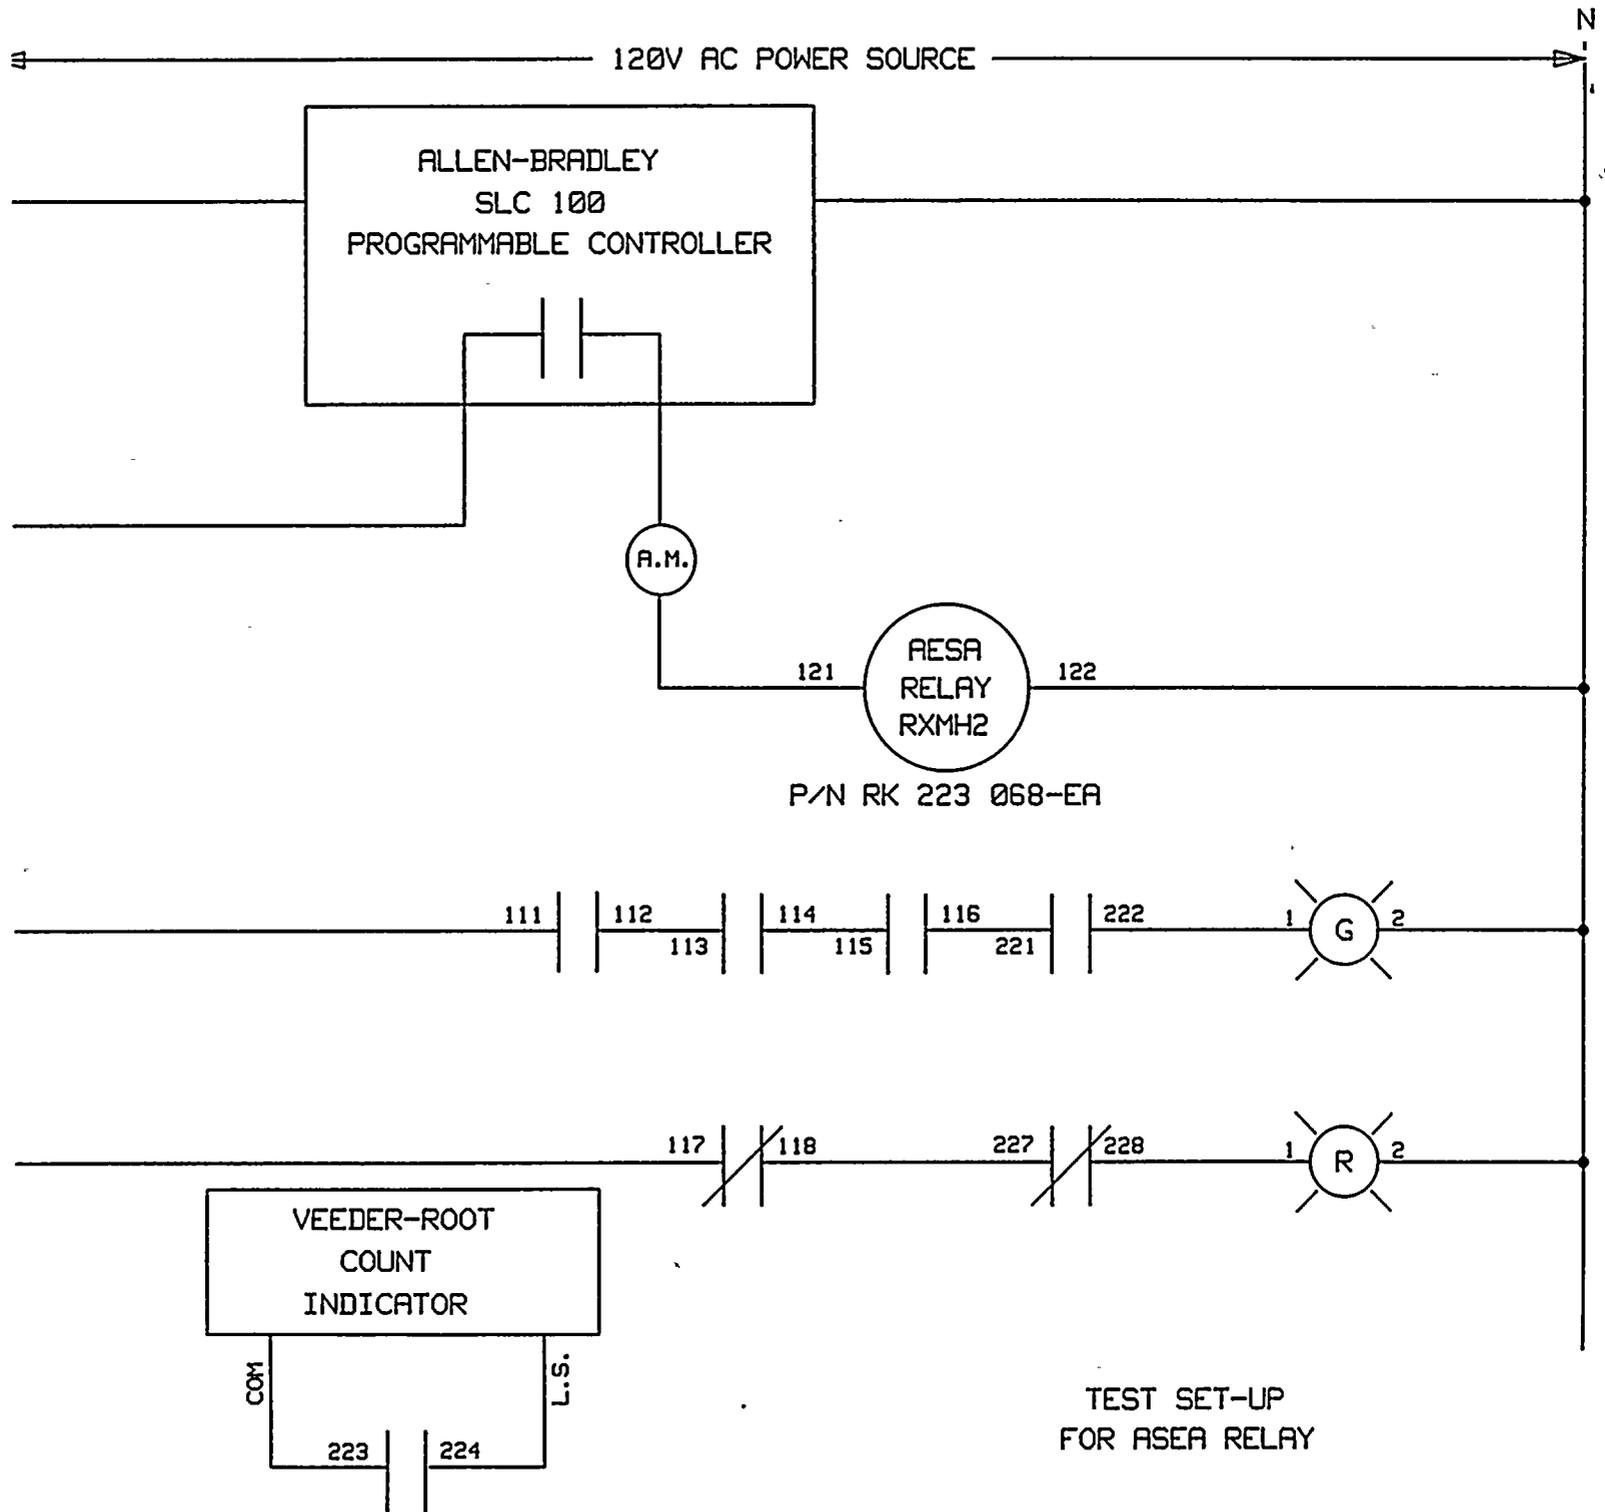
TEST SET-UP
FOR ASEA RELAY

programmable logic controller. The test was designed to achieve a simulation of actual relay use in the FP&L sequencers, and to establish cycling endurance capabilities. A diagram of the test set-up is attached.

The first portion of the test cycled the relay for 5 minutes of coil actuation, followed by a 3 second release and pickup. This was designed to simulate the in service application at Turkey Point in the EDG Sequencers. This was performed over a 48 hour period for a total of 621 cycles. The following readings were recorded by calibrated M&TE during the test:
