REGULATORY INFORMATION DISTRIBUTION SYSTEM (RIDS)

Re: Turkey Point Units 3 and 4
Docket Nos. 50-250 and 50-251
Reportable Event: 92-006-00
Recirculation of Waste Monitor Tanks not in Accordance
With Offsite Dose Calculational Manual Prior to Sample
Acquisition.

LICENSEE EVENT REPORT (LER)

FACILITY NAME (1) Turkey Point Unit 3										DOCKET NUMBER (2) 05000250		PAGE (3) 1 OF 3		
TITLE (4) Recirculation of Waste Monitor Tanks not in Accordance With Offsite Dose Calculational Manual Prior to Sample Acquisition.														
EVENT DATE (5)			LER NUMBER (6)			RPT DATE (7)			OTHER FACILITIES INV. (8)					
MON	DAY	YR	YR	SEQ #	R#	MON	DAY	YR	NAME			DOCKET # (S)		
06	10	92	92	006	00	07	10	92	Turkey Point Unit 4			05000251		
OPERATING MODE (2)		1 <u>10 CFR 50.73(a)(2)(i)(B)</u>												
POWER LEVEL (10)		100												
LICENSEE CONTACT FOR THIS LER (12)														
James E. Knorr, Regulation and Compliance Specialist										TELEPHONE NUMBER				
										305-246-6757				
COMPLETE ONE LINE FOR EACH COMPONENT FAILURE DESCRIBED IN THIS REPORT (13)														
CAUSE	SYSTEM	COMPONENT	MANUFACTURER	NPRDS		CAUSE	SYSTEM	COMPONENT	MANUFACTURER	NPRDS				
SUPPLEMENTAL REPORT EXPECTED (14)

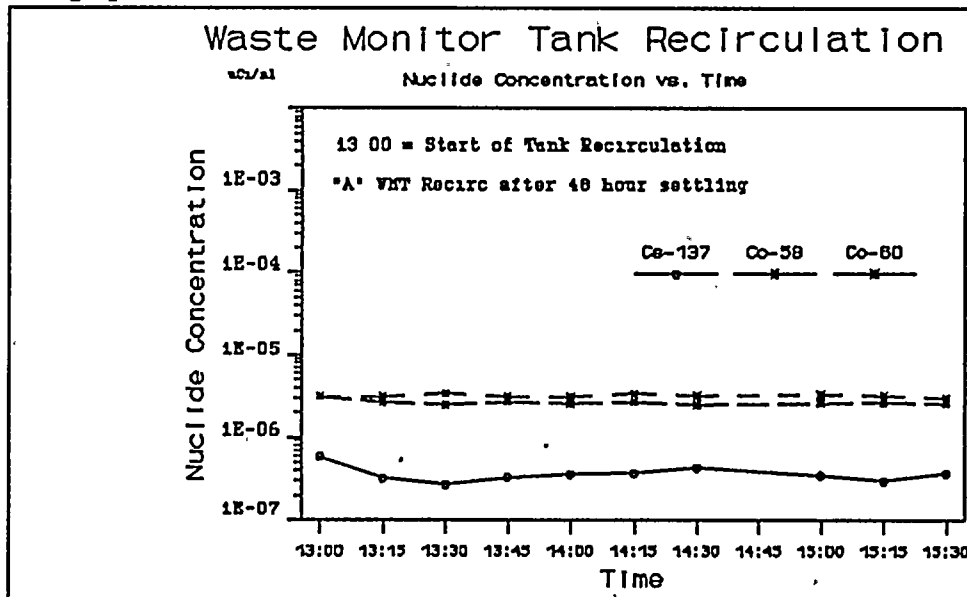
Following the discovery of the flow discrepancy, chemistry personnel performed a mixing analysis of the tank concentration. The tank was allowed to settle for 48 hours. A sample was taken prior to the beginning of a mixing of the tank by recirculation as normally performed.

Further samples were taken each 15 minutes for the following 2 hours. The graph on the right shows the result of that test. Virtually no concentration change occurred after 15 minutes.

The measurable nuclides contents of the tank appear to be colloidal in nature and reach equilibrium within 15 minutes of the beginning of the recirculation process. Therefore little recirculation time is required to obtain a representative sample of the tank contents.

1. The immediate corrective action was to double the recirculation time of the waste monitor tank volume to two hours to insure that one tank volume was turned over prior to sampling. This time was based upon the empirical data collected during the verification of the flow in the recirculation line during the recirculation process in accordance with Temporary Procedure TP-845.
