SUBJECT: MEETING TO DISCUSS ENGINEERING INITIATIVES AT FLORIDA POWER AND  
LIGHT

**NRC/FPL  
SEMIANNUAL COMMUNICATION MEETING  
NRC REGION II OFFICE, ATLANTA  
JULY 16, 10:00 A.M. - 12 NOON**

# ST. LUCIE REACTOR COOLANT PUMP I. BACKGROUND

## **PRESSURIZER INSTRUMENT NOZZLE CRACKING**

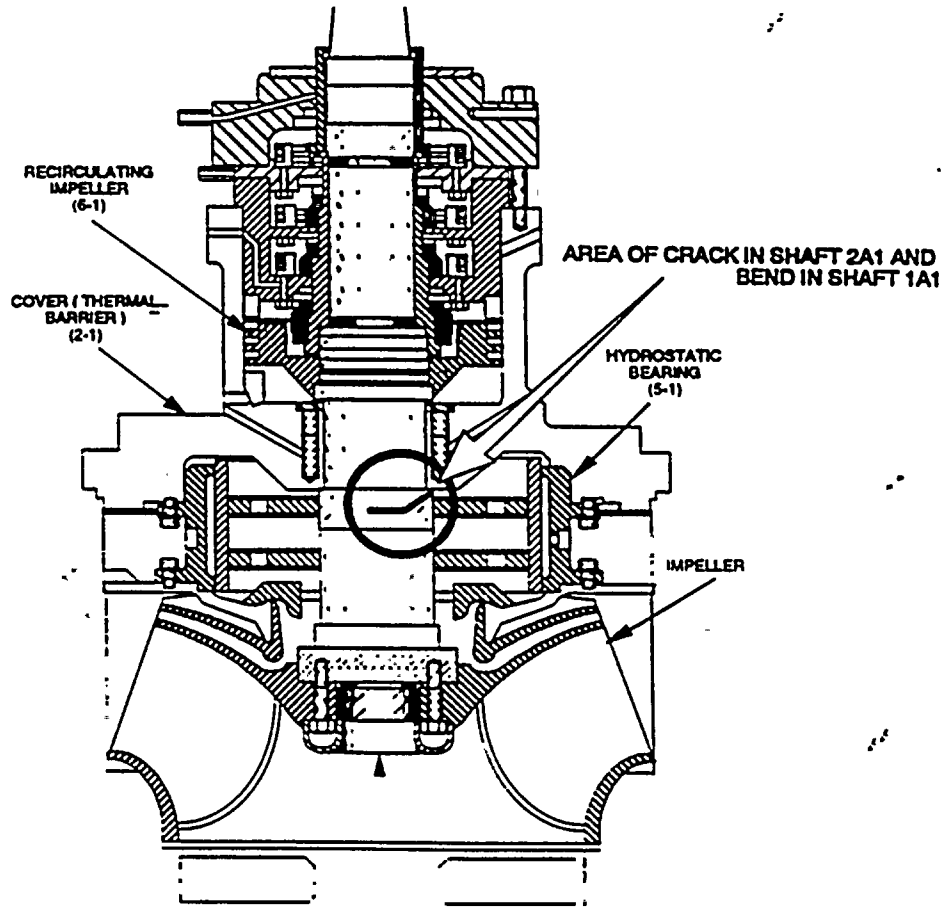
- 6/30/90 Pump 1A1 Experienced High Seal Leakoff Flow Requiring Plant Shutdown - Resultant Inspection Revealed Bent Shaft

- 1/13/93 Pump 2A1 Experienced High Vibration Requiring Plant Shutdown - Resultant Inspection Revealed A Cracked Shaft

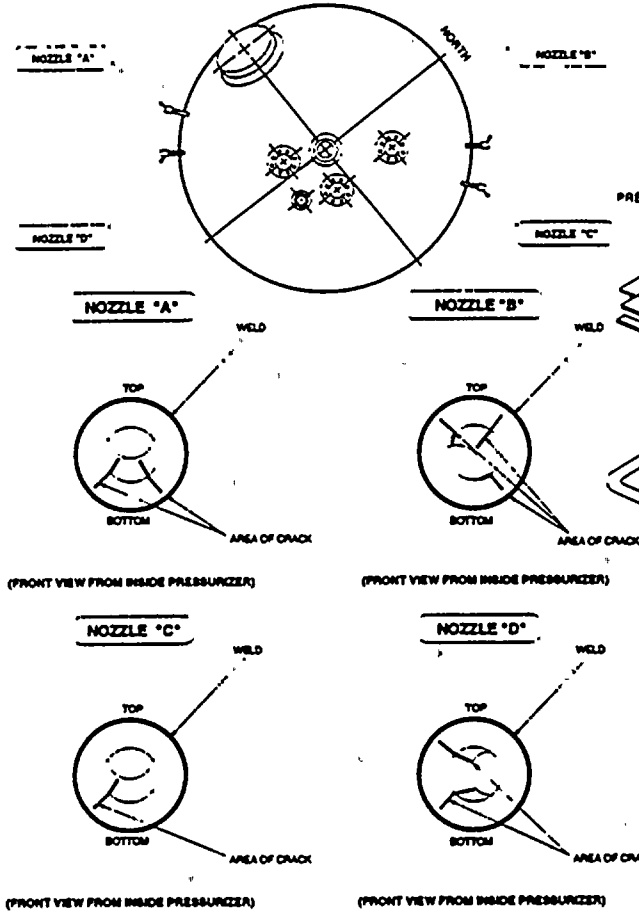
## PRESSURIZER NOZZLE EXAM FINDINGS UPPER NOZZLE LOCATIONS (PCM 8096-287)

**March 3, 1993, Visually Identified Four Steam Space Nozzles With Leakage On Unit 2 In Mode 5**

- **Primary Water Stress Corrosion Cracking**

- **Steam Space Nozzles Replaced With Alloy 690**
- **Inspected Liquid Space Nozzles Of Same Heat**

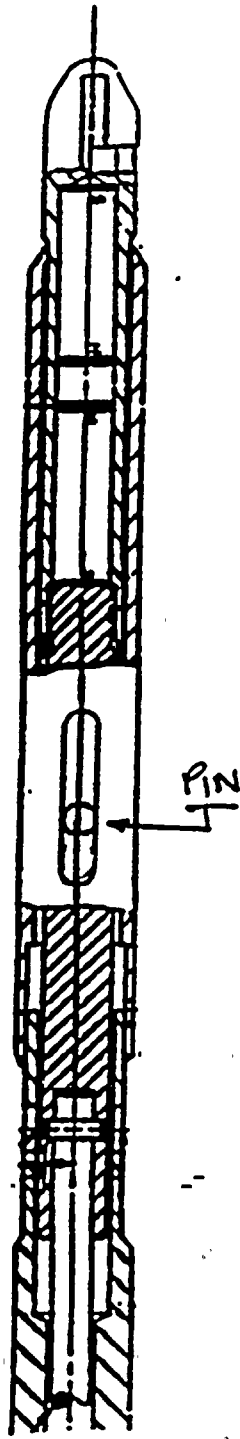
INCORRECT PIN POSITION

- 1. Inboard CEA #103 Found Unlatched From Dual Extension Shaft #7**
- 2. Dual CEDM Shaft #7 Removed From Upper Guide Structure. Functionally, Dimensionally And Visually Checked - No Anomalies Noted**
- 3. Inspection Of CEA Hubs #103 & #98 Showed No Damage**
- 4. Inspection Of Dual Shroud And Associated Area Above Fuel Found No Anomalies**

PROBABLE ROOT CAUSE

- 1. Enhance Coupling/Uncoupling Procedure By:**
  - (a) Add Requirements To Measure Coupled Extension Shaft Height**
  - (b) Include Step To Verify Adequate Slack Exists In Coupling Tool Suspension System**

- 2. Human Factor Improvements To Improve Indicator Pin Verification**
  - (a) Supply Additional Lighting To Assist Position Indicator Pin Verification**
  - (b) Independant Verification Of Position Indicator Pin Location**

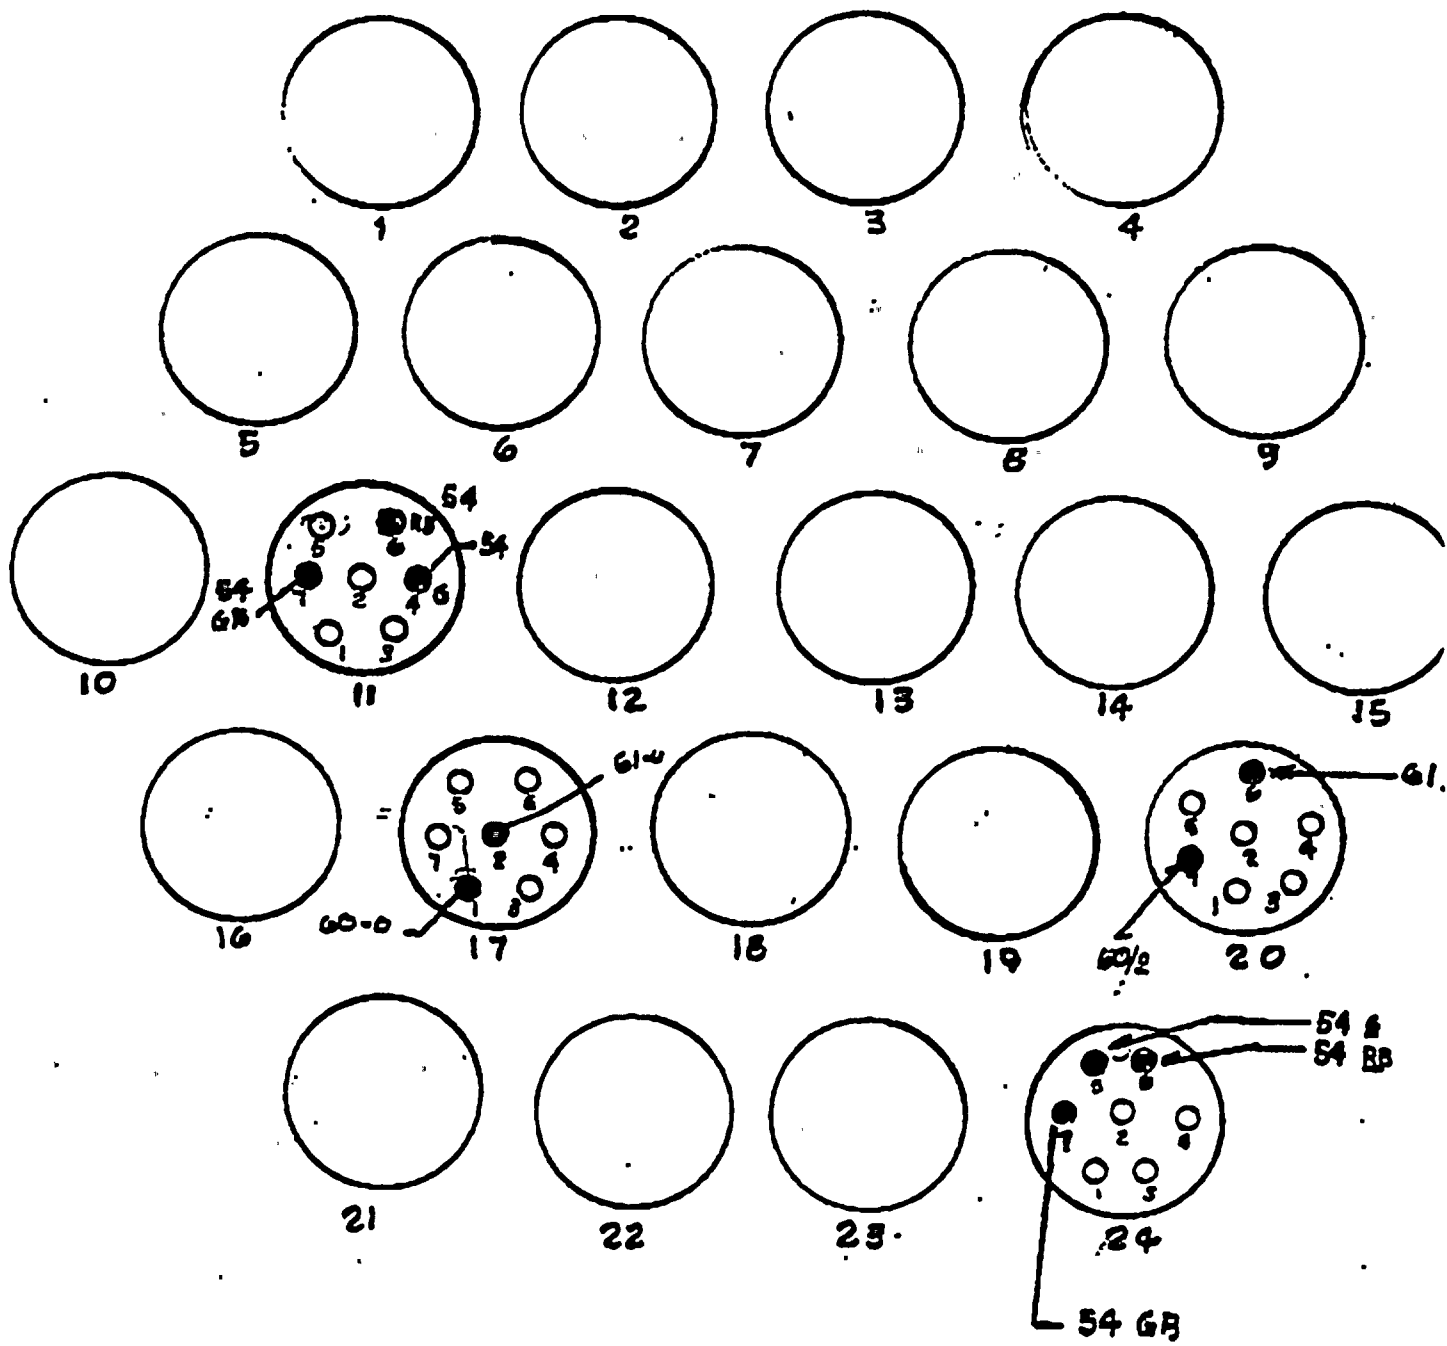
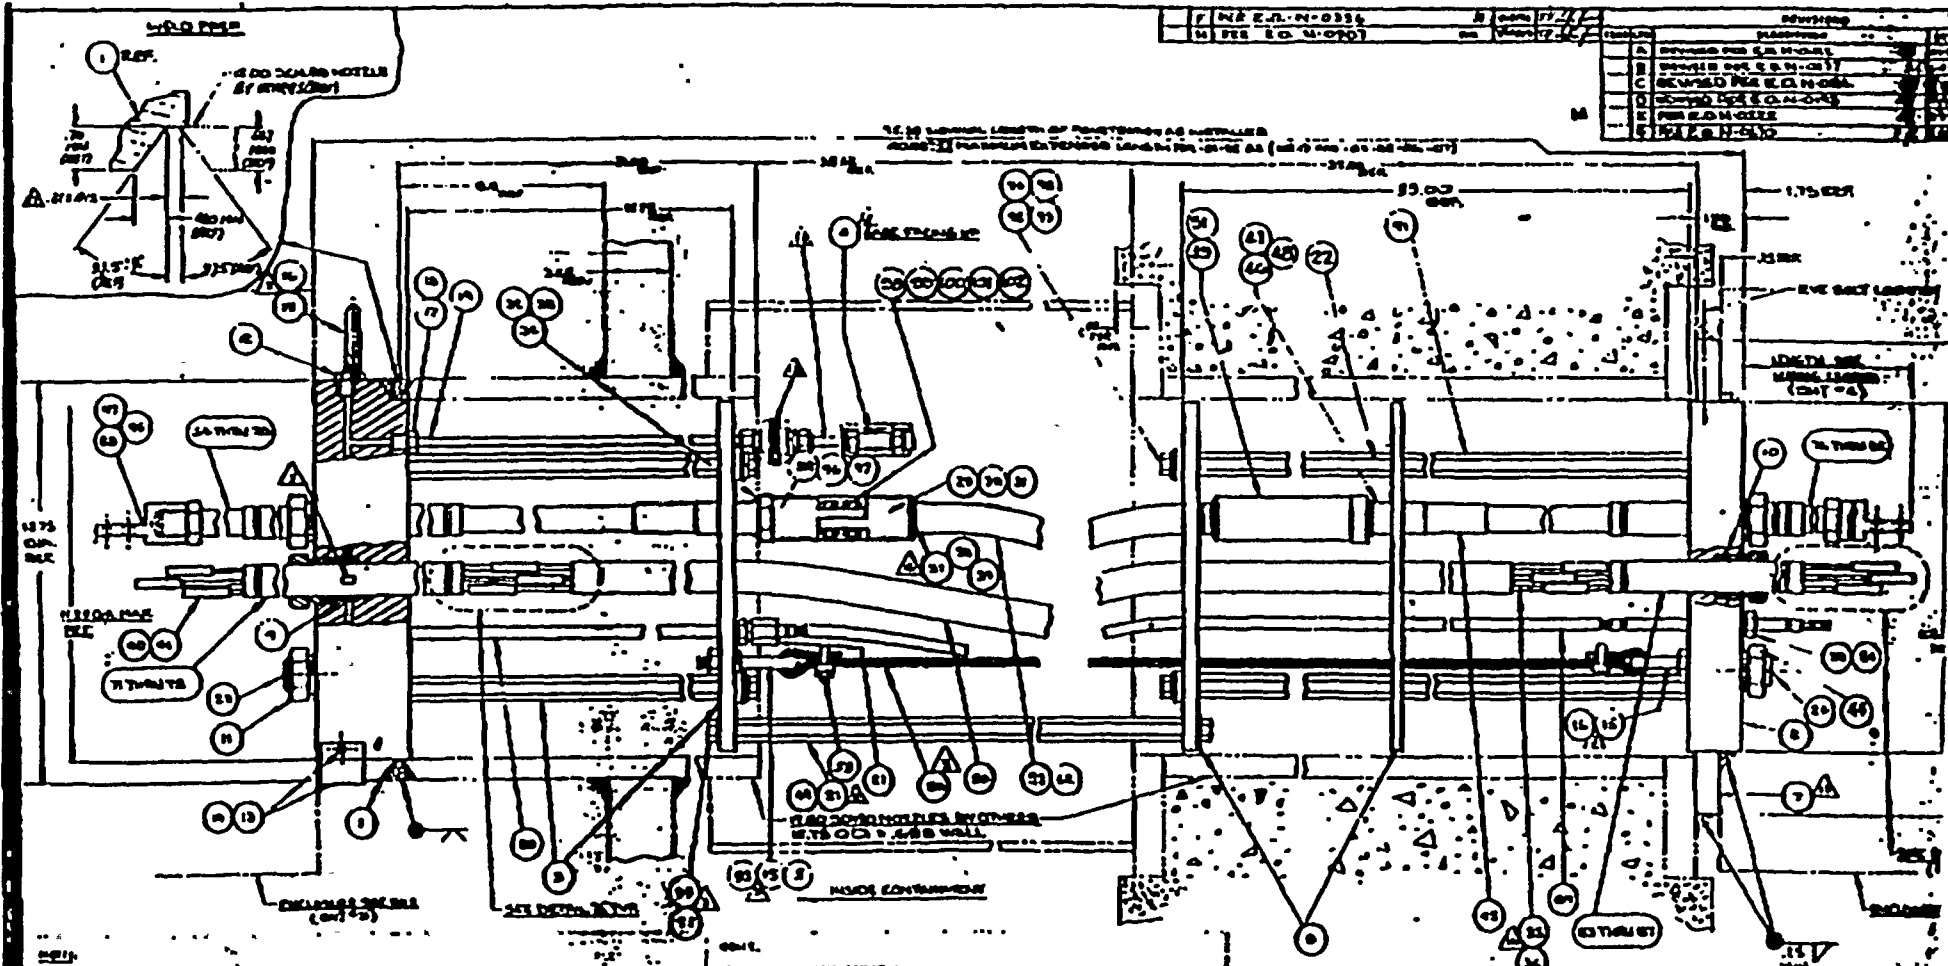
# PENET. D-1

- **Root Cause For Event**
  - Grounds In Containment Electrical Penetration

- **Meggered All CEDMs From CEDMCS To Identify Grounds**
- **Re-Routed Grounded Connections To Tested Spare Penetration Conductors**
- **Monitored Output Of MGs Via Power Line Monitor**

- **Perform Inspection Of Defective Penetration To Identify Failure Mechanism**
- **Addition Of Ground Detection System To CEDMCS Bus**
