SUBJECT: LER 94-005-00: on 940924, Unit 4 manually tripped. Caused by manual actuation. Light bulb & socket replaced. W/941020 ltr.

Re: Turkey Point Unit 4
Docket No. 50-251
Reportable Event: 94-005-00
Manual Reactor Trip

FACILITY NAME (1) TURKEY POINT UNIT 4										DOCKET NUMBER (2) 05000251		PAGE (3) 1 OF 3		
TITLE (4) MANUAL REACTOR TRIP DUE TO PARTIAL LOSS OF ROD POSITION INDICATOR														
EVENT DATE (5)			LER NUMBER(6)			RPT DATE (7)			OTHER FACILITIES INV. (8)					
MON	DAY	YR	YR	SEQ #	R#	MON	DAY	YR	FACILITY NAMES			DOCKET # (5)		
09	24	94	94	005	00	10	20	94						
OPERATING MODE (9)		3		<u>10 CFR 50.73(a)(2)(iv)</u>										
POWER LEVEL (10)		0%												
LICENSEE CONTACT FOR THIS LER (12)

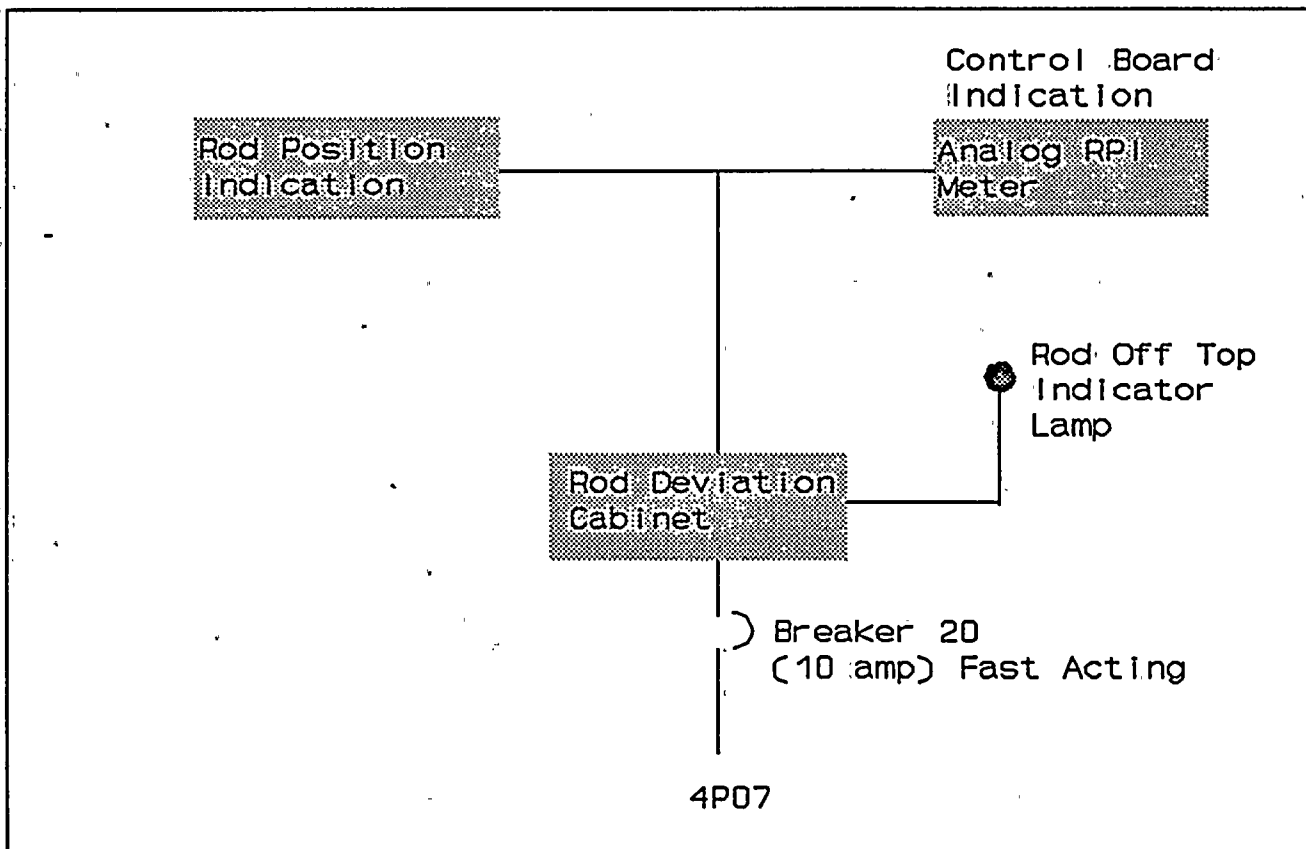
Figure 1.

The immediate cause of the trip was a manual actuation. The manual actuation was selected because of the mismatch between the indicated position of shutdown bank A and the position indicated by the analog rod position indicating system.

The mismatch was caused by the following chain of events. When the operator touched the light bulb on the number 4 control board status light, the remaining short filament on the burned out bulb relanded inside the bulb and caused a higher current than usual. The fast acting breaker (# 20 on panel 4P07) for the rod deviation cabinet opened due to the higher current. This breaker provides power to the rod deviation cabinet. Upon the opening of the breaker, the impedance in the common circuit between the rod deviation cabinet and the rod position indication circuit decreased causing an approximate 60% of full scale reading on the analog rod position indication meter for shutdown bank A. See figure 1 on page 3.

- 1. The light bulb and socket were replaced.
- 2. The cause of the change in the analog rod position indication was verified by test.
