SUBJECT: LER 94-006-00: on 941130, Unit 4 tripped automatically. Caused by failure of flexible link connection between main generator B phase bus & associated isolated phase bus bar. All bolts on flexible link checked. W/941213 ltr.

Re: Turkey Point Unit 4
Docket No. 50-251
Reportable Event: 94-006-00
Automatic Reactor Trip Due to Main Generator Ground

AUTOMATIC REACTOR TRIP DUE TO MAIN GENERATOR GROUND

FACILITY NAME DOCKET NUMBER LER NUMBER PAGE NO.
TURKEY POINT UNIT 4 05000251 94-006-00 02 OF 04

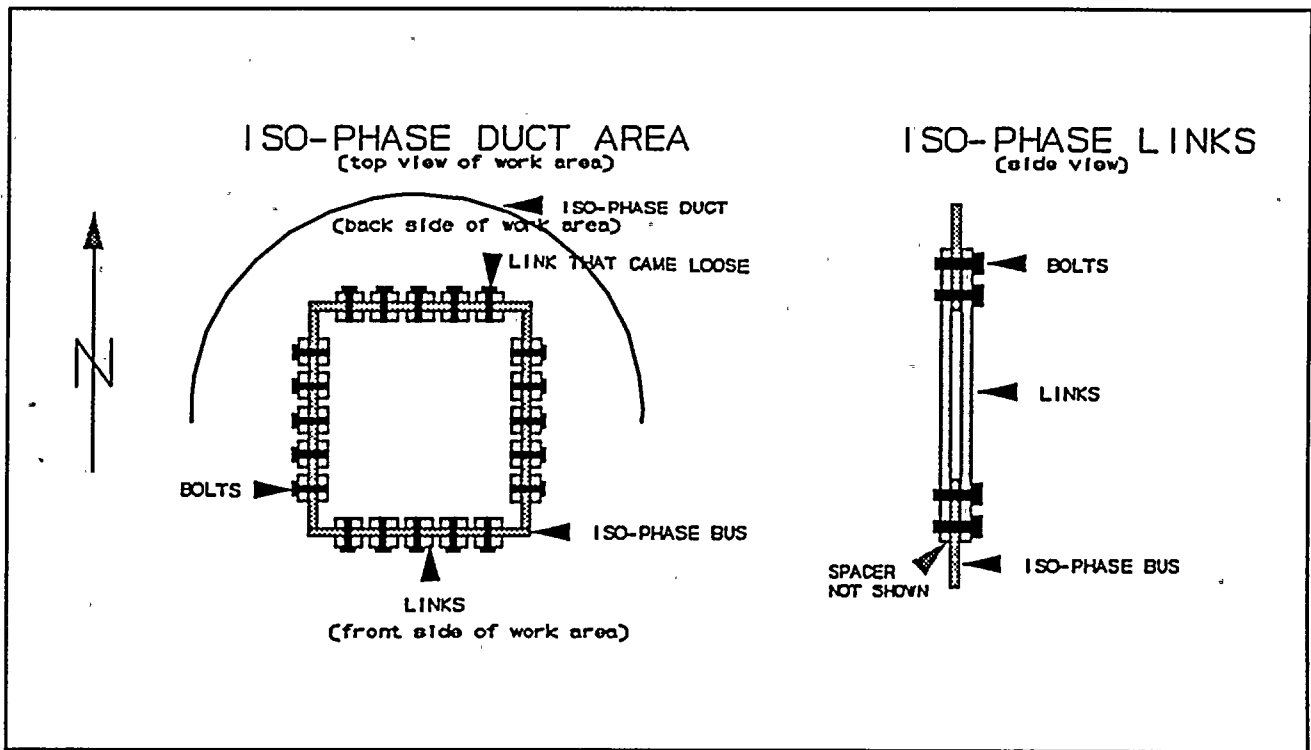
The cause of the failure of the flexible link connection was a personnel error resulting in an inadequate torque of the bolted connection. The required torque for the connection was 40 foot-pounds. These connections were disconnected, cleaned and reinstalled as part of the maintenance scheduled for this equipment during the recent refueling outage. After the trip, one flexible link was found fallen away from the bus and touching the isolated phase bus ductwork. Five bolts on the north face of the B phase of the generator bus were found loose.

Procedure 0-PME-090.1 Power Generator Grounding For Safety and Testing Preparation, was used as work control for the flexible link removal and reinstallation. This work control was not adequate to ensure all flexible link connections were retorqued to 40 foot pounds. A contributor to the event was more than one worker completing torquing of the bolts on the B phase flexible links without verification of each link during the process. The A and C phases were each completed by one worker.

Each output phase of the main generator is connected to its associated isolated phase bus by a series of 20 pairs of flexible links. Each pair of links is installed back to back and requires two bolts at each end to connect it to the main generator bus at one end and the isolated phase bus on the other. Each bolt must be torqued to 40 foot-pounds. A total of 240 bolts are required to complete the installation of all flexible links between the each of three phases of the main generator buses and their associated isolated phase bus.

1. All 240 connecting bolts on the main generator flexible links were checked for proper torque.
2. The main generator was megger tested with satisfactory results.
3. The procedure used to install the main generator flexible links will be reviewed to determine necessary work process improvements. These improvements, if necessary, will be completed prior to the next outage requiring work on these links.
