SUBJECT: LER 97-008-00: on 970909, containment sump debris screens outside design basis due to stress damage was discovered. Caused by inadequate procedural guidance & personnel error. Discrepancies found on screens corrected. w/971008 ltr.

Re: Turkey Point Units 3 and 4
Docket Nos. 50-250/251
Reportable Event: 97-008
Date of Event: September 9, 1997
Containment Sump Debris Screens Outside Design
Basis Due to Screen Damage

TITLE (4) Containment Sump Debris Screens Outside Design Basis Due To Screen Damage

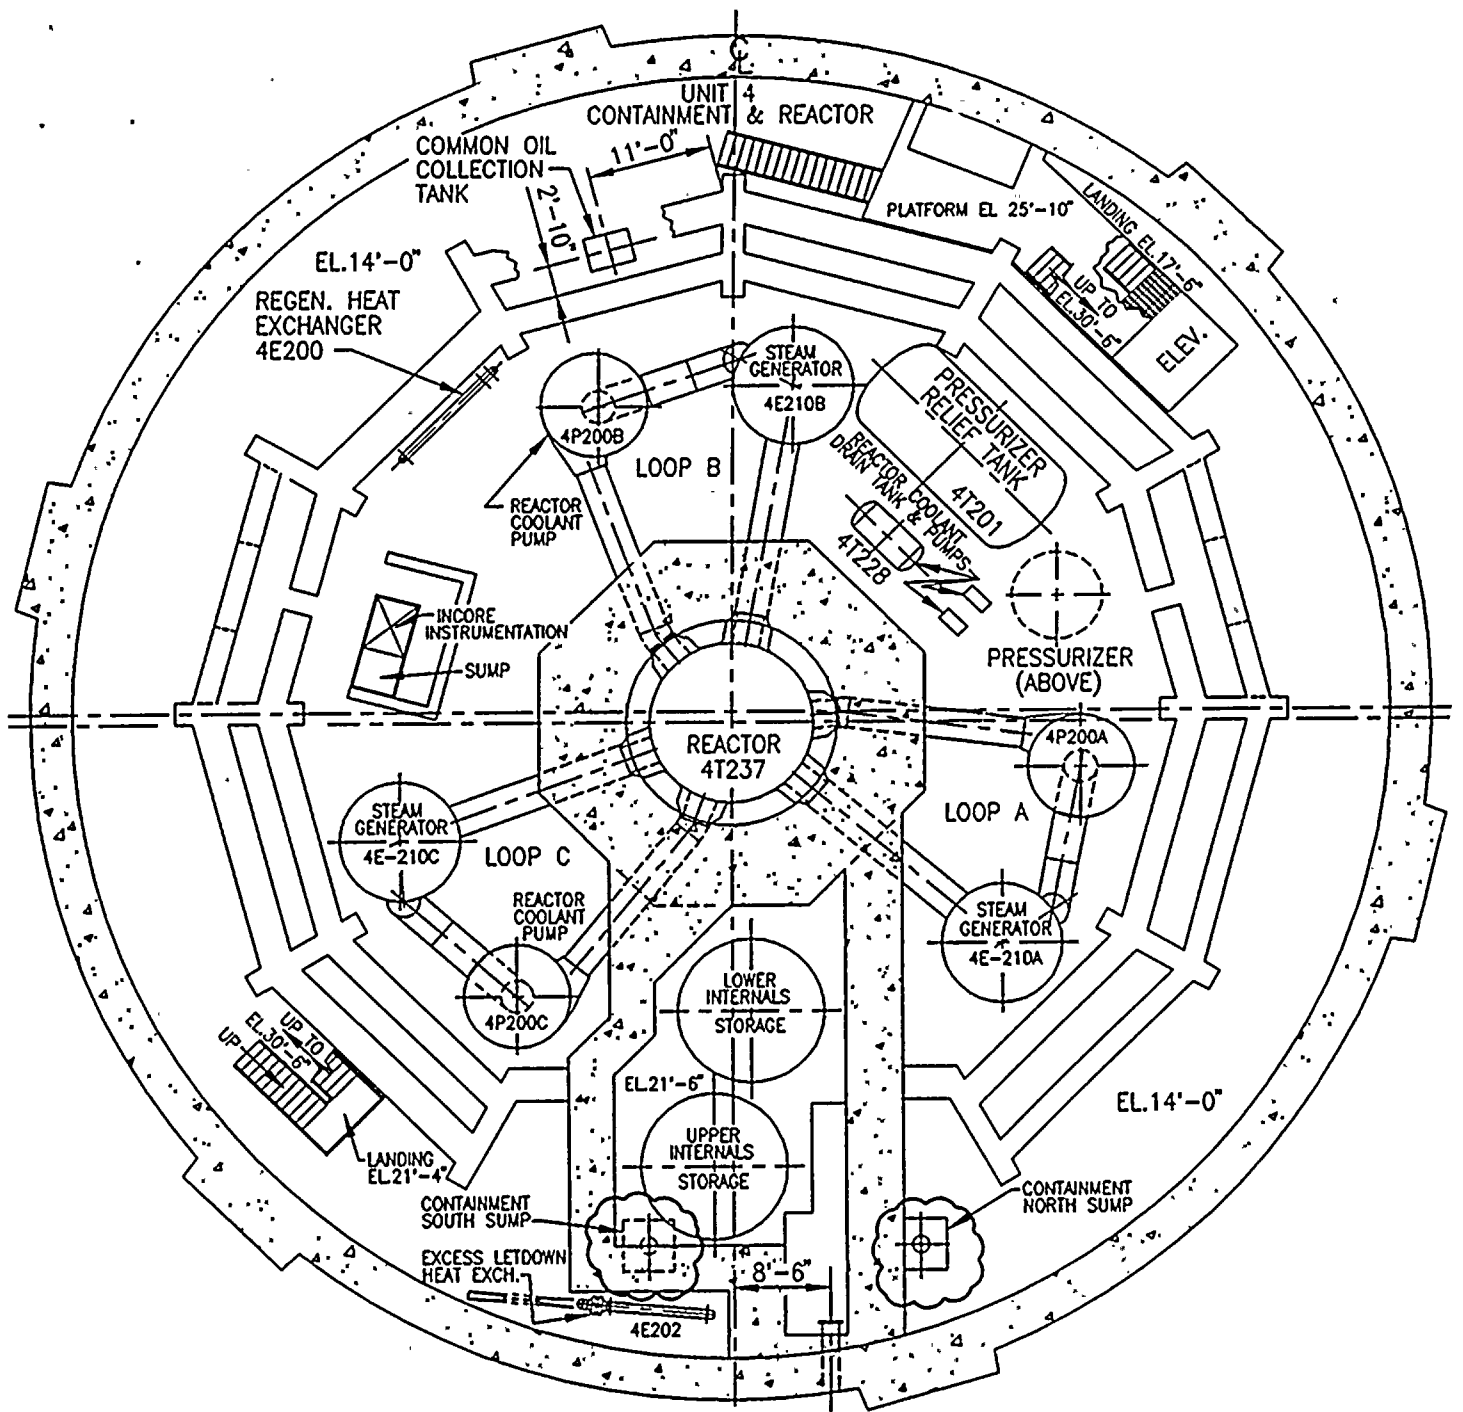
**SIMPLIFIED SKETCH OF
UNIT 4 CONTAINMENT BUILDING
(BASEMENT ELEVATION)**

A simplified sketch of the Unit 4 containment building (basement elevation) is attached.
