# LICENSEE EVENT REPORT (LER)

| FACILITY NAME (1)<br><p style="text-align: center;">TURKEY POINT UNIT 3</p> | DOCKET NUMBER (2)<br><p style="text-align: center;">05000250</p> | PAGE (3)<br><p style="text-align: center;">1 OF 6</p> |

TITLE (4) **Console Switch Position Disabled Auxiliary Feedwater Auto Start Logic on 3B Steam Generator Feedwater Pump Trip**

| FACILITY NAME | DOCKET NUMBER | LER NUMBER | PAGE NO. |
|---|---|---|---|
| TURKEY POINT UNIT 3 | 05000250 | 97-009-01 | 2 OF 6. |

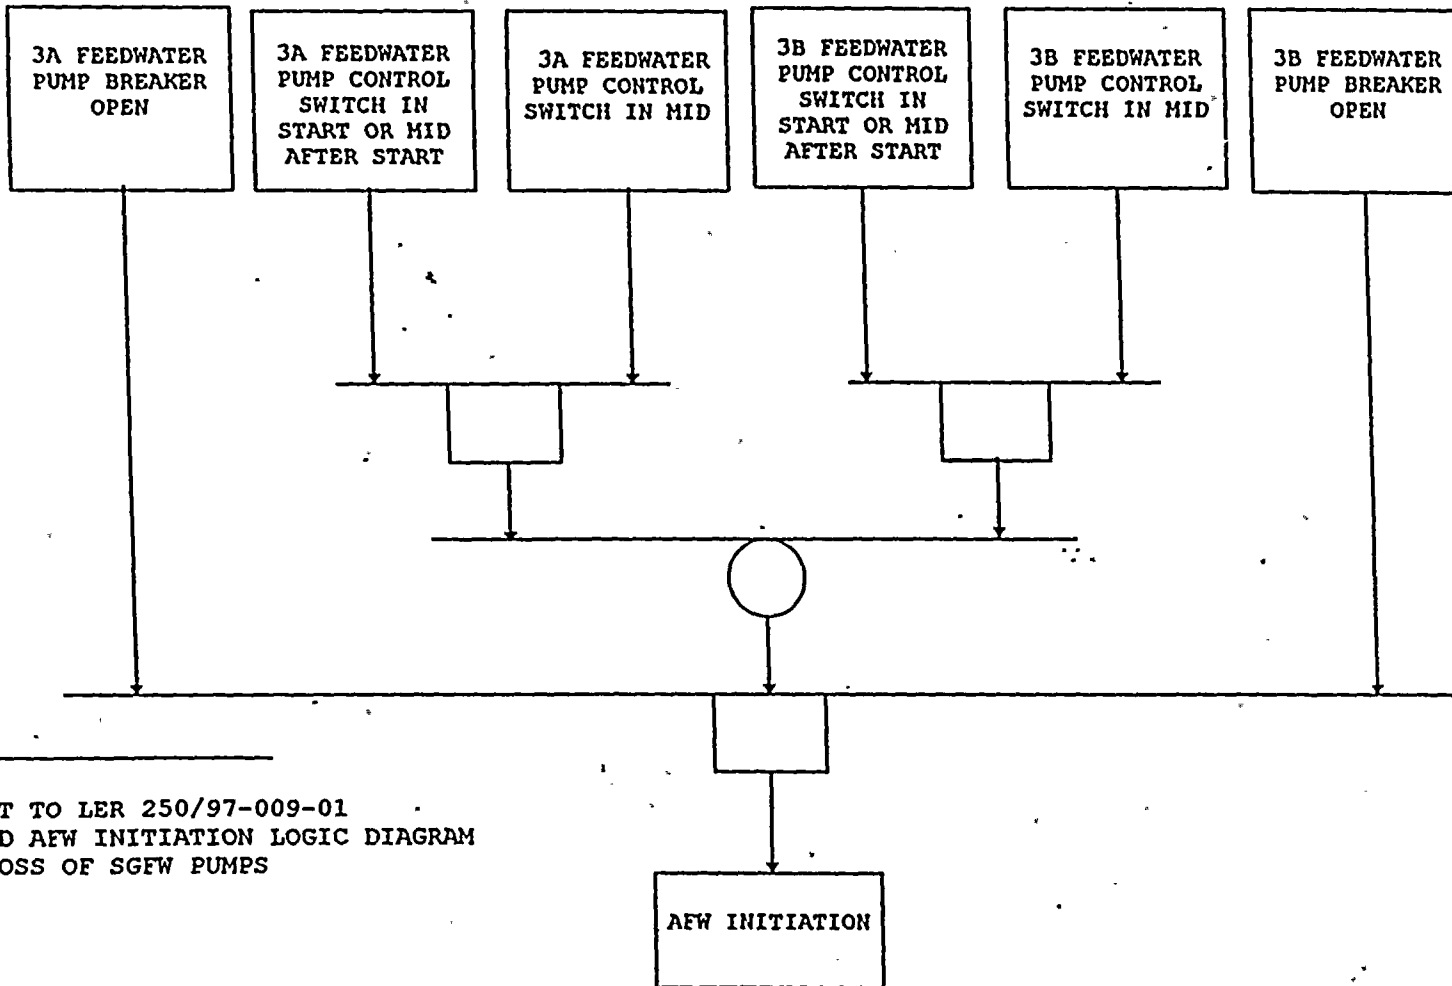
ATTACHMENT TO LER 250/97-009-01  
 SIMPLIFIED AFW INITIATION LOGIC DIAGRAM  
 FOR THE LOSS OF SGFW PUMPS

The AFW Initiation logic diagram for the loss of SGFW pumps is attached.
