LICENSEE EVENT REPORT (LER)

FACILITY NAME (1) TURKEY POINT UNITS 3 & 4	DOCKET NUMBER (2) 05000250	PAGE (3) 1	OF 7
--	--------------------------------------	----------------------	----------------

TITLE (4) **Potential LOCA-Initiated Electrical Fault Places ECCS Outside Design Basis**

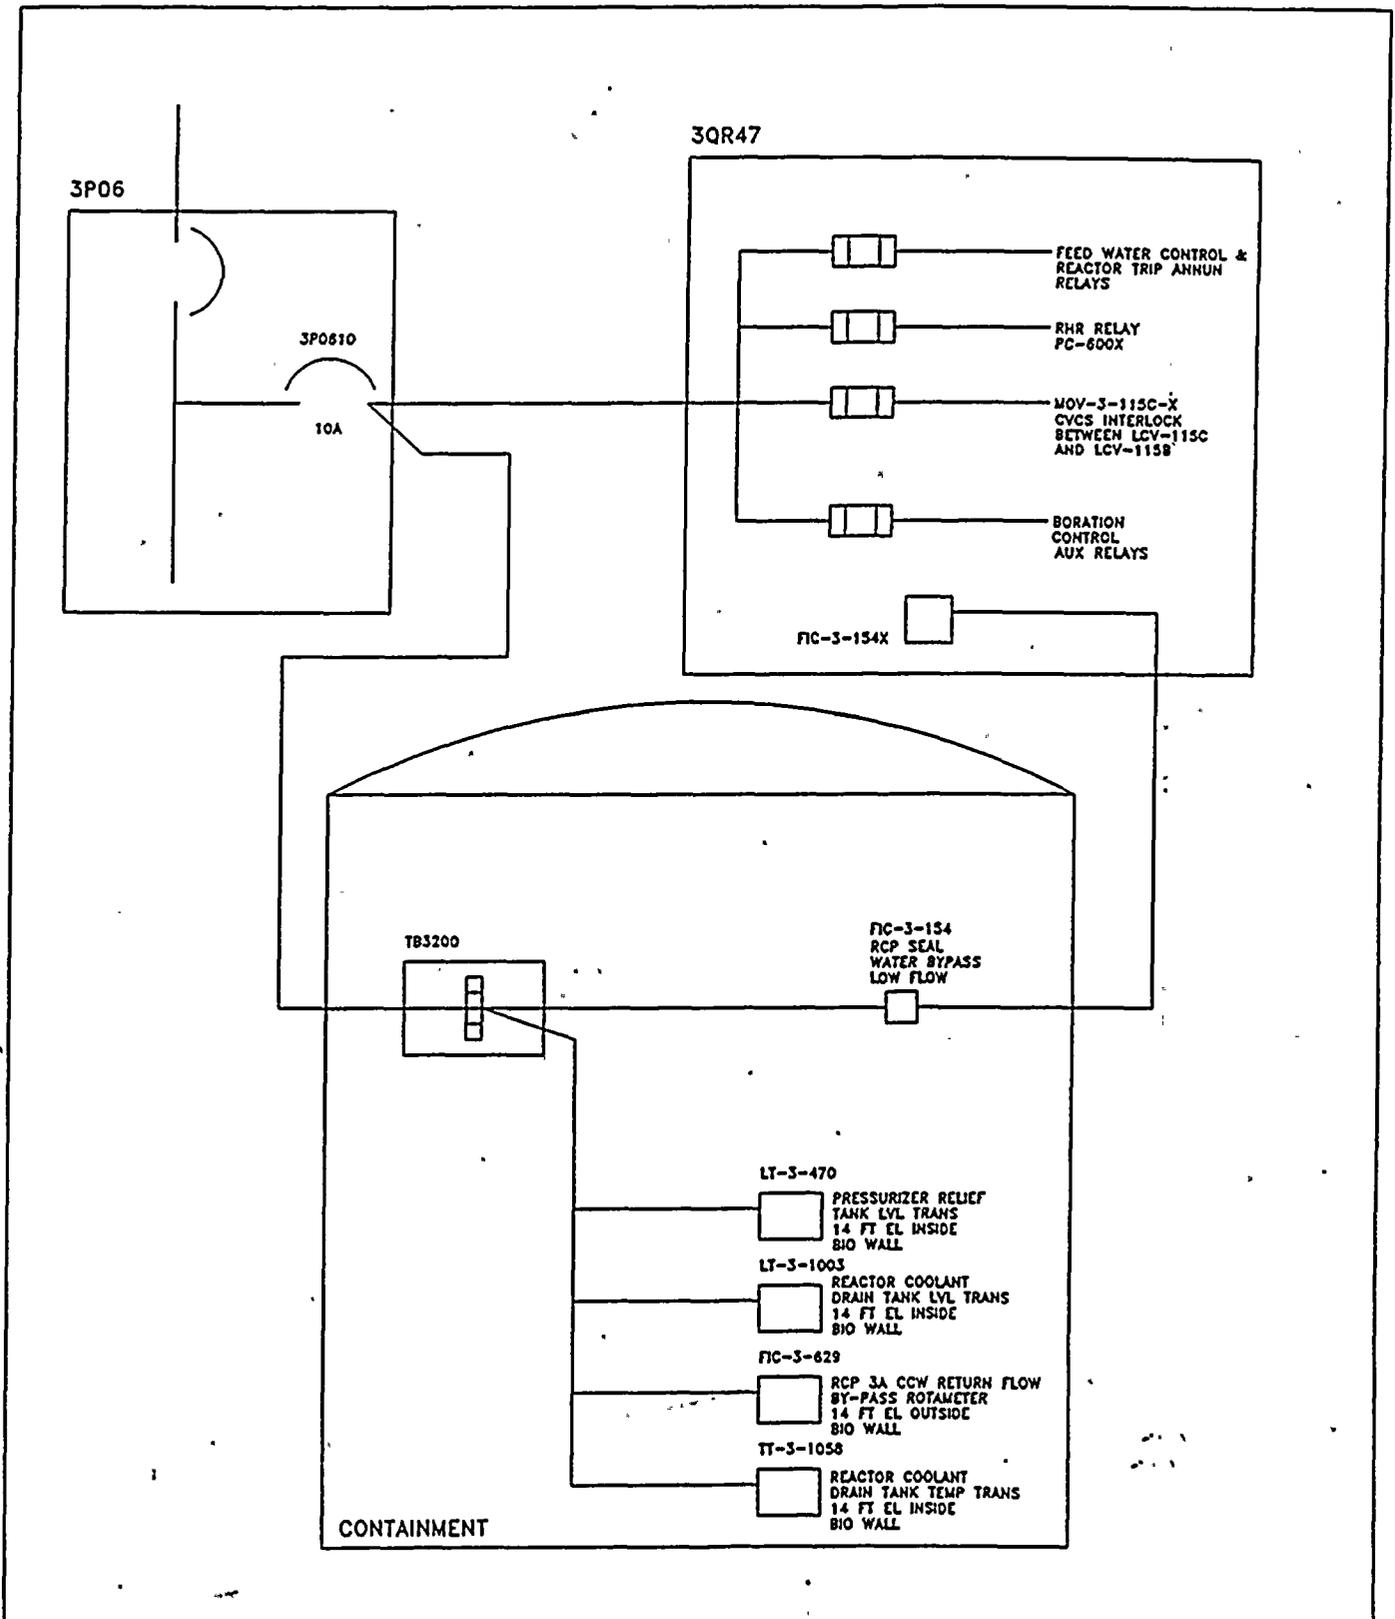
Pressure control relay PC-*-600X is powered from breaker 3(4)P06-10 on safety related 120 volt AC instrument bus 3(4)P06. The 120 VAC vital instrument busses are powered from inverters [EF:inv] which are backed by the plant safety related batteries [EJ:btry]. Because of specific issues related to instrument panel operation when powered from inverters, the instrument busses use high speed, magnetic only, breakers to prevent an instrument fault from tripping the instrument bus.

The condition reported herein involves a specific set of devices powered from vital instrument breaker 3(4)P06-10 (a 10 amp high speed breaker). These are shown on the attached simplified diagram (page 7). Each of these devices was evaluated, and only the loss of PC-*-600X resulted in a reportable condition.

In the event of a LOCA, the containment recirculation sump will fill with water as the RWST is depleted: The LOCA may submerge the Reactor Coolant Drain Tank (RCDT) instrumentation powered from 3(4)P06-10 and would expose all of the non-safety related instruments inside containment to environmental conditions for which they have not been qualified. The submergence or environmental conditions affecting these non-safety related, non-qualified devices would be expected to result in a fault that would open 3(4)P06-10.

- 1) PC-*-600X has been repowered from a dedicated, appropriately protected, safety related power supply (breakers 3P21-09 and 4P23-05). There are no other loads on these breakers.
