SUBJECT: LER 87-054-00: on 870915, determined that more limiting single failure might exist & on 870916 two addl potential failure modes identified & plant shutdown. Mod made to solid state protection sys. W/871015 ltr.

FACILITY NAME (1) SHEARON HARRIS NUCLEAR POWER PLANT, UNIT 1										DOCKET NUMBER (2) 0 5 0 0 0 4 0 0 1 OF 0 8										PAGE (3) 1 OF 0 8	
TITLE (4) UNANALYZED CONDITION - ISOLATION OF AUXILIARY FEEDWATER CAUSED BY LOSS OF VITAL DC BUS 1B-SB COINCIDENT WITH LOSS OF OFF-SITE POWER																					
EVENT DATE (5)			LER NUMBER (6)				REPORT DATE (7)			OTHER FACILITIES INVOLVED (8)											
MONTH	DAY	YEAR	YEAR	SEQUENTIAL NUMBER	REVISION NUMBER	MONTH	DAY	YEAR	FACILITY NAMES					DOCKET NUMBER(S)							
0 9	1 5	8 7	8 7	0 5 4	0 0	1 0	1 5	8 7						0 5 0 0 0							
OPERATING MODE (9) 1			THIS REPORT IS SUBMITTED PURSUANT TO THE REQUIREMENTS OF 10 CFR §: (Check one or more of the following) (11)																		
POWER LEVEL (10) 1 0 0			20.402(b)				20.405(c)				50.73(a)(2)(iv)				73.71(b)

LICENSEE EVENT REPORT 87-054-00

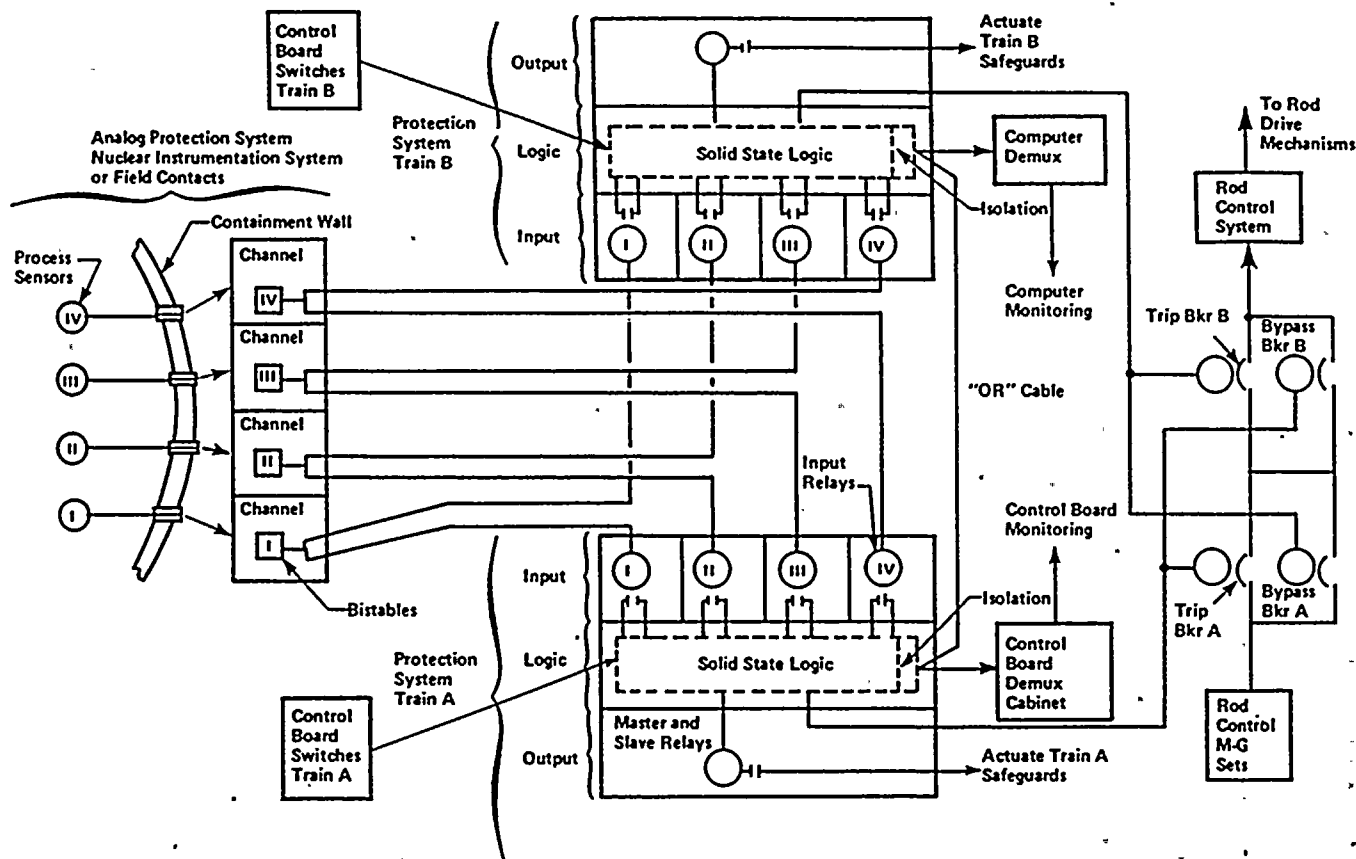
FIGURE 8.1.3-3

As shown in FSAR Figure 8.1.3-3 (Attachment 1), DC bus 1B-SB is the alternate power supply to the inverters supplying instrument busses SII and SIV. The safety-related AC power (EIIS:EL) is the normal supply to these inverters through train B safety-related, diesel generator connectable AC busses (EIIS:EK). Upon a loss of DC bus 1B-SB, the instrument

busses remain powered via the AC input to the inverters. However, this power supply is deenergized upon a postulated loss of off-site power. Emergency power is supplied by the 1B-SB emergency diesel generator; however, it requires DC bus 1B-SB to power the starting air valves (EIIS:EK), field flashing and breaker control power. Since the DC bus is also postulated to fail, the diesel generator will not be available, and the two instrument busses will deenergize.

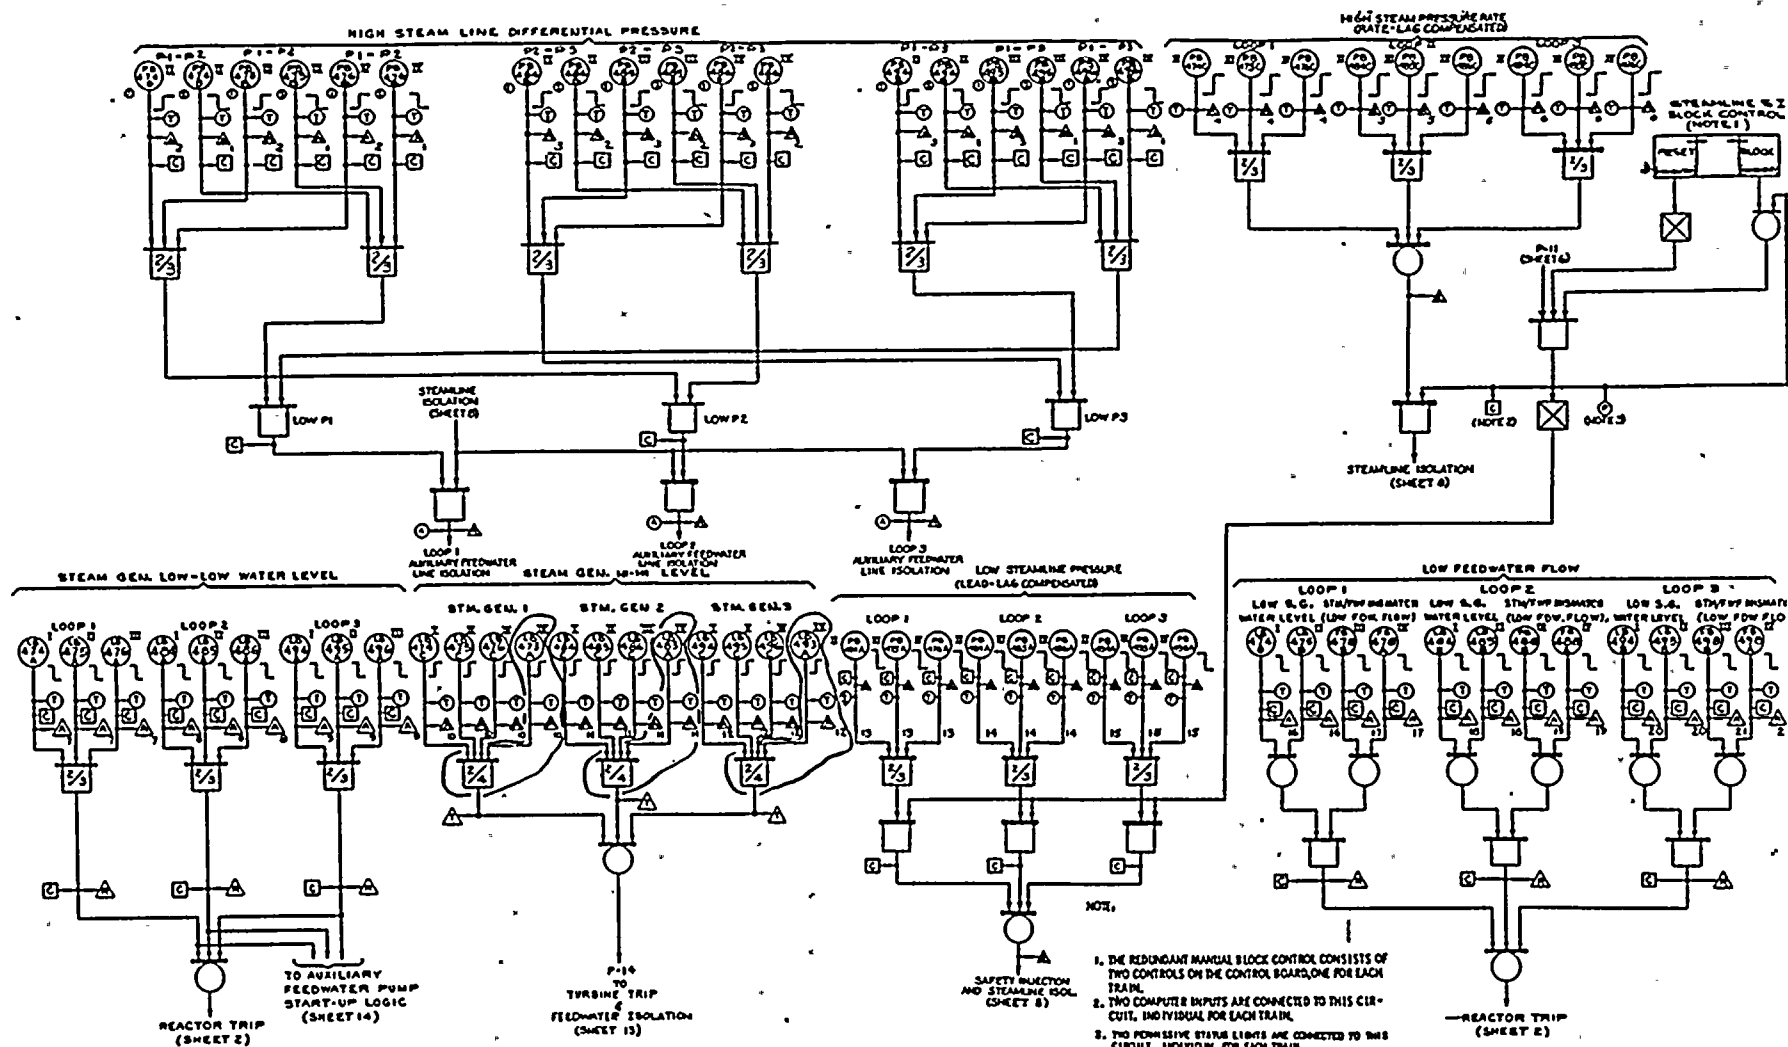
STEAM GENERATOR TRIP SIGNALS
FIGURE 7.2.1-1
SHEET
7 OF 15

Shearon Harris Technical Specification 3.3.2 requires the capability to automatically isolate AFW to a faulted steam generator. As shown in FSAR Figure 7.2.1-1 (Attachment 3), this requirement is met by comparing steam generator pressures from instrument channels 2, 3, and 4 using a two out of three logic. The failure of any one channel will not cause inadvertent actuation, and since the bistables deenergize to actuate, the failure of any one channel will not prevent actuation when required. Since the postulated failure of DC bus 1B-SB causes a loss of both channels 2 and 4, the actuation logic for AFW isolation will be made up and AFW isolation will occur for all three steam generators. The two deenergized PICs provide trip signals to the Train A logic which will respond to the input. This is sufficient to complete the required 2/3 logic even if the valid Channel III input remains untripped.

To prevent the inadvertent isolation of AFW to all three steam generators, a modification was made to the SSPS and PIC 4. The modification changed one channel of AFW isolation relays (EIIS:BA) and bistables (EIIS:BA) from "deenergize to actuate" to "energize to actuate". Thus if the single failure deenergized both channels II and IV, the correct action of channel III would determine if an AFW isolation signal would result.
