SUBJECT: LER 87-054-00: on 870915, determined that more limiting single failure might exist & on 870916 two addl potential failure modes identified & plant shutdown. Mod made to solid state protection sys. W/871015 ltr.

TITLE (4) UNANALYZED CONDITION - ISOLATION OF AUXILIARY FEEDWATER CAUSED BY LOSS OF VITAL DC BUS 1B-SB COINCIDENT WITH LOSS OF OFF-SITE POWER

SHEARON HARRIS NUCLEAR POWER PLANT UNIT 1  
DOCKET NO. 50-400  
LICENSE NO. NPF-63  
LICENSEE EVENT REPORT 87-054-00

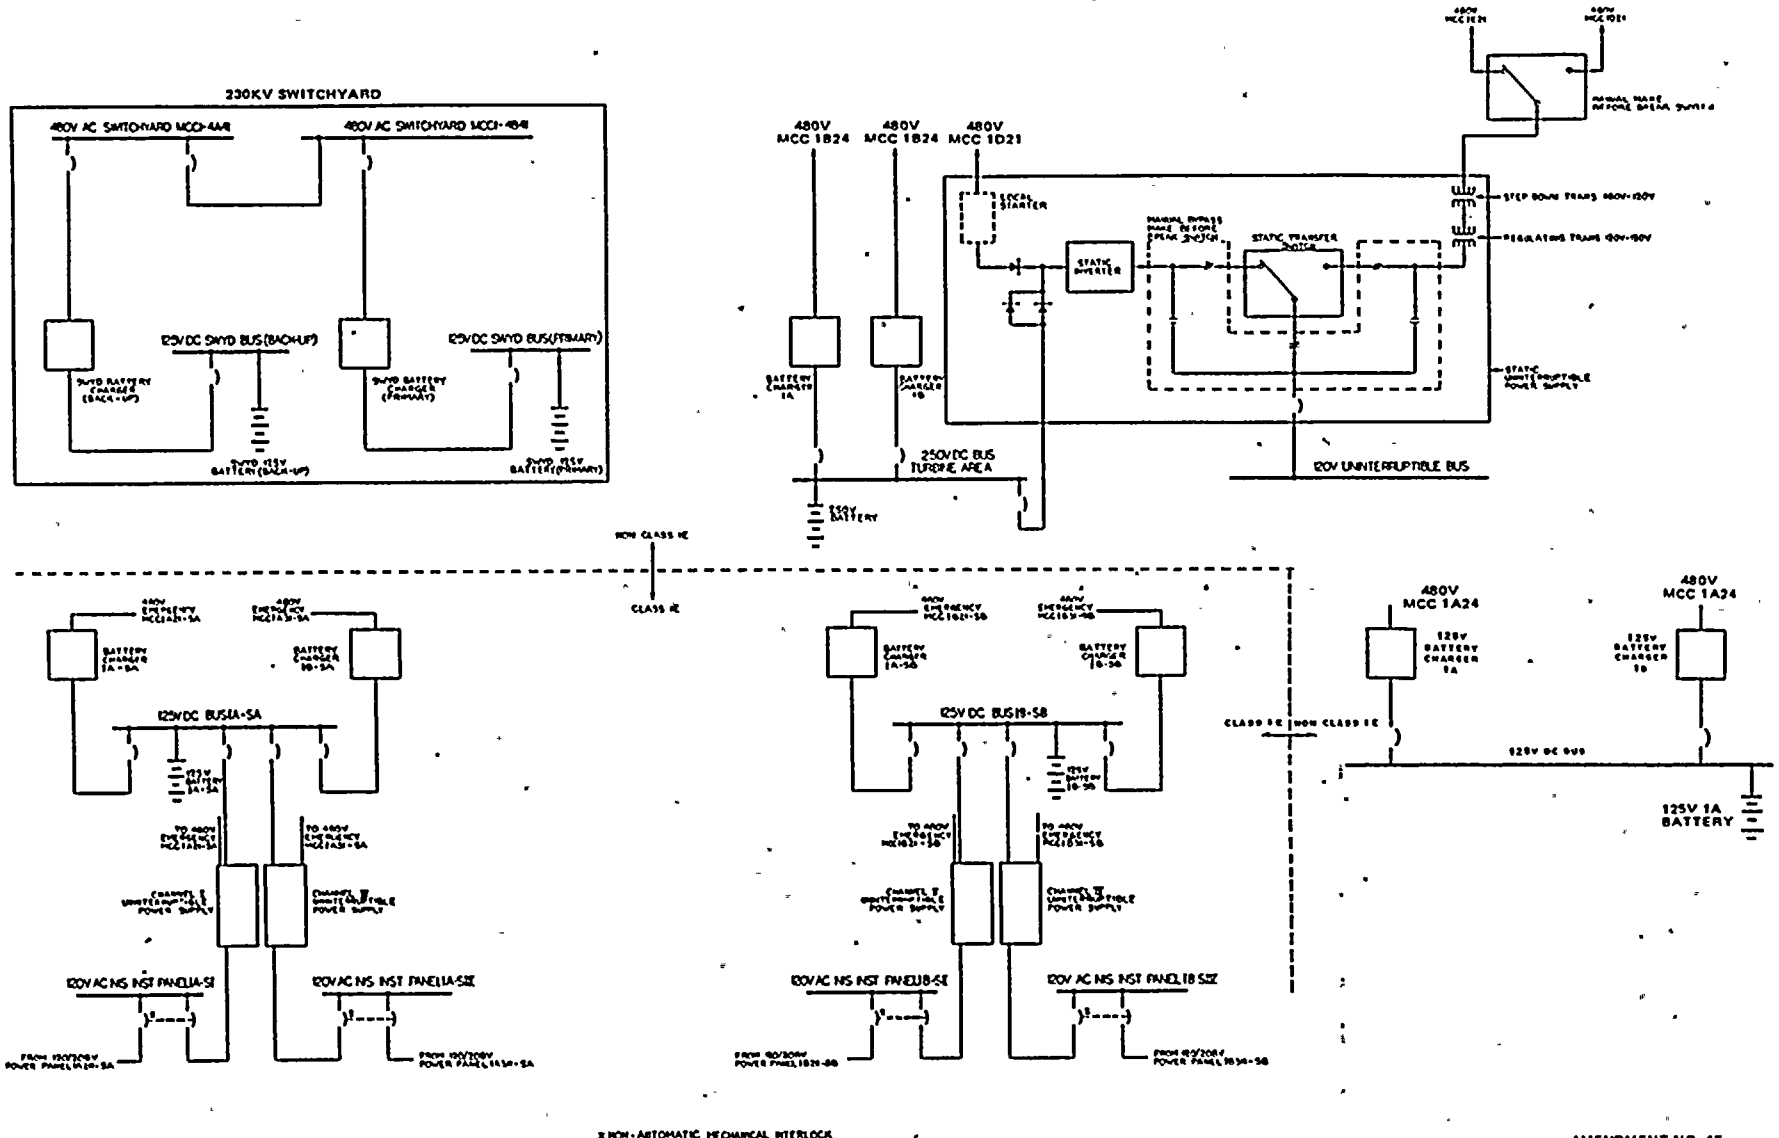
AMENDMENT NO. 15  
SHEARON HARRIS NUCLEAR POWER PLANT  
Carolina Power & Light Company  
FINAL SAFETY ANALYSIS REPORT  
125 VOLT D-C, 250 VOLT D-C AND  
120 VOLT A-C ONE-LINE DIAGRAM  
FIGURE 8.1.3-3

As shown in FSAR Figure 8.1.3-3 (Attachment 1), DC bus 1B-SB is the alternate power supply to the inverters supplying instrument busses SII and SIV. The safety-related AC power (EIIS:EL) is the normal supply to these inverters through train B safety-related, diesel generator connectable AC busses (EIIS:EK). Upon a loss of DC bus 1B-SB, the instrument

busses remain powered via the AC input to the inverters. However, this power supply is deenergized upon a postulated loss of off-site power. Emergency power is supplied by the 1B-SB emergency diesel generator; however, it requires DC bus 1B-SB to power the starting air valves (EIIS:EK), field flashing and breaker control power. Since the DC bus is also postulated to fail, the diesel generator will not be available, and the two instrument busses will deenergize.

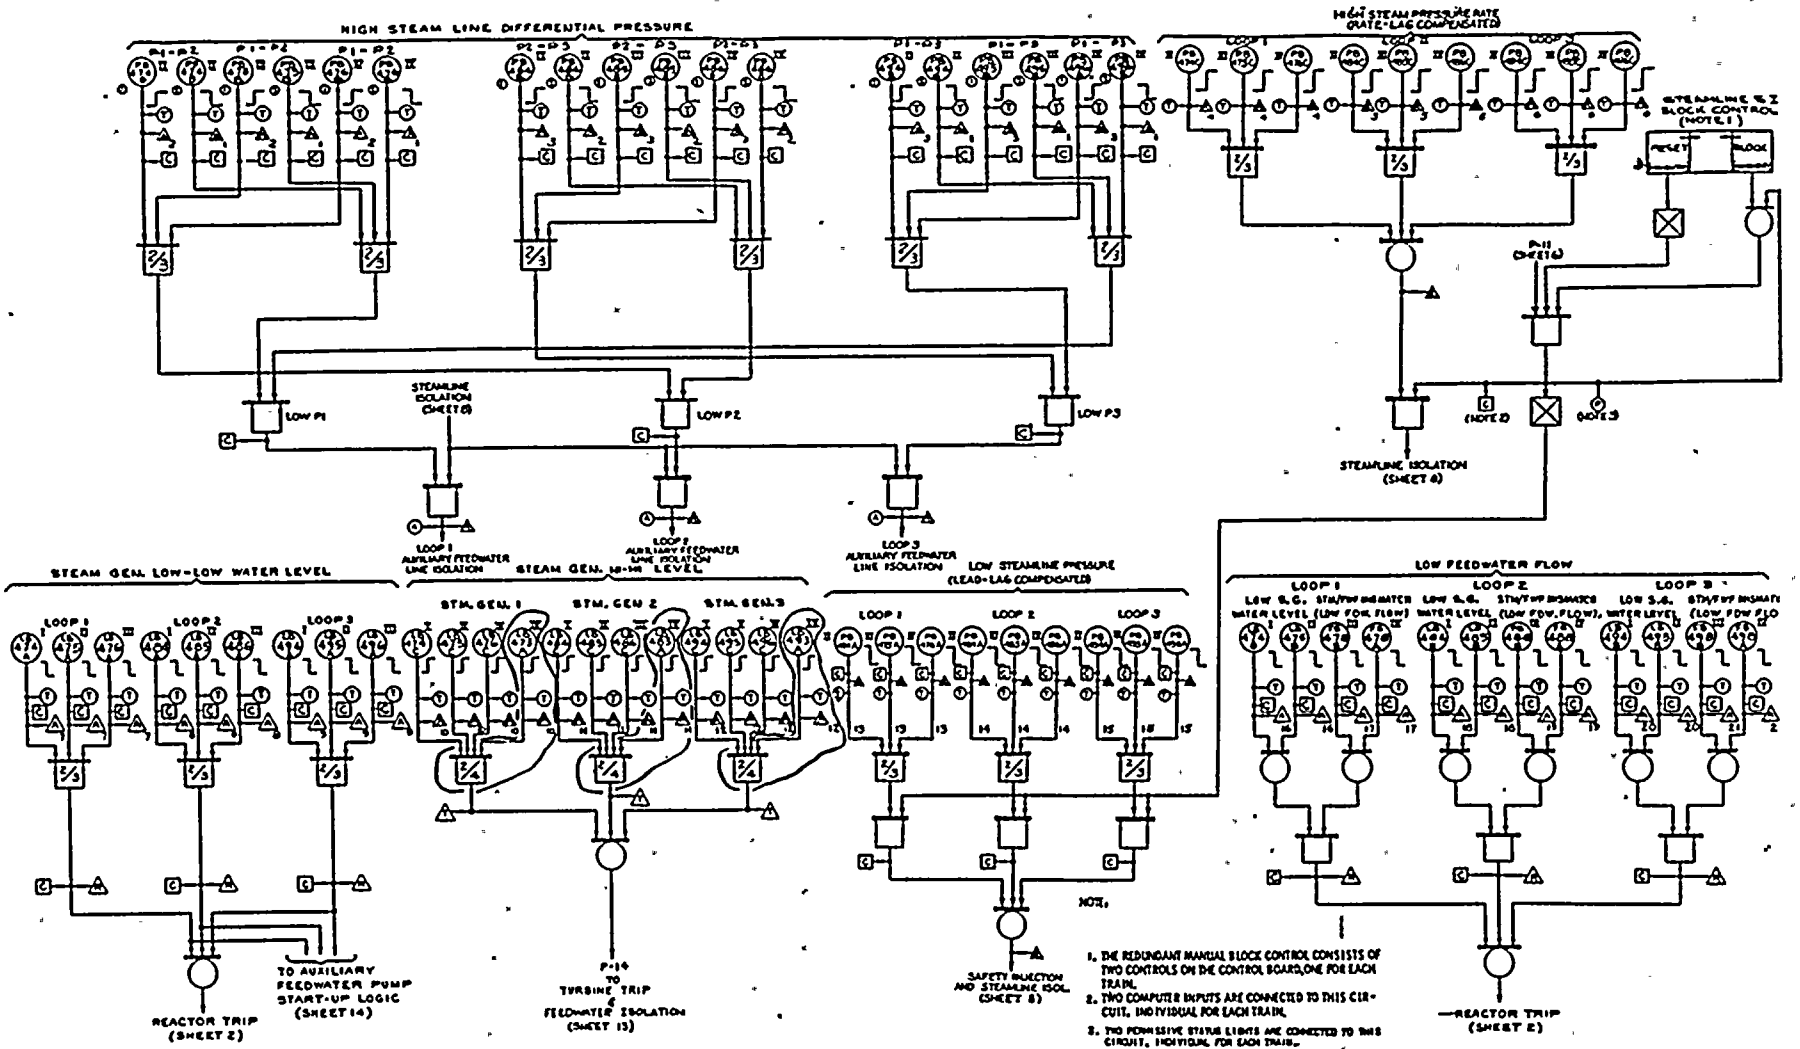
SHEARON HARRIS NUCLEAR POWER PLANT  
Carolina Power & Light Company  
FINAL SAFETY ANALYSIS REPORT  
STEAM GENERATOR TRIP SIGNALS  
FIGURE 7.2.1-1  
SHEET  
7 OF 15

Instrument bus SII is the power supply for Process Instrument Cabinet (EIIS:EF) (PIC) 2, and bus SIV is the power supply for PIC 4. In addition, these busses provide power to the Solid State Protection System (SSPS) train B (EIIS:JG). Upon a loss of power to the PICs, the instrument bistables deenergize to a "fail-safe" position. As shown in FSAR Figure 7.1.1-1 (Attachment 2), the output of these bistables, referred to as Channel II and Channel IV, is input into both trains of solid state logic.

Shearon Harris Technical Specification 3.3.2 requires the capability to automatically isolate AFW to a faulted steam generator. As shown in FSAR Figure 7.2.1-1 (Attachment 3), this requirement is met by comparing steam generator pressures from instrument channels 2, 3, and 4 using a two out of three logic. The failure of any one channel will not cause inadvertent actuation, and since the bistables deenergize to actuate, the failure of any one channel will not prevent actuation when required. Since the postulated failure of DC bus 1B-SB causes a loss of both channels 2 and 4, the actuation logic for AFW isolation will be made up and AFW isolation will occur for all three steam generators. The two deenergized PICs provide trip signals to the Train A logic which will respond to the input. This is sufficient to complete the required 2/3 logic even if the valid Channel III input remains untripped.

To prevent the inadvertent isolation of AFW to all three steam generators, a modification was made to the SSPS and PIC 4. The modification changed one channel of AFW isolation relays (EIIS:BA) and bistables (EIIS:BA) from "deenergize to actuate" to "energize to actuate". Thus if the single failure deenergized both channels II and IV, the correct action of channel III would determine if an AFW isolation signal would result.
