Re: **WRT License No. 99-06-01** – Uranium Water Treatment System at Grand Island NE –  
Incident Report of a Pipe Leak and Treatment Media Release, October 9, 2013

Date of Incident: October 9, 2013  
Facility: WRT Uranium Removal System  
Central Basin Treatment Facility  
2700 Wellfield Road  
Grand Island Utilities Department  
Grand Island NE 68801

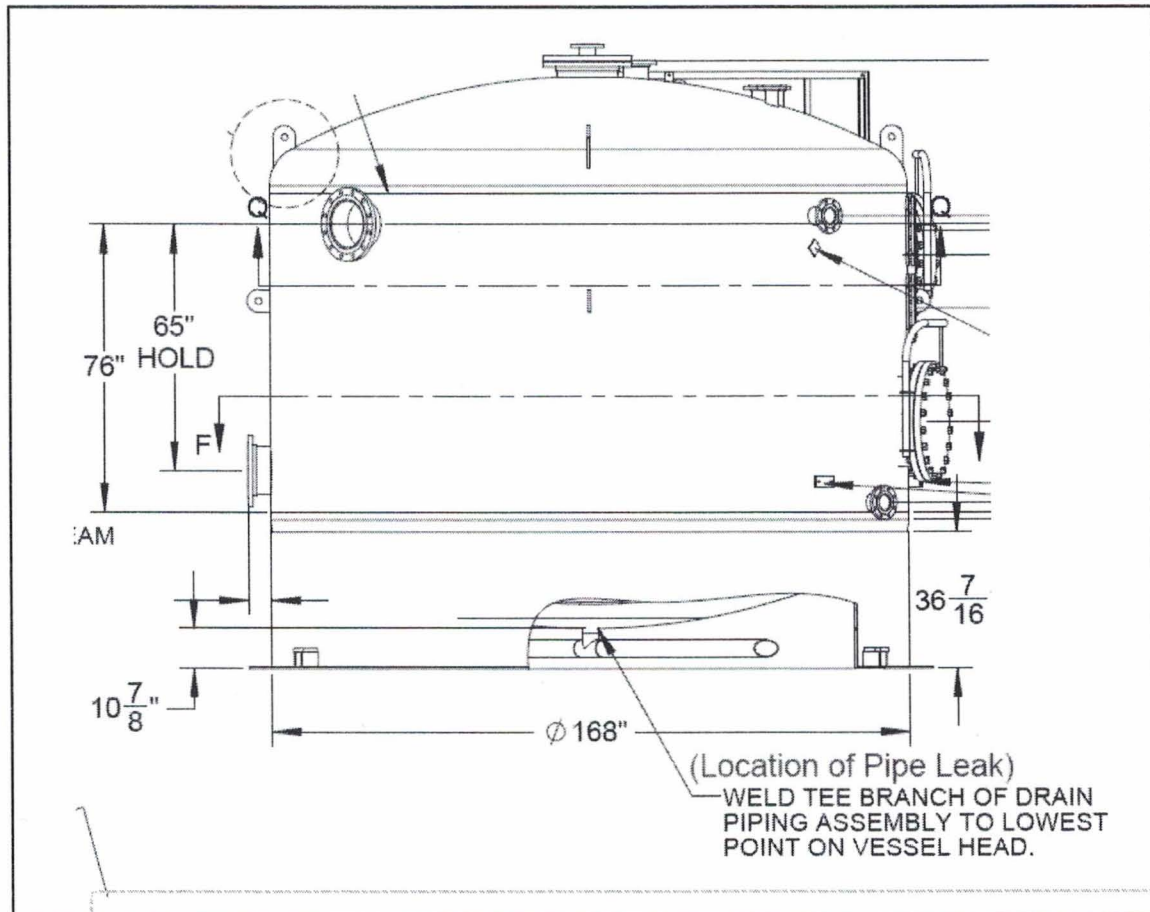
Figure 1 – WRT Uranium Removal System, Grand Island NE  
Typical Treatment Vessel

It wasn't until Wednesday morning, October 9, 2013, after a welder cut an access opening in the vessel skirt, that it was first discovered that the leak was not in the vessel itself, but rather was a leak in the weld that attached a pipe "tee" to the bottom of the vessel (see Figure 1). This tee is part of the drain pipe assembly that runs out to and through the vessel skirt. This drain pipe is used to remove resin from the treatment vessel.

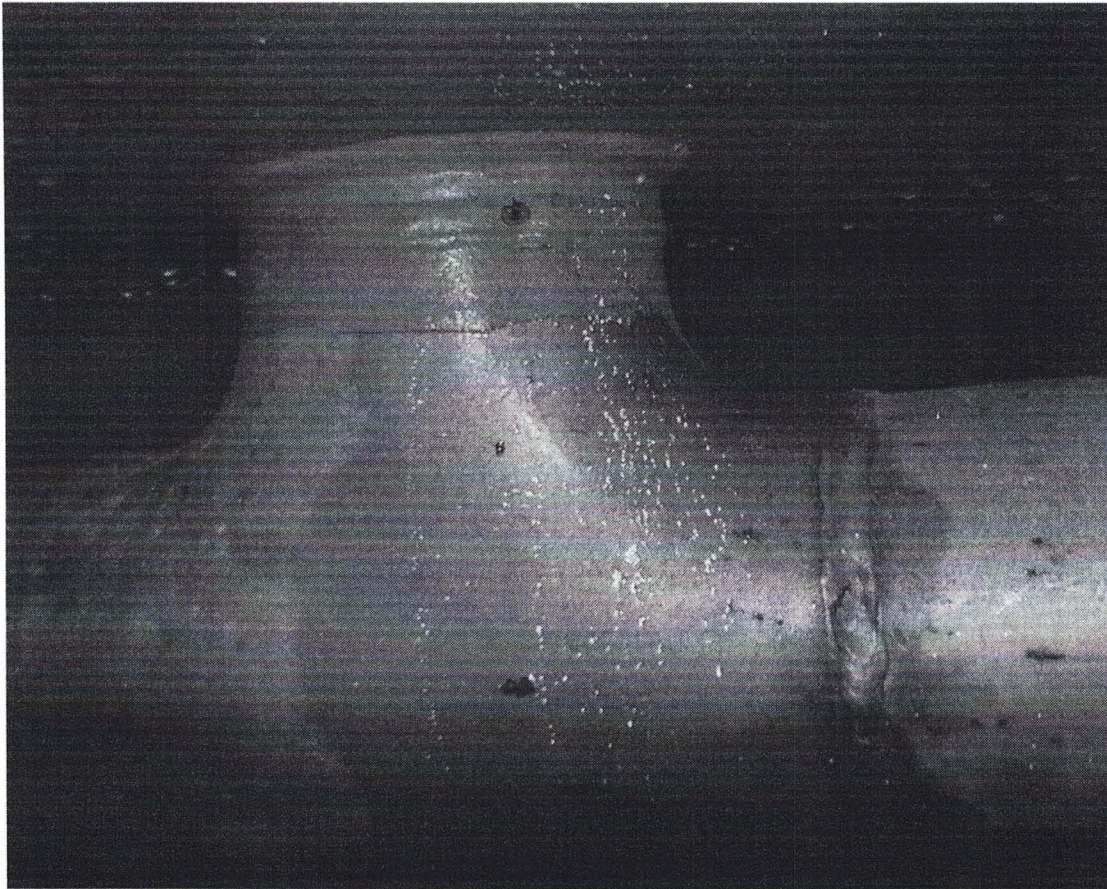
Figure 2 – Pipe Leak at Weld Joint (at top of the tee, in the blue paint)

The hole in the weld joint is shown in Figure 2 above. Upon gaining access to underneath the Stage 2 vessel on October 9, 2013, it was discovered that there was also a relatively-small release of resin associated with the water leak. As sketched in Figures 1 and 2 of the attached contamination survey report, and as pictured on pages 4 and 5 of the same report, the majority of the resin released covered an area of about 2 ft x 4 ft, directly under the pipe tee and somewhat spreading out in a south-southwest direction from under the tee. Beyond this primary area where the resin beads had quickly settled, there were scattered or small clumps of resin beads seen on the concrete in the direction of the water flow out toward the vessel skirt.

potentially may contact only a small amount of uranium. Thirdly, the pipe tee and the drain pipe assembly underneath the vessel are a dead leg in the system piping. While the pipe tee is under the normal operating pressure during system operation, no water is normally running through this piping. Speculation is that the flowing of water and resin through the tee and the resin removal pipe when the resin was being transferred to Stage 1 likely caused what started as a pinhole water leak to expand enough to also release resin beads. Whatever the cause, the result, radiologically, was the release of a relatively-small amount of lowly-loaded resin.

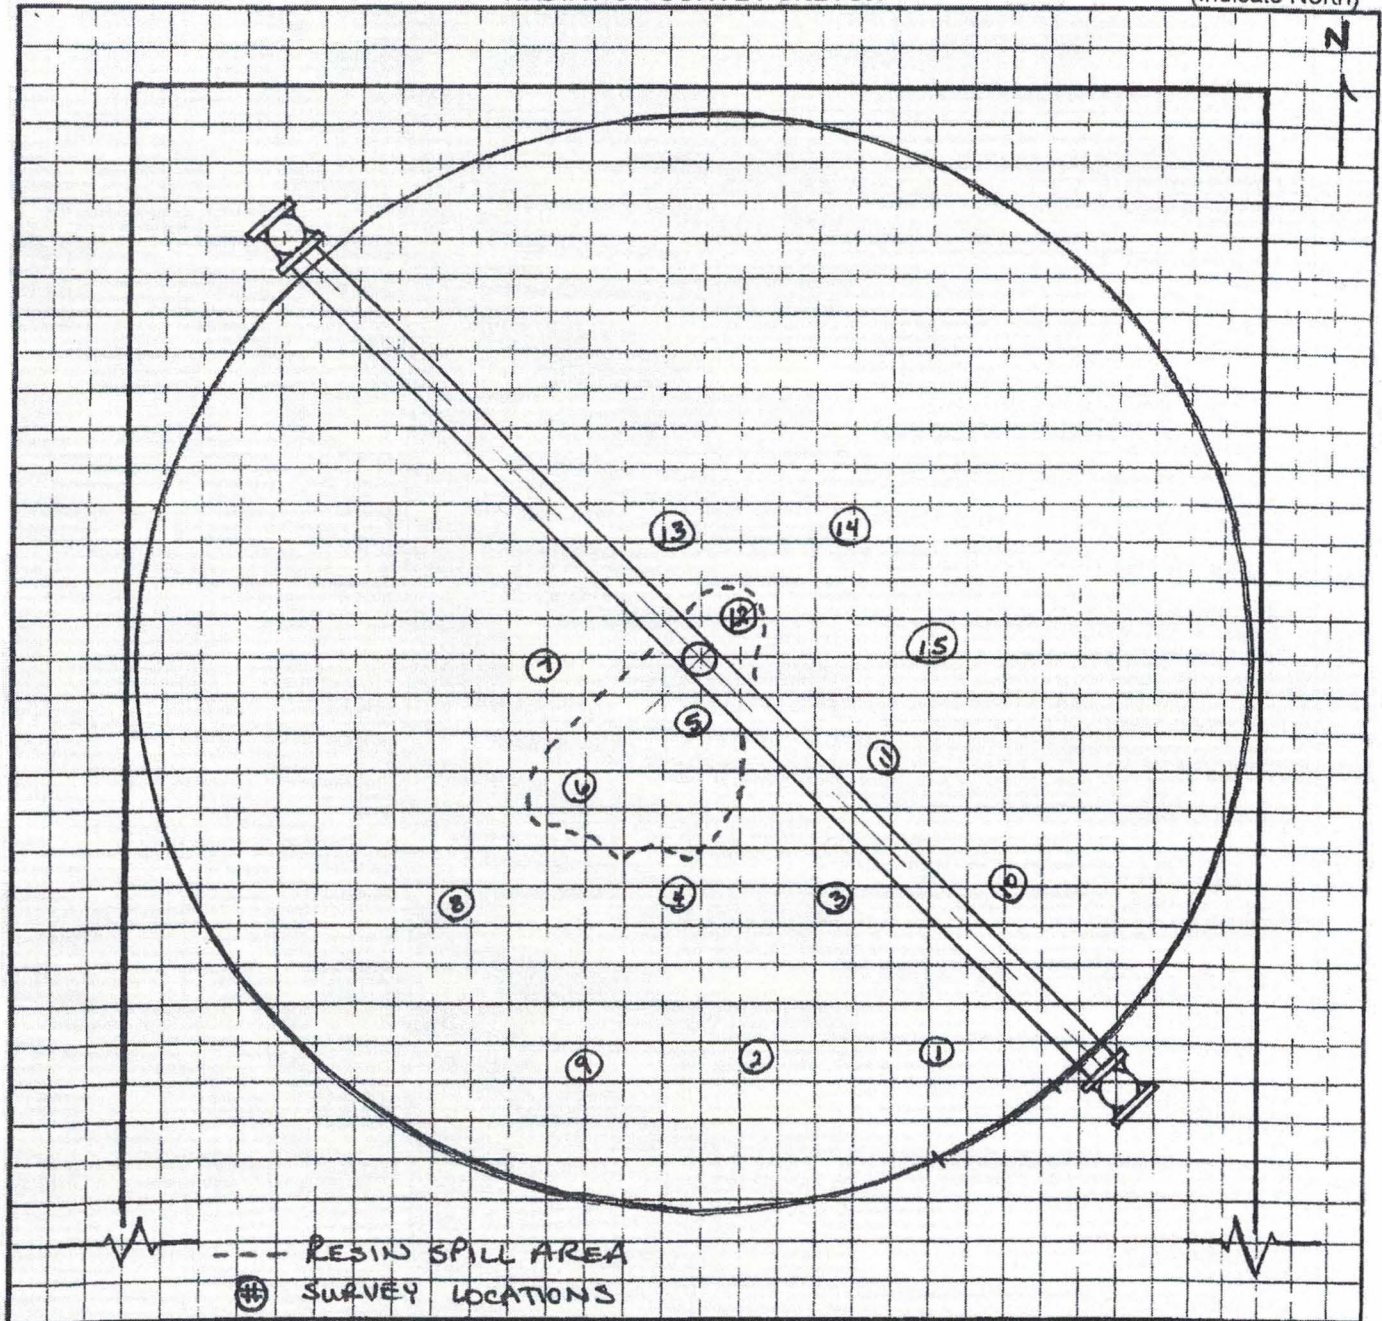
Fig No. 1

Reason for Survey POST CLEAN-UP OF PIPE LEAK AREA, TRAIN I VESSEL II

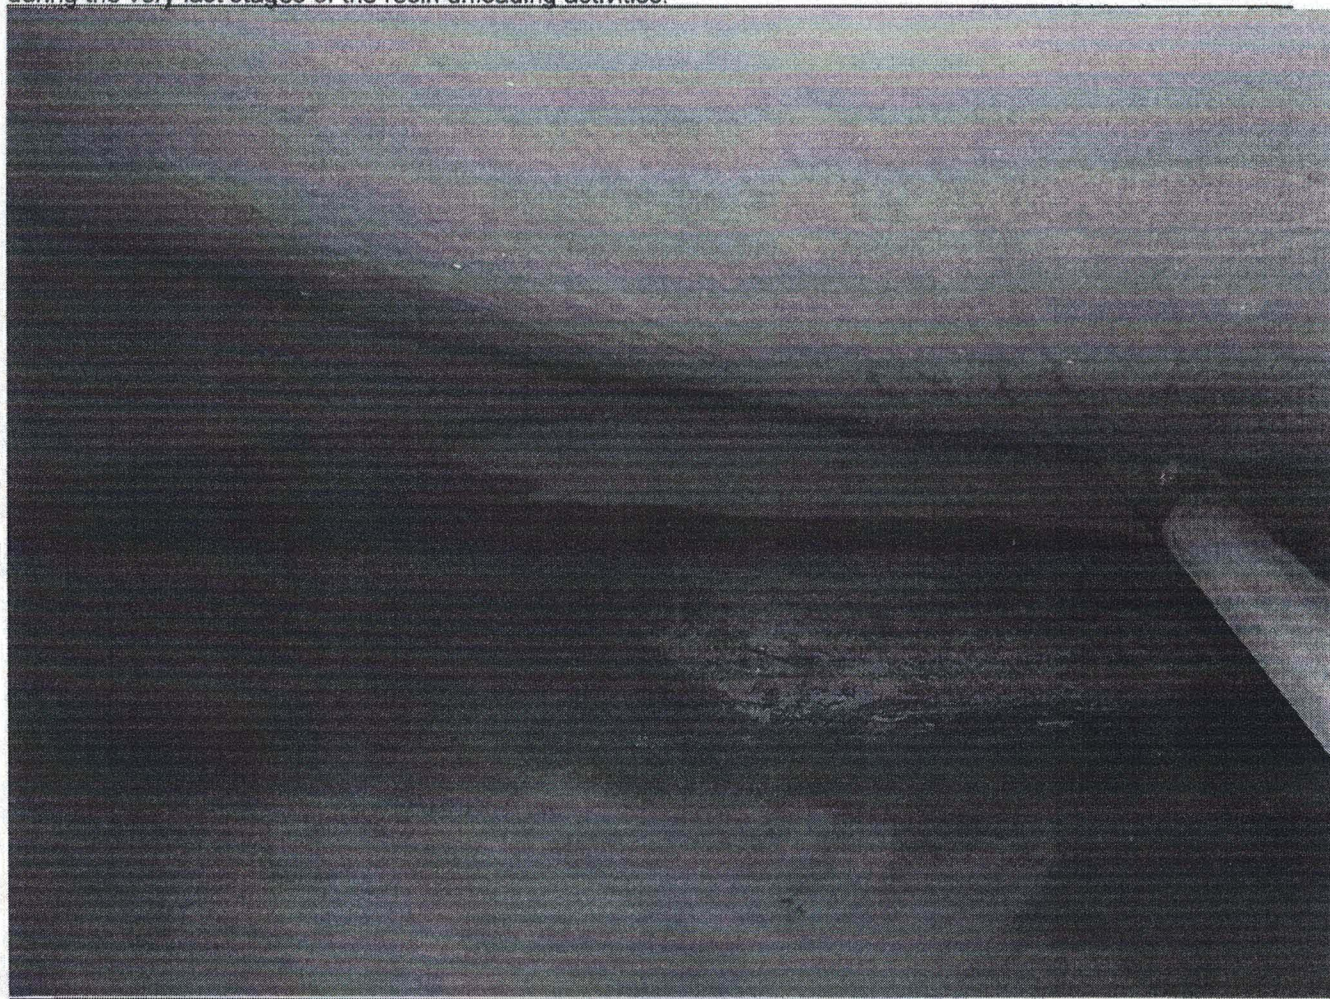
Notes/Comments: Collection of initial contamination survey data was not attempted due to the nature of the affected area and resin being soaked in water. Based on the visual inspection of the resin spill, the resin appeared to be relatively fresh, unloaded resin due to the opaque, light tan coloring. The uranium-loaded resin is a dark reddish color. This follows process knowledge because the last resin to unload from the vessels in the unloading process is the static volume of resin under the lower nozzles. This is resin that is below the normal flow path of the water in the vessel and, therefore, has contacted very little uranium. The resin leak appeared to spring from a weak weld point during the very last stages of the resin unloading activities.

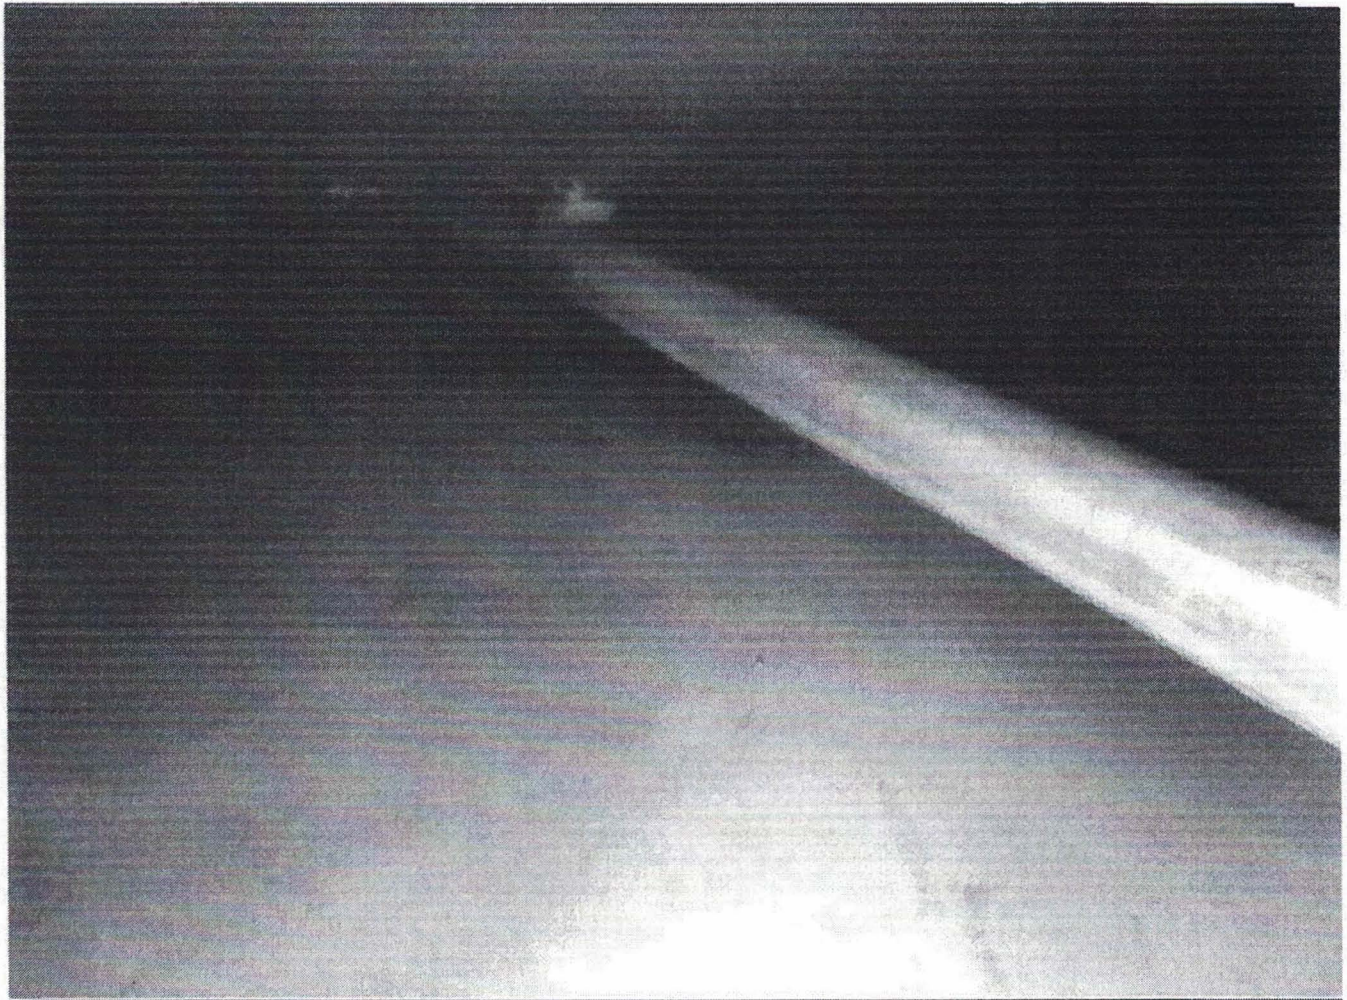
Notes/Comments: Post job surface contamination surveys were completed for fixed+removable and removable alpha and beta/gamma surface contamination. All survey results were less than the minimal detectable activity (<MDA) for each instrument used. See page 1 and 2 of this document for detailed survey and instrumentation information.
