LICENSEE EVENT REPORT (LER)

FACILITY NAME (1) SHEARON HARRIS NUCLEAR POWER PLANT - UNIT ONE	DOCKET NUMBER (2) 0 5 0 0 0 4 0 0	PAGE (3) 1 OF 06
---	---	----------------------------

TITLE (4) **EMERGENCY OPERATING PROCEDURE DEFICIENCY FOR SWITCHOVER TO RECIRCULATION AFTER A LOSS OF COOLANT ACCIDENT**

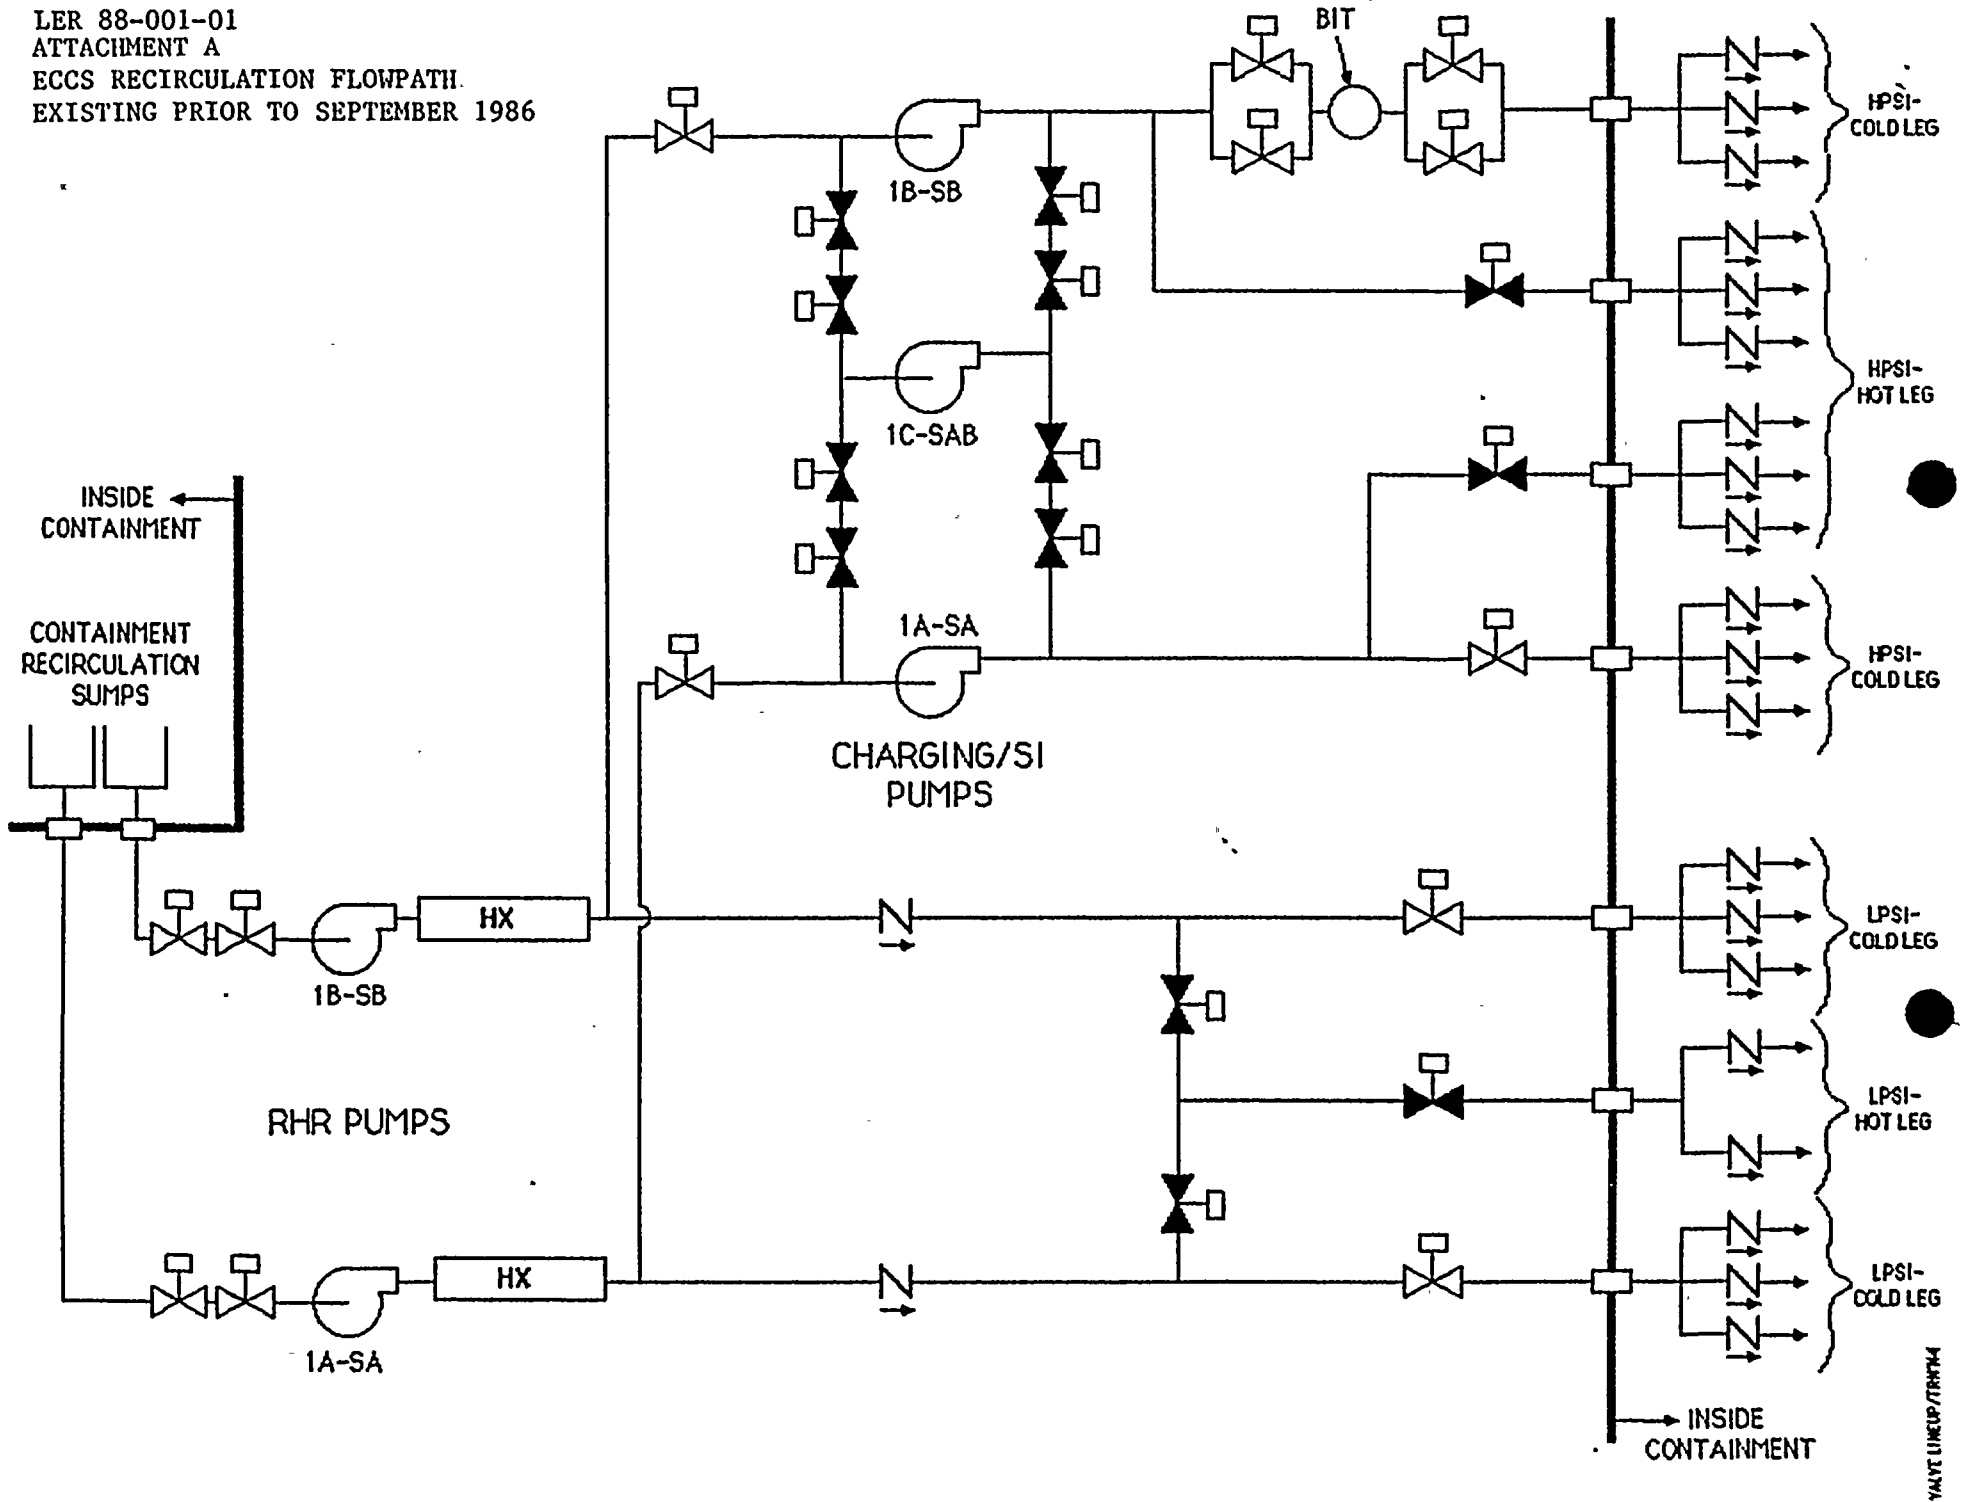
LER 88-001-01
 ATTACHMENT A
 ECCS RECIRCULATION FLOWPATH.
 EXISTING PRIOR TO SEPTEMBER 1986

Attachment A - ECCS Recirculation Flowpath Existing Prior to September 1986

The switchover procedure for transferring the Emergency Core Cooling System (ECCS) from injection to recirculation is outlined in FSAR Table 6.3.2-6. The initial practice required closing isolation valves to separate the ECCS headers into two separate trains, thus providing protection for passive failures of the piping. The resulting valve lineup for recirculation is shown in Attachment A. On September 27, 1985, and on August 21, 1986, Westinghouse Electric Corporation, the Nuclear Steam Supply System designer for the Shearon Harris Nuclear Power Plant (SHNPP), issued letters (serial CQL-9018 and CQL-9445) to Ebasco Services, Inc., the architect/engineer for SHNPP. The letters documented recommendations for changes to the procedure described in FSAR Table 6.3.2-6 for the switchover. Westinghouse recommended deletion of the procedure steps which separated the two ECCS trains, since these steps did not provide complete passive failure protection, and since their elimination would allow a single RHRP to supply both CSIPs. In addition, the second correspondence identified the need for new check valves to be installed in the piping connecting the discharge of an RHRP to the CSIP suction, to prevent potential backflow through an idle RHRP during recirculation.

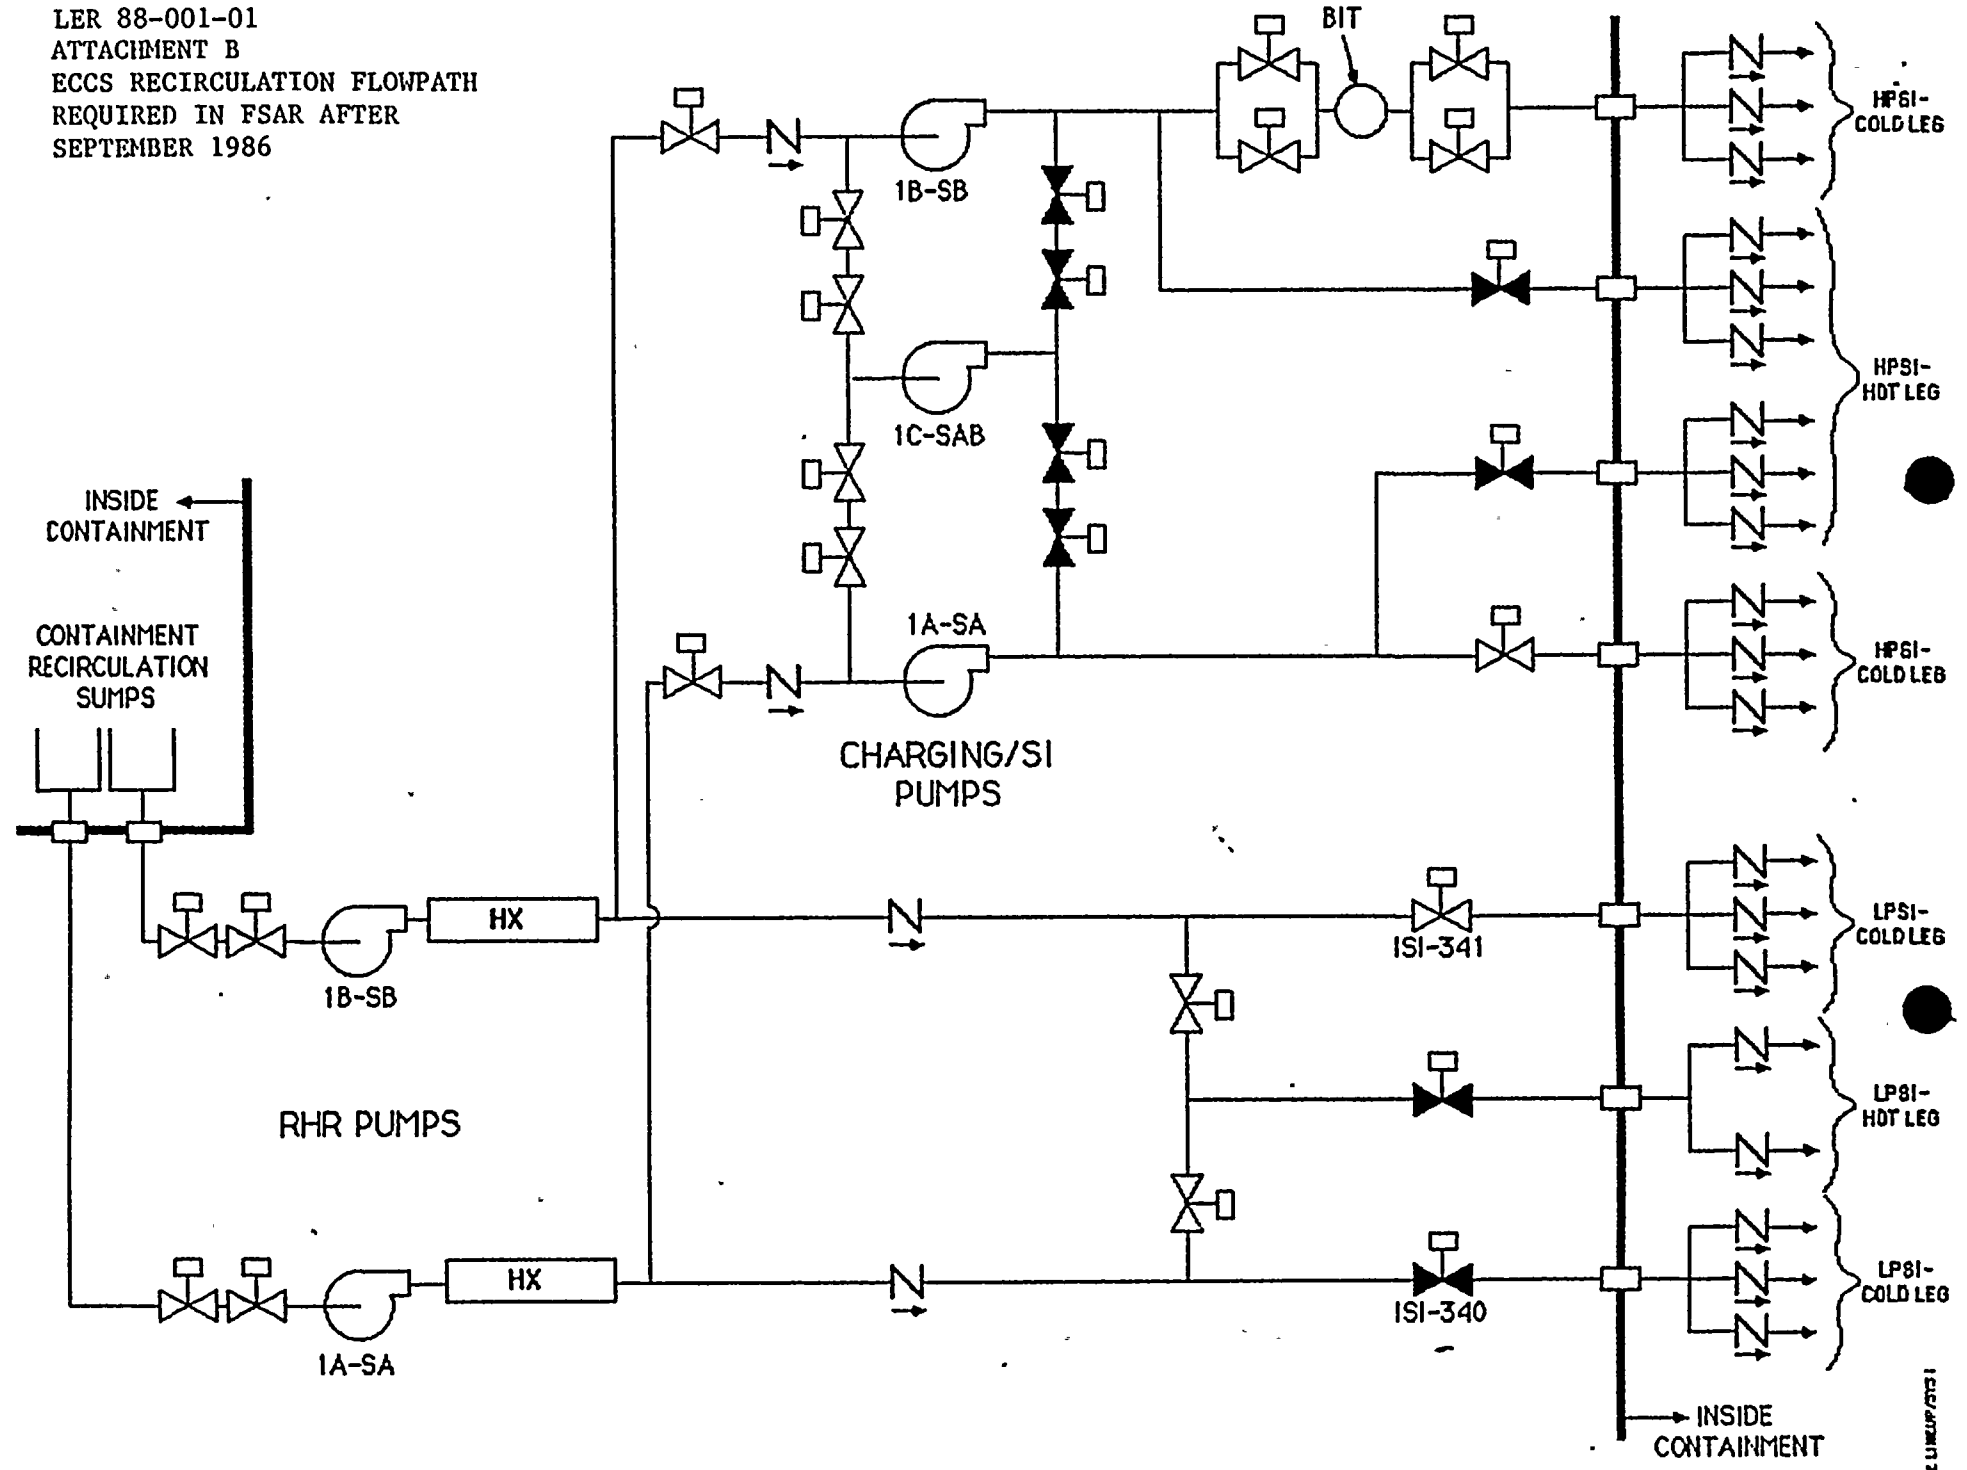
LER 88-001-01
 ATTACHMENT B
 ECCS RECIRCULATION FLOWPATH
 REQUIRED IN FSAR AFTER
 SEPTEMBER 1986

Attachment B - ECCS Recirculation Flowpath Required in FSAR After September 1986

An FSAR change (serial HPOS-845) was initiated to incorporate these changes. As part of the review of these changes, Technical Support determined that a single RHRP could not supply two CSIPs and both low pressure ECCS injection headers, as the proposed recirculation lineup required. However, by isolating one of the two low pressure safety injection (LPSI) header containment isolation valves, an acceptable configuration was created. This revised lineup demonstrated that the RHRP would not run out (Preoperational Test 2085-P-05, completed October 5, 1986). Therefore, the FSAR change included the new requirement to close one of the two LPSI containment isolation valves to ensure that runoff of the RHRP would not occur during recirculation if the other RHRP failed.

This change was incorporated into the FSAR change which was approved on September 24, 1986. A letter was also submitted to the NRC describing this change.
