# ACCELERATED DISTRIBUTION DEMONSTRATION SYSTEM

SUBJECT: LER 88-007-00: on 880309, plant trip occurred due to loss of feedwater to steam generator B.

TITLE (4) PLANT TRIP DUE TO A LOSS OF FEEDWATER TO 'B' STEAM GENERATOR CAUSED BY A FAILED FUSE

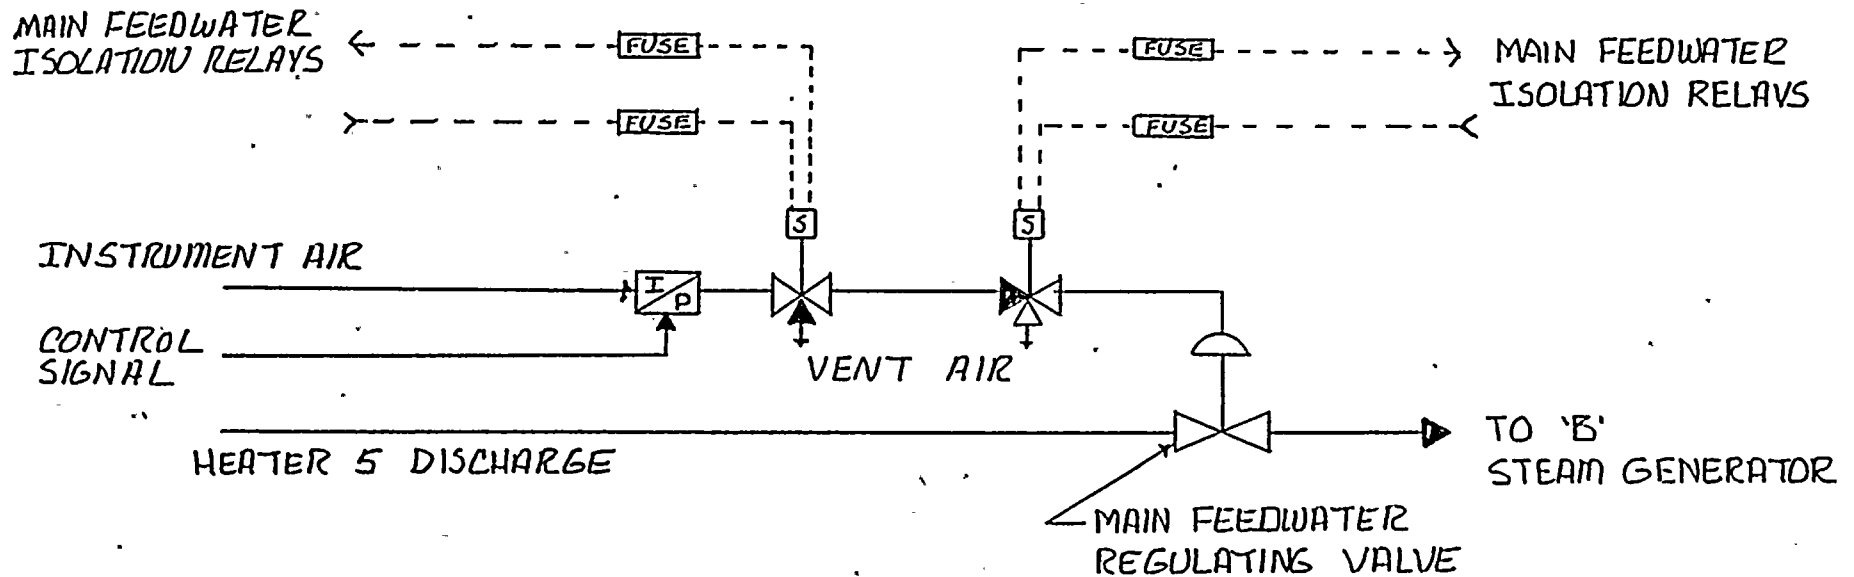
The cause of the event was a failed renewable fuse which fed the solenoid for "B" MFRV. The end cap on the fuse had loosened which resulted in a loss of power to a solenoid which interrupted instrument air to the valve. The valve failed shut cutting off the feedwater supply to "B" SG.

The failed fuse was in the circuit for the Feedwater Isolation Signal to the "B" MFRV. The circuit is normally energized and allows instrument air (EIIS:LD) to be supplied to the air actuator for the 'B' MFRV through a solenoid valve. (SEE ATTACHMENT). When the fuse failed the solenoid repositioned and interrupted the air supply causing the MFRV to fail shut cutting off the feedwater supply to 'B' SG.

1. The failed REN type fuse was replaced with an NON type fuse and similar fuses for the other MFRV's were replaced.
2. A hold was put on REN type fuses in stock.
3. Upon identifying further uses of REN type fuses they will be replaced as plant conditions permit.
