SUBJECT: LER 89-001-01: on 890116, plant trip due to low condenser vacuum caused by personnel error on valve lineup.

LICENSEE EVENT REPORT (LER)

FACILITY NAME (1) <b>SHEARON HARRIS NUCLEAR POWER PLANT - UNIT ONE</b>	DOCKET NUMBER (2) <b>0 5 0 0 0 4 0 0</b>	PAGE (3) <b>1 OF 0 6</b>
---	---	-----------------------------

TITLE (4)  
**PLANT TRIP DUE TO LOW CONDENSER VACUUM CAUSED BY PERSONNEL ERROR ON VALVE LINEUP**

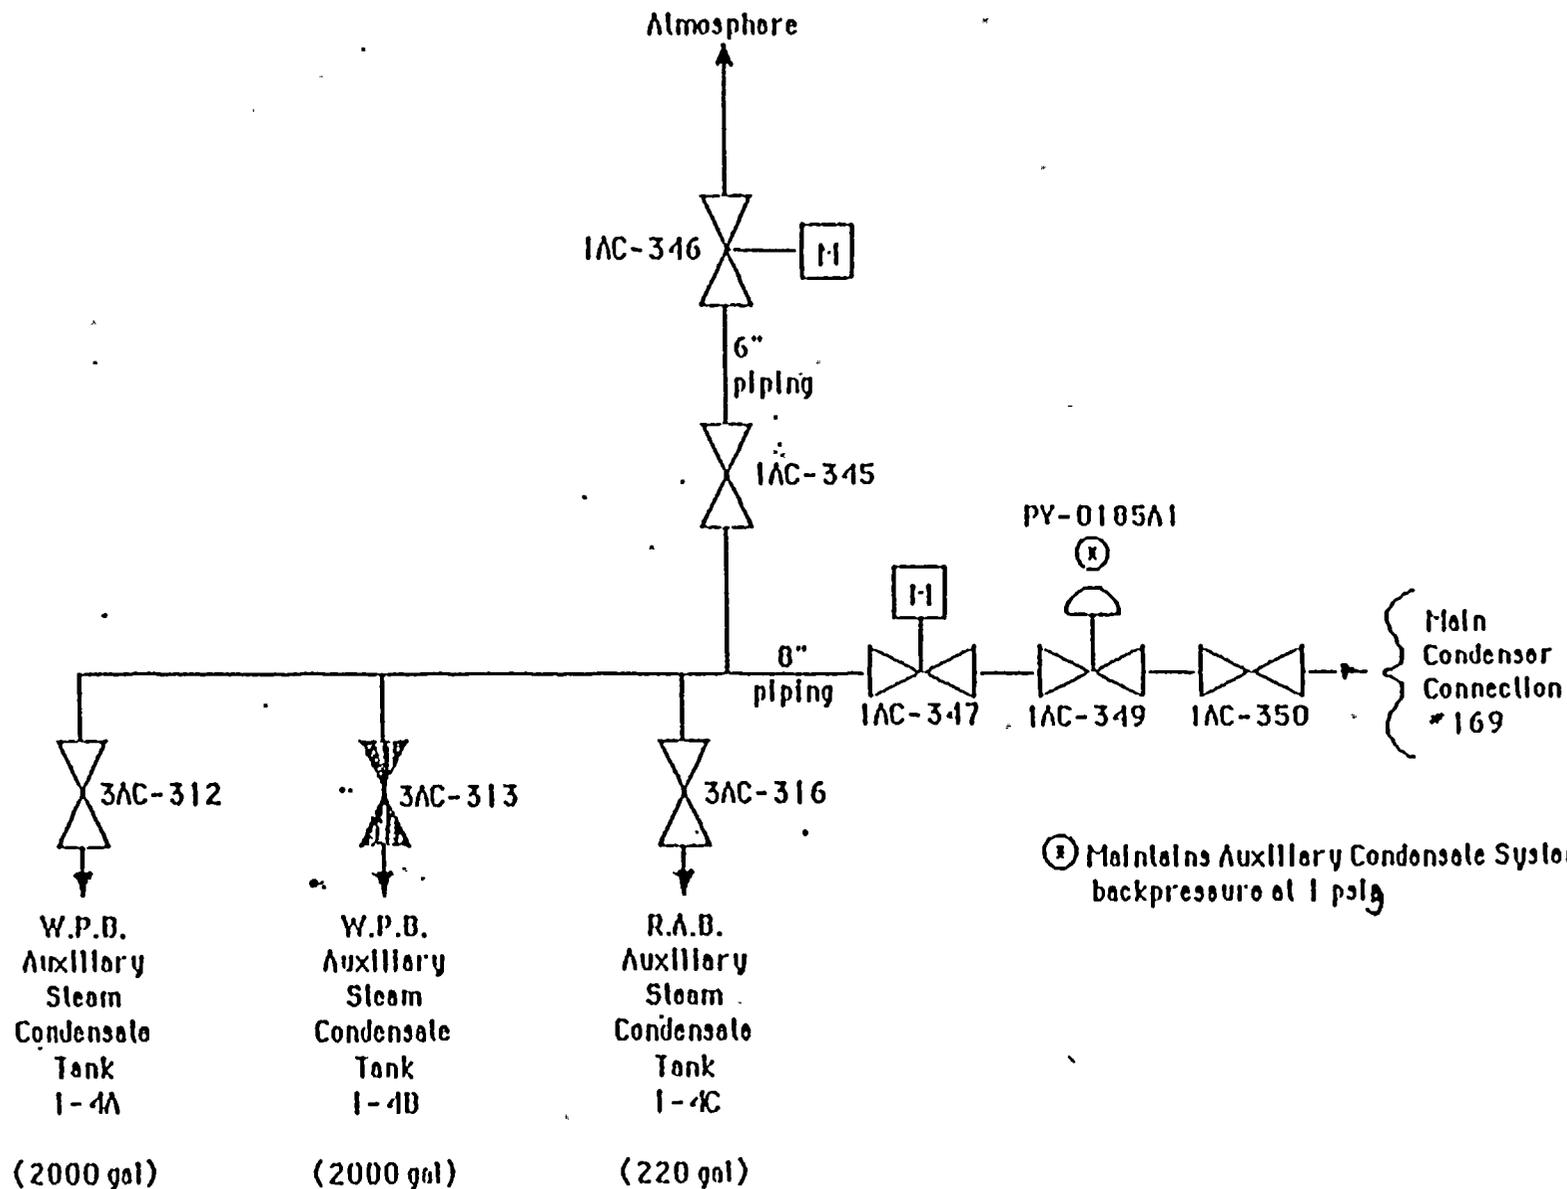
# Auxiliary Steam Condensate System Return Venting Path

When clearance RW89-63 was prepared the placement sequence was clearly specified but the existence of a caution tag on valve 1AC-346 was not noted on the clearance and no restoration sequence was specified. The lubrication maintenance was conducted in a routine manner and should not have affected valve position.

When the clearance was removed, the restoration sequence consisted of verbal instructions by the Radwaste Control Room to a Radwaste operator. As a result, 1AC-345 was opened to place it in the position required by OP-130.01 before any attempt to shut or verify the position of 1AC-346. This caused the loss of condenser vacuum since 1AC-346 was in an undetermined intermediate position.

1. The applicable personnel involved were counselled and disciplinary action was taken.
2. The event was discussed by the Operations Manager in a Shift Foreman meeting. The meeting stressed: a) the necessity for adequately researching clearances, b) the necessity for periodically observing activities being performed outside the control room to insure procedures and good working practices are being implemented properly, and c) the necessity of using a shift foreman clearance when manipulation of a component could result in a challenge to the plant.
3. A shift foreman clearance was placed on valve 1AC-345 pending the repair of 1AC-346.
4. The repair of valve 1AC-346 will be completed.
