SUBJECT: LER 89-006-00:on 890314,reactor/turbine trip due to water
 leakage into motor junction box.W/890413 ltr.

SHEARON HARRIS NUCLEAR POWER PLANT UNIT 1
DOCKET NO. 50-400
LICENSE NO. NPF-63
LICENSEE EVENT REPORT 89-006-00

| TITLE (4) REACTOR TRIP/TURBINE TRIP ON LOSS OF MAIN FEEDWATER PUMP DUE TO WATER LEAKAGE INTO THE MOTOR JUNCTION BOX | | | | | | | | | | | | | | | | |

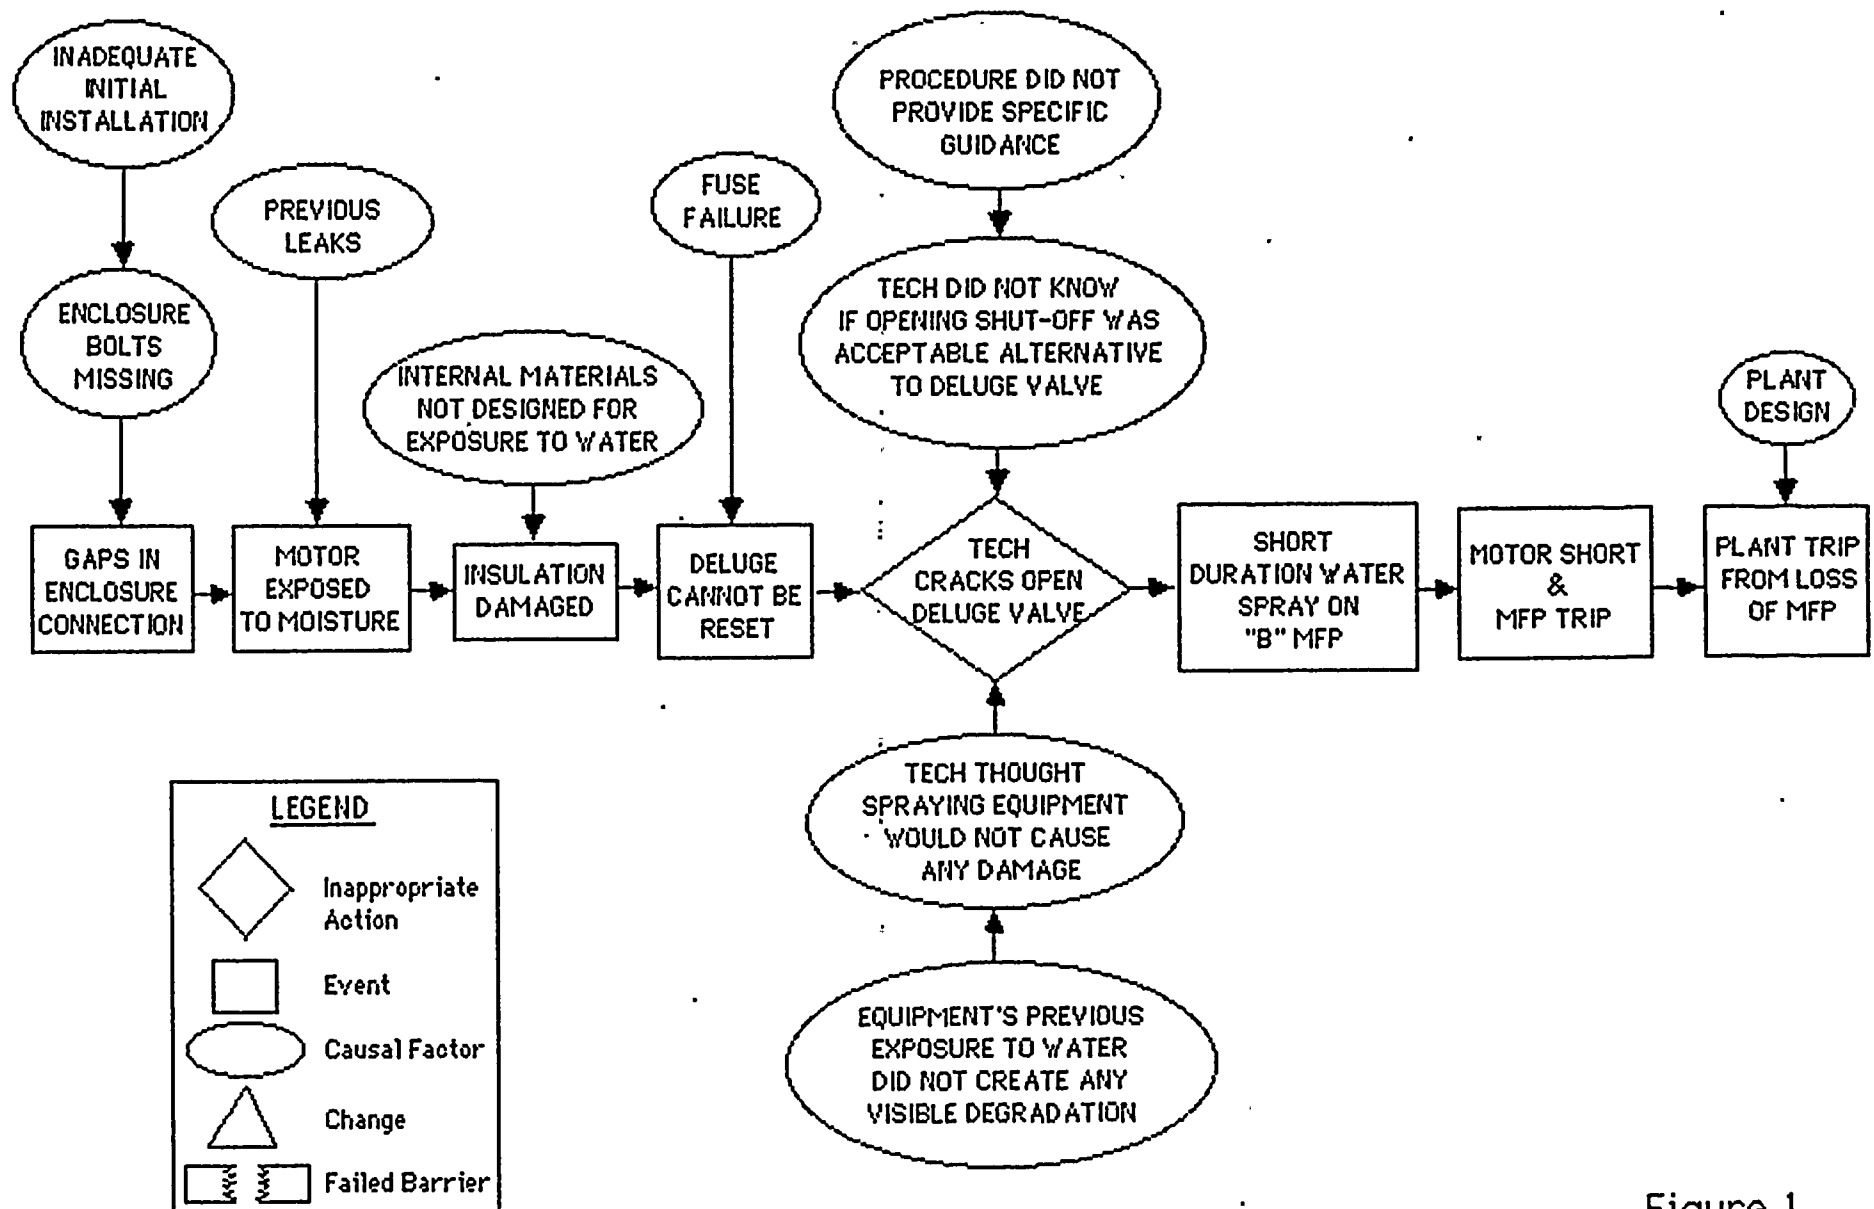
Figure 1

The reactor trip was the result of several unrelated conditions that led to the trip on "B" MFP. The causal factors to consider include:

- a. Gaps in the "drip proof" housing for the "B" MFP.
- b. Previous exposure of the "B" MFP motor to moisture resulted in degraded insulation of the connections in the junction box.
- c. Failure of a fuse in the control circuit for the solenoid valve (1FP-2117) which prevent successful resetting of the deluge valve (1FP-2520).
- d. Incorrect action by Fire Protection Technicians when 1FP-2520 did not reset properly.
- e. Plant design which limits the ability of the plant to sustain a loss of one Main Feedwater Pump at high power levels without a reactor trip.

The relationship of these events is shown in Figure 1. These causal factors are discussed separately below.

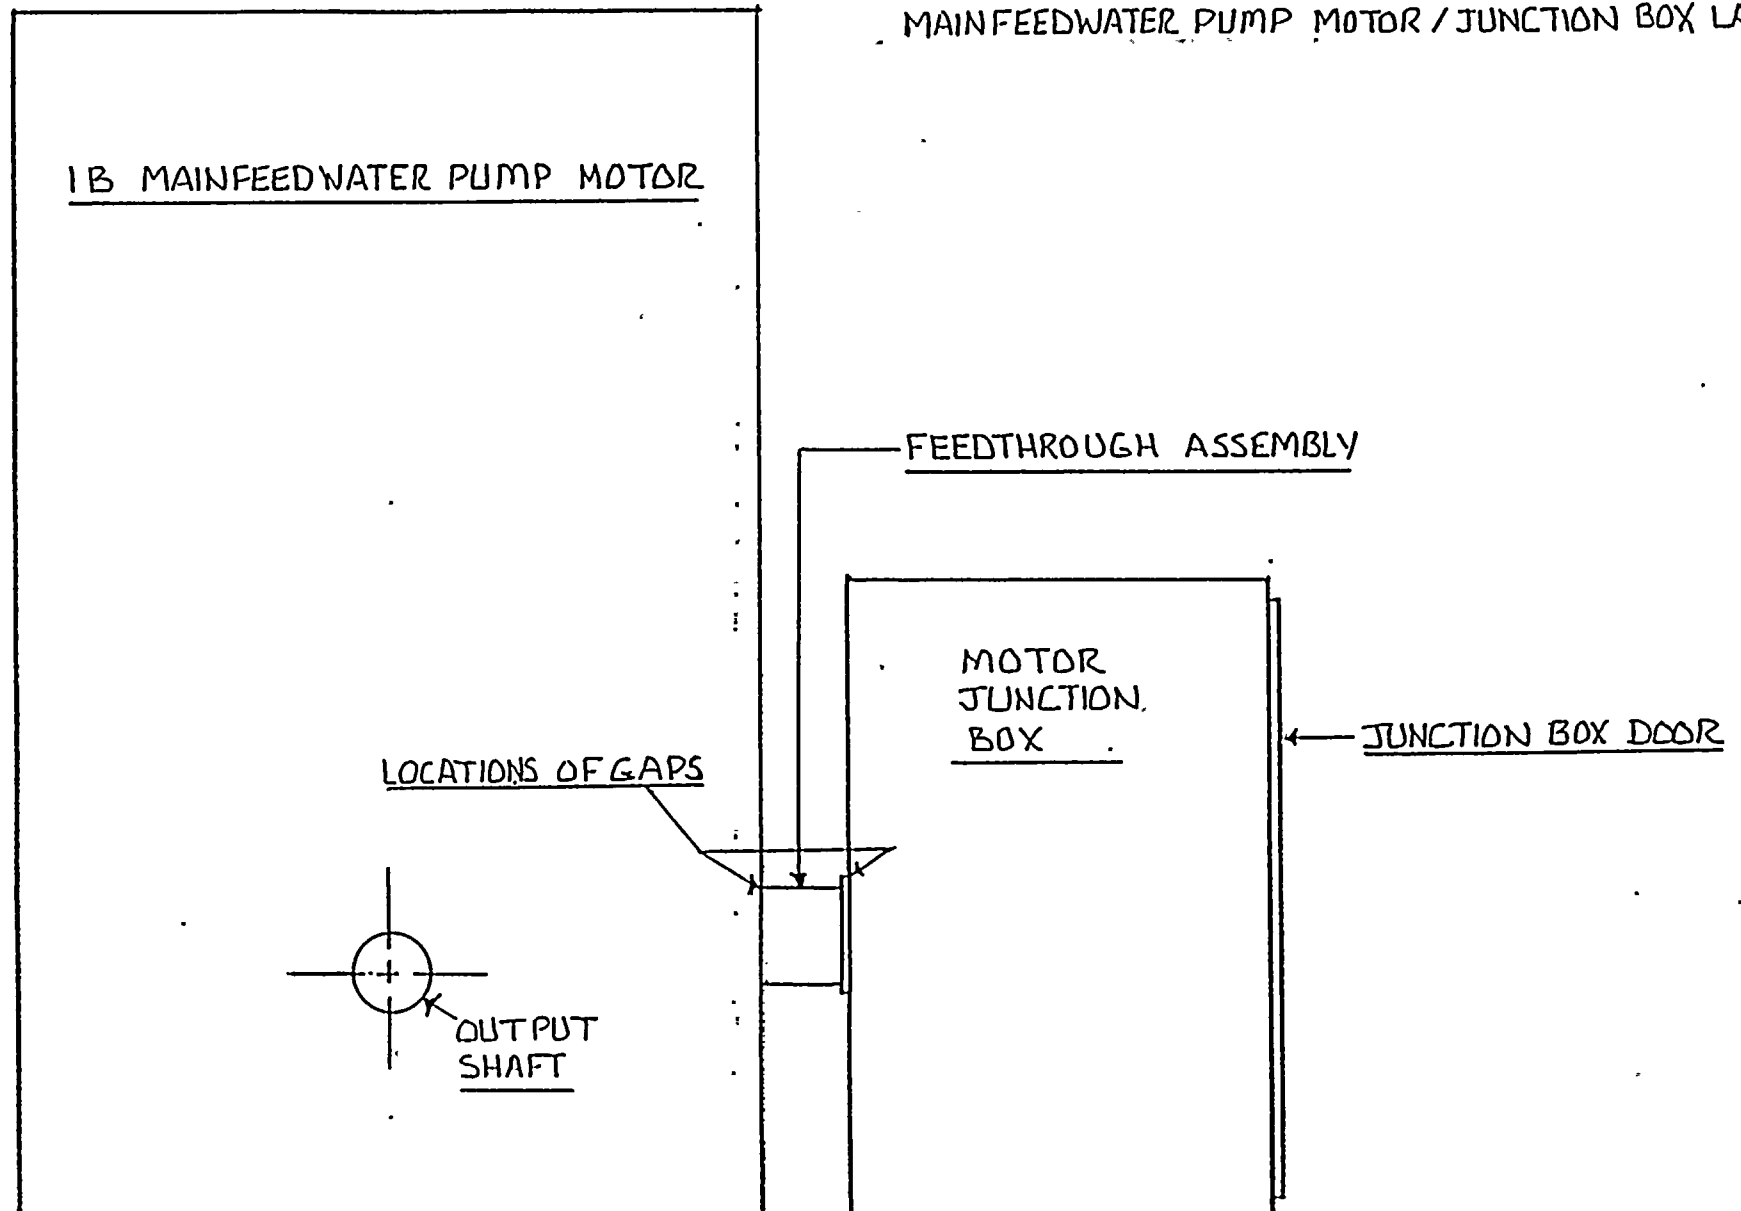
FIGURE 2

Figure 2 shows a sketch of the motor enclosure and junction box for the MFPs. The motor enclosure is designed as a NEMA II and the junction box as NEMA III. Both levels of protection provide for a "drip proof" enclosure. The enclosures were inspected and gaps were found where the "feed through assembly" that connects the junction box to the motor enclosure. The connection to the junction box is flanged and several mounting bolts were missing. There is no record of any repairs to this area of the motor and it is presumed that these deficiencies have existed since initial construction.

The motor and junction box were inspected during the 1988 refueling outage (August-October 1988) and no moisture problems were noted. When the motor and its junction box were inspected after this event, rust was observed in the junction box below the place where the "feed through assembly" was bolted to the junction box. The presence of rust and the gaps show that water entered the enclosures in the past and immediately prior to the motor trip.

The actual location of the short was determined to be the connection between the "B" phase motor lead and the cable internal to the junction box. Lugs on the field run cable and the motor lead are bolted to form a typical connection. The combination is wrapped with insulating material. The connections for all three phases were dissected. Evidence of melting was found in one "B" phase connection. It was concluded that the connector was exposed to water and that water had migrated through the wrapped insulation. Eventually, a path to ground was established. When this path to ground was completed, an electrical short circuit occurred.

1. The "A" MFP motor was inspected prior to restart of the plant.
2. Missing bolts on the MFP "feed through assembly" were replaced and the joints were sealed.
