SUBJECT: 10CFR21 INITIAL NOTIFICATION

SHEARON HARRIS NUCLEAR POWER PLANT

ITEM: DEFICIENCY IN THE ACTUATOR TO THE MAIN FEEDWATER

PREHEATER BYPASS ISOLATION VALVES.

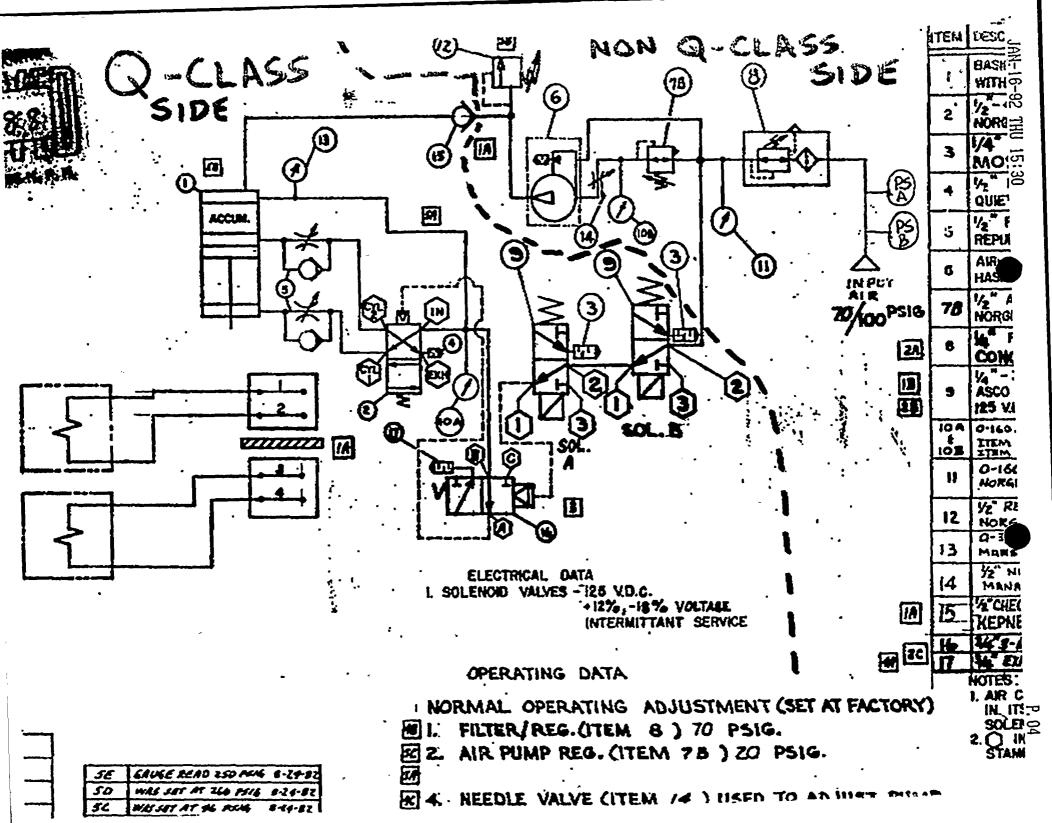
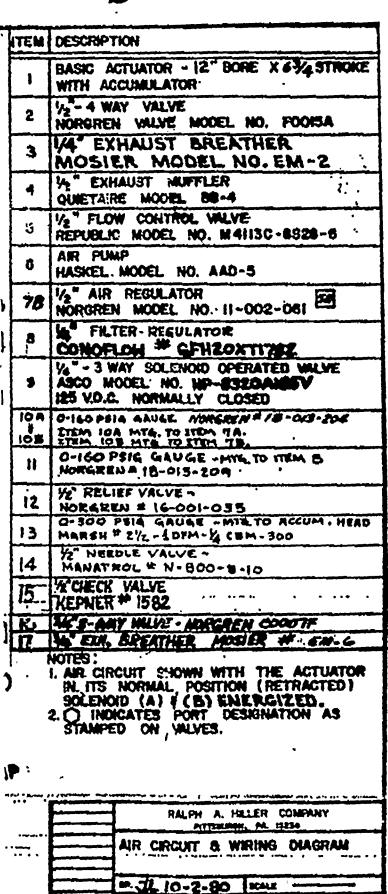
## NATURE OF DEFICIENCY: (See attached drawing)

The valve and actuator for the 3 Main Feedwater Preheater Bypass Isolation Valves were specified, purchased, and installed for a Q Class application. During review of a proposed plant modification, it was determined that several actuator components were in fact non-Q.

A potential failure mechanism existed where the failure of a non-Q component could result in the inability of a Q-class component to perform as designed. Specifically, a postulated failure of the air pump (#6 in drawing), could cause a situation where normal leakage of the accumulator (item 1) from its normal 150 psig pressure would go undetected by redundant pressure switches (PS A and B). These switches provide the valves an auto close signal when pressure drops to 66 psig in the input air header.

The valves are containment isolation valves and are required to close within 10 seconds of a feedwater isolation signal. If accumulator pressure drops from its normal 150 psig to below 122 psig, it may not close within the required time. If accumulator pressure drops to approximately 20 psig, there may not be sufficient force to reposition the valve and maintain it closed against maximum differential pressure.

IMMEDIATE CORRECTIVE ACTION: Upon discovery of this condition on January 7, 1992 a two hour surveillance interval was commenced to verify the actuators' components were functioning properly and the accumulators were fully pressurized. On January 12, 1992, all non-Q components were replaced with suitable components and tested satisfactorily. Following this the two hour surveillance interval was suspended. An engineering review was in progress during this time to determine the 10CFR21 reportability. On January 15, 1992 the Harris Plant Nuclear Safety Committee determined a 10CFR21 report was appropriate.
