## REGULATORY INFORMATION DISTRIBUTION SYSTEM (RIDS)

SUBJECT: LER 92-006-00: on 920619, determined that since 1987 until May 1992 excess flow check valves was mispositioned. Caused by personnel error. Valves properly aligned w/internal manual bypass shut & procedures revised. W/920720 ltr.

SHEARON HARRIS NUCLEAR POWER PLANT UNIT 1  
DOCKET NO. 50-400  
LICENSE NO. NPF-63  
LICENSEE EVENT REPORT 92-006-00

Mispositioned Excess Flow Check Valves

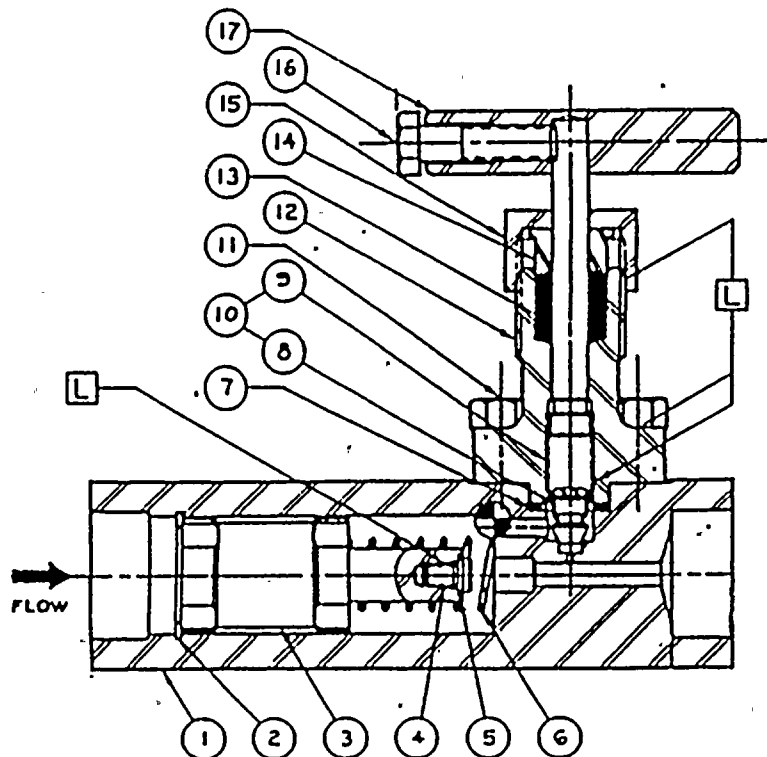
## Attachment 1

The excess flow check valves were manufactured by Dragon Valves, Inc. These valves have two major operating components; a poppet assembly which closes on high flow and an internal manual bypass valve, see Attachment 1. The excess flow check valve has a handwheel on the valve which opens and shuts this bypass. This handwheel was mistakenly identified as operating the actual check valve and was open to allow flow through these lines. This internal manual bypass valve is used to equalize pressure on both sides of the valve after actuation on high flow, thus allowing the poppet assembly to reopen. With the internal manual bypass open, a higher flow rate would be required to cause the poppet assembly to shut and even if it had shut, flow would not have been completely isolated.

This problem was identified while researching a tagout for maintenance on the auxiliary steam system. Once it was identified that the external handwheel on these valves only affected the internal bypass and did not isolate the primary flow path through the poppet assembly, it was realized that the excess flow check valves were not in the correct position to automatically isolate flow on a pipe break as required. The internal manual bypass valves were shut as required to provide break protection. The operating procedures for these excess flow check valves were revised to specify that the handwheel be in the closed position and a note was added to explain that this only isolates the internal manual bypass valve and does not prevent flow through the valve. Additional instructions were added to the appropriate procedures for use of the internal manual bypass valves for resetting an actuated poppet mechanism.

The cause of the excess flow check valves being bypassed was personnel error, in that the internal operation of these valves was inadequately researched when these valves were incorporated into the system operating procedures.

- 1) The RAB hydrogen supply and auxiliary steam excess flow check valves were properly aligned with the internal manual bypass shut.
- 2) Procedures were revised to properly specify the required position for the excess flow check valve manual bypass handwheel.
