SUSQUEHANNA STEAM ELECTRIC STATION  
FINAL REPORT OF A DEFICIENCY RELATING TO  
LIMITORQUE CORPORATION TORQUE SWITCHES  
ERs 100450/100508                      FILE 840-4  
PLA-577

ATTACHMENT TO PLA-577

Defective Limitorque Torque Switches

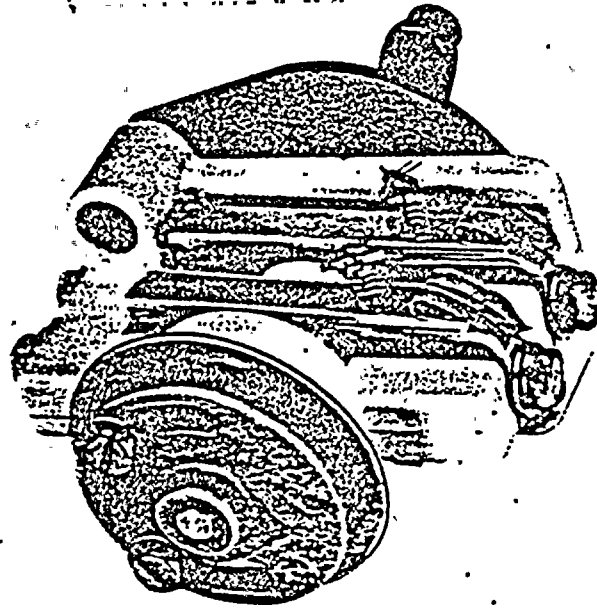
A Consultant for the Company, in conjunction with the scope of work they were performing for PP&L at the Susquehanna Site, issued a report on Limitorque Torque Switches which stated as follows: "Adjustments and preoperational checks on both safety related and non-safety related motor operated valves, made prior to post-construction startup tests of Limitorque valve operator models SMB-00 SMB-000, revealed that the stationary electrical contacts on the 'close' side of the torque switch had loosened. The torque switches in question are of the leaf type. The electrical contacts are small machined hex-head cap screws (see page 4 of Attachment, piece #3). Locking devices for the cap screws were not installed.

In some cases the loose cap screws backed out sufficiently to prevent the contacts from breaking open when the valve seated."

Visual inspection of four valves (1F001A, 1F001B, type SMB-00; HV11314, HV15112, Type SMB-000) confirmed that the hex-head contact screws were loose.

One pair of cap screws on each torque switch has one or more fiber shims installed under a metal bridge plate. Limitorque stated that the fiber shims were used to make the height of both pairs of cap screws equal.

The screws have no locking device because the height of the screw is critical and lock-washers would raise the height.

These fiber shims under the proper torque value of six inch lbs. (Limitorque requirement, installed at factory) have a tendency to relax with time, thus relieving the preload on the screw.

Project engineering has directed the field to use "Loctite" on the threads of all the Limitorque torque switch no. 6 cap screws on the unit 1 and 2 motor operators. They will continue to maintain the same number of fiber shims under the metal bridge plate. They will also torque these screws to the manufacturers recommended torque requirements of 6 inch lbs.
