REFERENCE: Docket No. 50-186  
University of Missouri-Columbia Research Reactor  
Renewed Facility Operating License No. R-103

SUBJECT: Written communication as required by University of Missouri Research  
Reactor Technical Specification 6.6.c(3) regarding a deviation from  
Technical Specifications 3.4.b and 3.4.a(6)

**Licensee Event Report No. 17-06 – December 30, 2017**  
**University of Missouri Research Reactor**

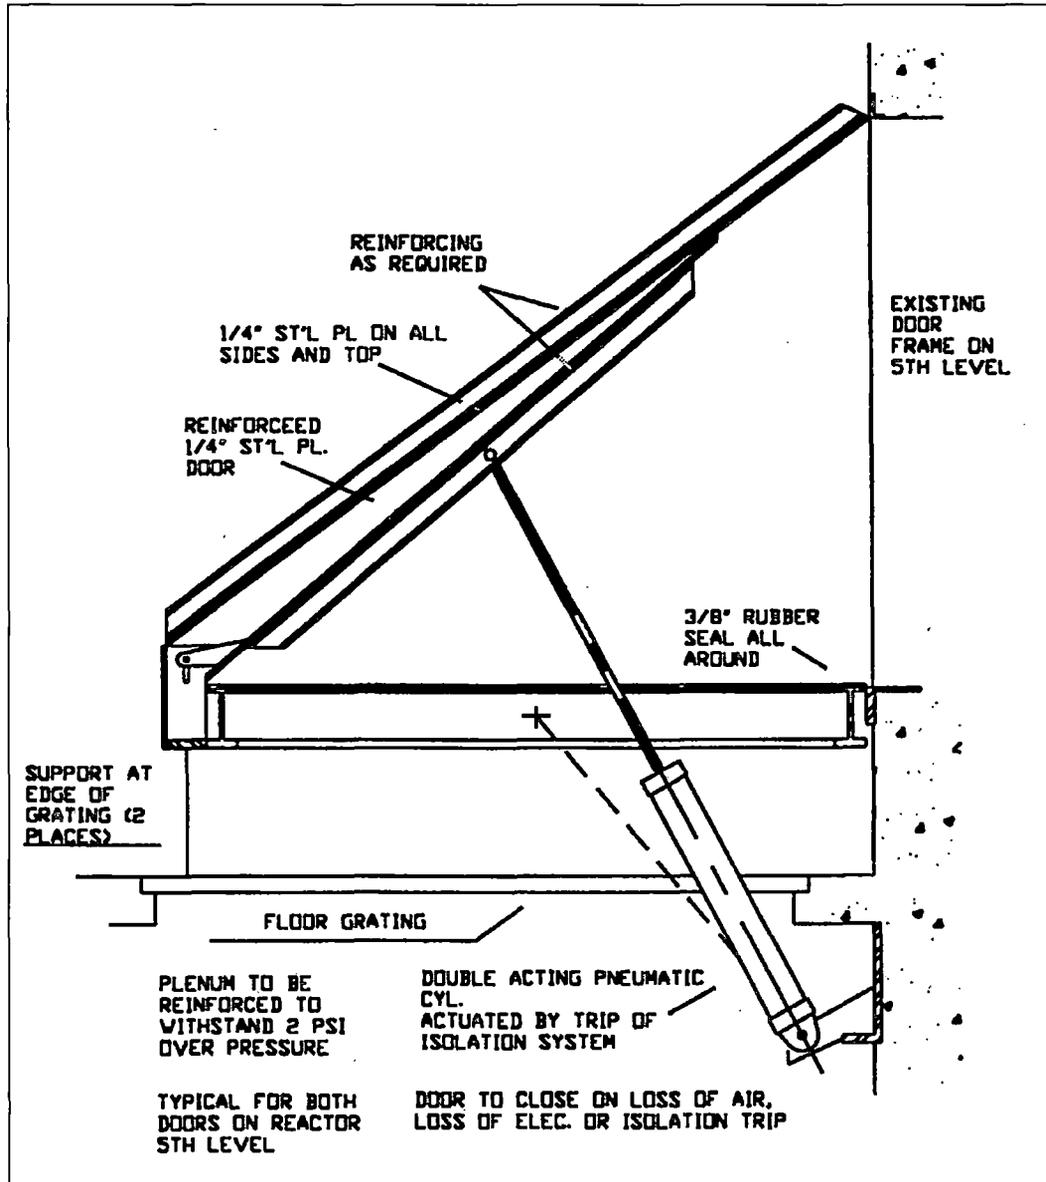
FIGURE 1  
BACKUP DOOR

The backup doors are constructed of ¼-inch (0.64-cm) thick metal plate and reinforced to withstand 2.0-psig overpressure (13.8-kPa above atmosphere) (see Figure 1). Each door is held open against gravity by a pneumatic cylinder. Compressed air is supplied to the pneumatic cylinders from the facility main air compressors and the emergency air compressor. A ⅜-inch (0.95-cm) rubber gasket installed in the door facing creates a seal for the backup doors when in the closed position.

Closure of the exhaust plenum backup door blocked the path for air to exit the reactor containment building. The supply fan continued to run, and the supply plenum was still open; therefore, air continued to be supplied to the building without air exhausting, which increased pressure in the reactor containment building, thus driving differential pressure to zero (0).

Though the backup door was closed and unable to open due to ice blockage of its compressed air supply line, the reactor isolation and facility evacuation systems were fully operational and capable of isolating the reactor containment building from the surrounding areas. In addition, the air supply lines to all the other components of the reactor containment system are housed inside the building in controlled temperature environments. Therefore, reactor isolation and facility evacuation systems could perform their safety functions as described in the SAR. The backup doors failed to their 'fail safe' position, which is closed.

The cause of this event was lower than normal air temperatures surrounding the compressed air piping combined with moisture in the piping. This combination allowed ice to form and slowly block off the air supply to the exhaust plenum backup door air cylinder. As the air pressure slowly bled out of the cylinder, the weight of the door overcame the upward force of the air cylinder, and the exhaust backup door closed. Prior to reactor startup on December 30, 2017, the water was drained from the compressed air lines, and heat trace with insulation was applied to the piping to prevent ice from forming in the lines as a short-term solution. Until the compressed air quality is improved, Reactor Operations staff are also draining condensation for the air supply

pipng near the cylinders every week. MURR is currently investigating possible improvements to the main air system to reduce the amount of moisture in the compressed air piping.

If Reactor Operations staff had continuous indication of reactor containment building differential pressure in the Control Room, they may have be able to prevent the deviation of TS 3.4.b by taking action to secure the reactor prior to the negative pressure decreasing below the TS 3.4.a(6) specification of 0.25 inches of water. MURR will be installing a continuous Control Room indication with a low differential pressure alarm in the future. In addition, a Reactor Emergency Procedure will be developed to provide Reactor Operations staff direction in case of a lowering reactor containment building differential pressure.
