UNITED STATES  
 NUCLEAR REGULATORY COMMISSION  
 REGION II  
 101 MARIETTA STREET, N.W.  
 ATLANTA, GEORGIA 30323

Report No.: 50-400/86-61

Facility Name: Harris 1

Inspection Conducted: July 28 - August 1 and August 11 - 15, 1986

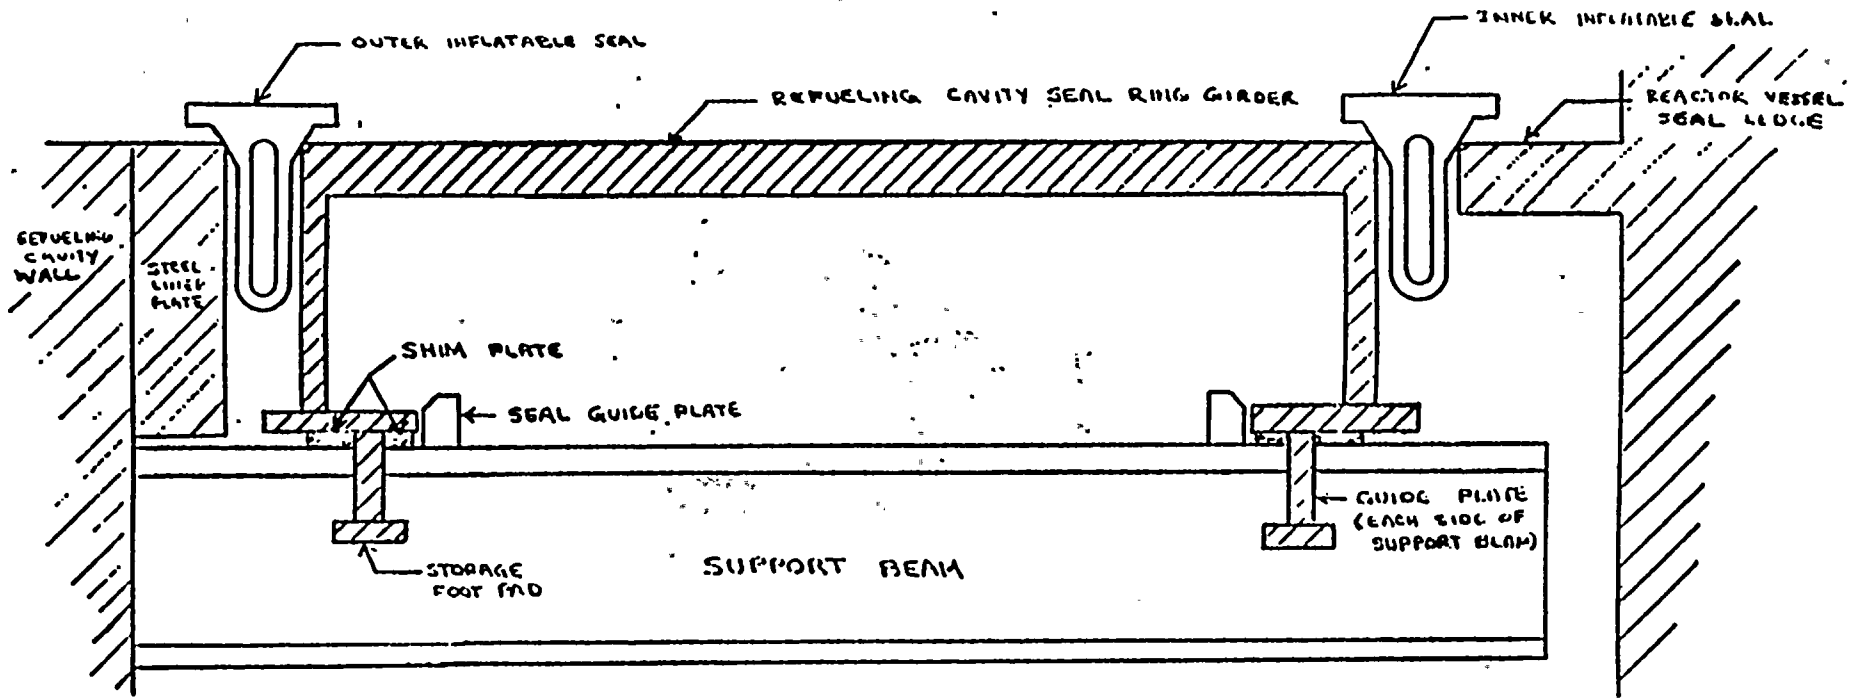
ORIGINAL CAVITY SEAL DESIGN

The cavity seal at Shearon Harris plant consists of two inflatable seals positioned on both side of the ring girder. The ring girder which is a circular metal plate structure resting on support beams that spans the open area between the reactor vessel refueling flange and the refueling cavity liner (Attachment 1). The ring girder structure is designed seismic Category 1. When the cavity seal is installed, the ring girder spans the majority of the three (3) feet eleven (11) inches opening, but leaves two inch nominal gaps on both sides for the pressurized inflatable seals.

To ensure that the ring girder is installed in the proper position on the support beams, guide plates are welded to the bottom of the support beam. When installed, the girder guide plates straddle the support beams. These design features assures that the cavity seal gap dimensions are established and remain constant for each refueling outage.

An inflatable seal is installed in the nominal two inch gaps on both sides of the ring girder. When inflated, the lower portions of the seals expand to press tightly against the reactor vessel refueling ledge and ring girder on one side, and refueling cavity liner and ring girder on the other side to form the water-tight seal.

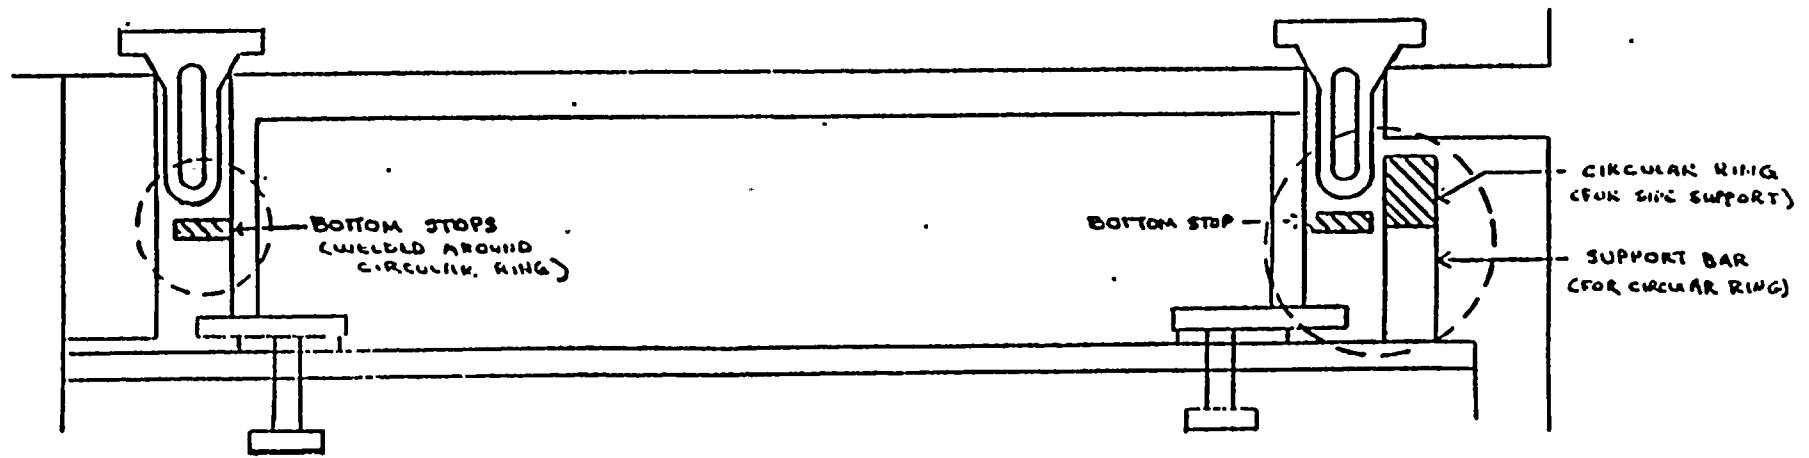
MODIFIED CAVITY SEAL DESIGN

To further reduce the possibility of a seal failure incident, the design has been modified to prevent the inflatable seal from pushing through the cavity gap as follows:

- 1) Metal plates have been welded around the side of the ring girder below the location of the inflatable seals and will act as "bottom stops" for the seals to prevent slippage down through the gap.
- 2) A circular metal ring welded to support bars which are attached to the cavity seal support beam provides additional surface for the inflatable seal to press against.
