REGULATORY INFORMATION DISTRIBUTION SYSTEM (RIDS)

SUBJECT: LER 91-008-01:on 910403,common causes failure of high head safety injection alternate miniflow.Caused by water hammer that apparently occurred because of air void.Supports added to test connection lines.W/910515 ltr.

SHEARON HARRIS NUCLEAR POWER PLANT UNIT 1
DOCKET NO. 50-400
LICENSE NO. NPF-63
LICENSEE EVENT REPORT 91-008-01

TITLE (4)
Common Cause Failure of High Head Safety Injection Alternate Miniflow

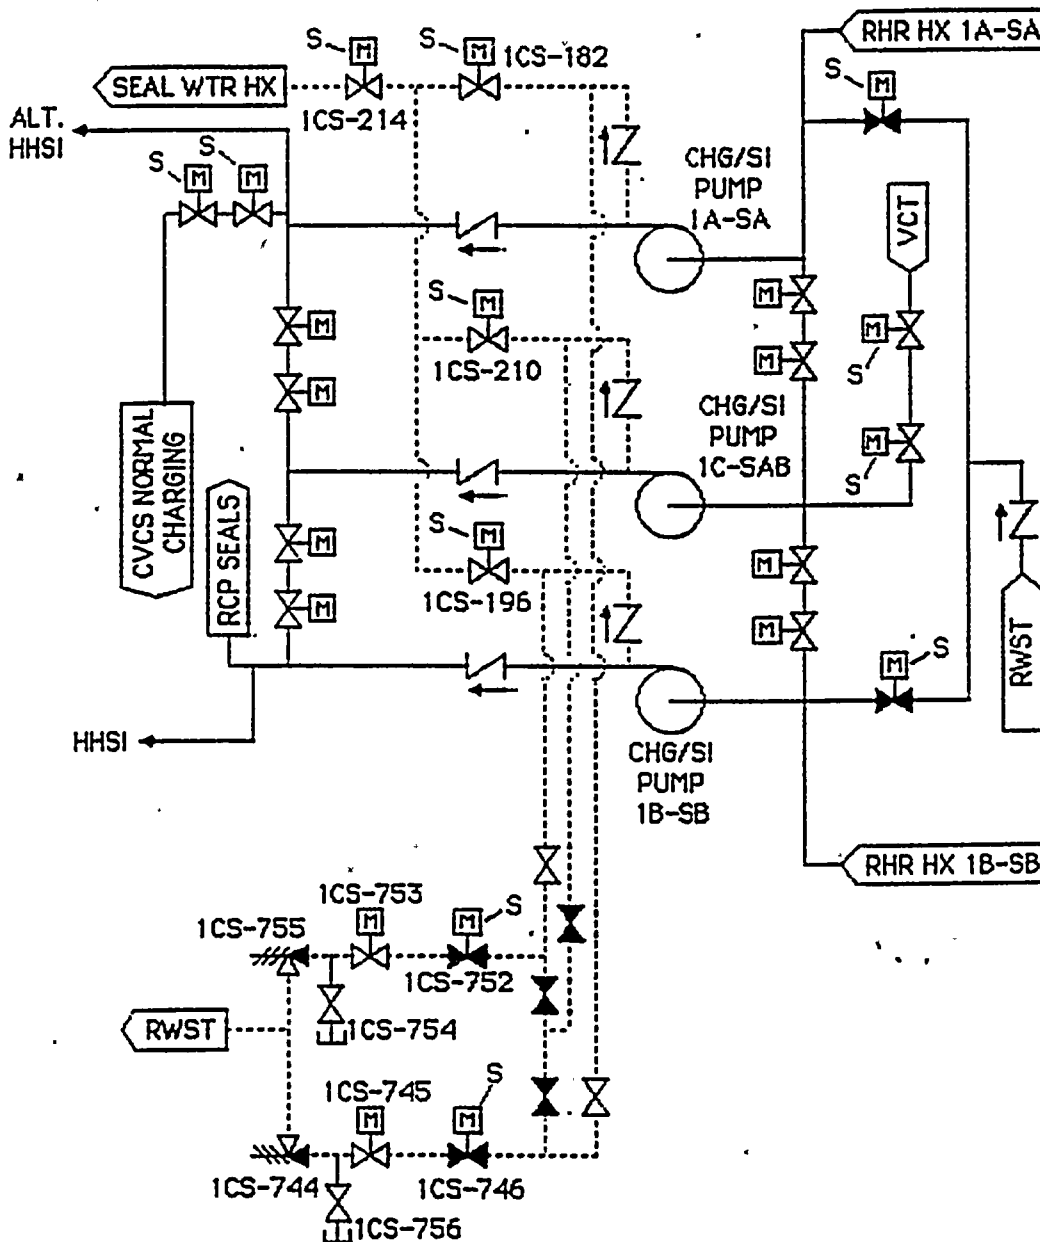
ATTACHMENT 1

The CSIPs provide charging flow and Reactor Coolant Pump seal injection during normal plant operation. While operating in this mode, the CSIPs are protected from pump deadhead operation by normal miniflow lines that are designed to provide a minimum flow of 60 gpm. During accident conditions, the CSIPs provide High Head Safety Injection to the RCS. While operating in this safety injection mode of operation, the normal miniflow lines are automatically isolated to ensure all safety injection flow is provided to the RCS.

If the plant accident is a secondary side break, safety injection will be automatically actuated. After the secondary side of the steam generator is dry, the excess heat removal would end and the RCS would repressurize. To prevent CSIP failure from deadhead operation in this event, an alternate miniflow is placed into service when the normal miniflow is isolated (see Attachment 1). This alternate miniflow path is through relief valves (1CS-744 and 1CS-755) which are set to open at 2300 +/- 69 psig and recirculate to the Refueling Water Storage Tank.

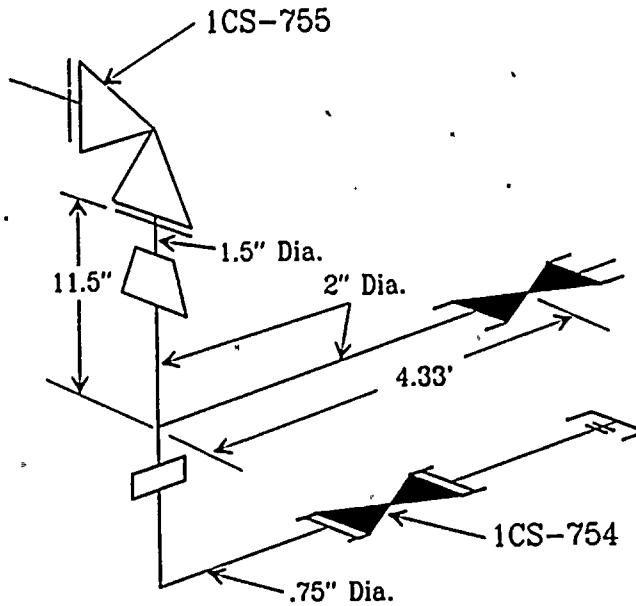
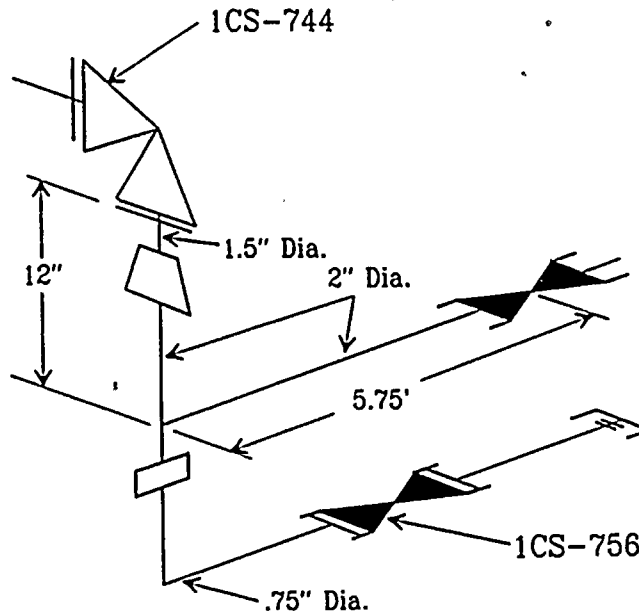
ATTACHMENT 2

The physical layout of the piping upstream of the alternate miniflow relief valves is shown in Attachment 2. This piping arrangement results in an air void being trapped below the relief valves when they are installed in the system. After the relief valves are installed and the clearance is removed, one of the upstream valves remains closed. This prevents water from refilling this piping. In addition, the piping upstream of the relief valves does not have a high point vent to remove the trapped air. Procedures are being developed to refill and vent this piping.

The cause of this event was water hammer that apparently occurred because of an air void that remained in the alternate miniflow lines following previous testing and maintenance. Previous to this outage, LCS-744 was tested in May 1989. At that time, the as found relief setpoint was less than one percent below the acceptable range.

- 2) Supports were added to test connection lines upstream of LCS-754 and LCS-756 to prevent future cracking.
- 3) Relief valves LCS-744 and LCS-755 are being rebuilt and will be retested, or replaced prior to entry into Mode 3.

- 4) Maintenance instructions for installation of these relief valves (LCS-744 and LCS-755) are being changed to refill the piping prior to installation and to vent the piping through the relief valves by hydraulic pressure following installation, thereby eliminating the air void.
