SUBJECT: LER 97-006-00: on 970318, breach was identified in Thermo-Lag fire barrier wall due to inadequate initial design, poor construction methods & incomplete as-built design. Visual insp of Thermo-Lag barrier walls performed. W/970417 ltr.

SHEARON HARRIS NUCLEAR POWER PLANT UNIT 1
DOCKET NO. 50-400
LICENSE NO. NPF-63
LICENSEE EVENT REPORT 97-006-00

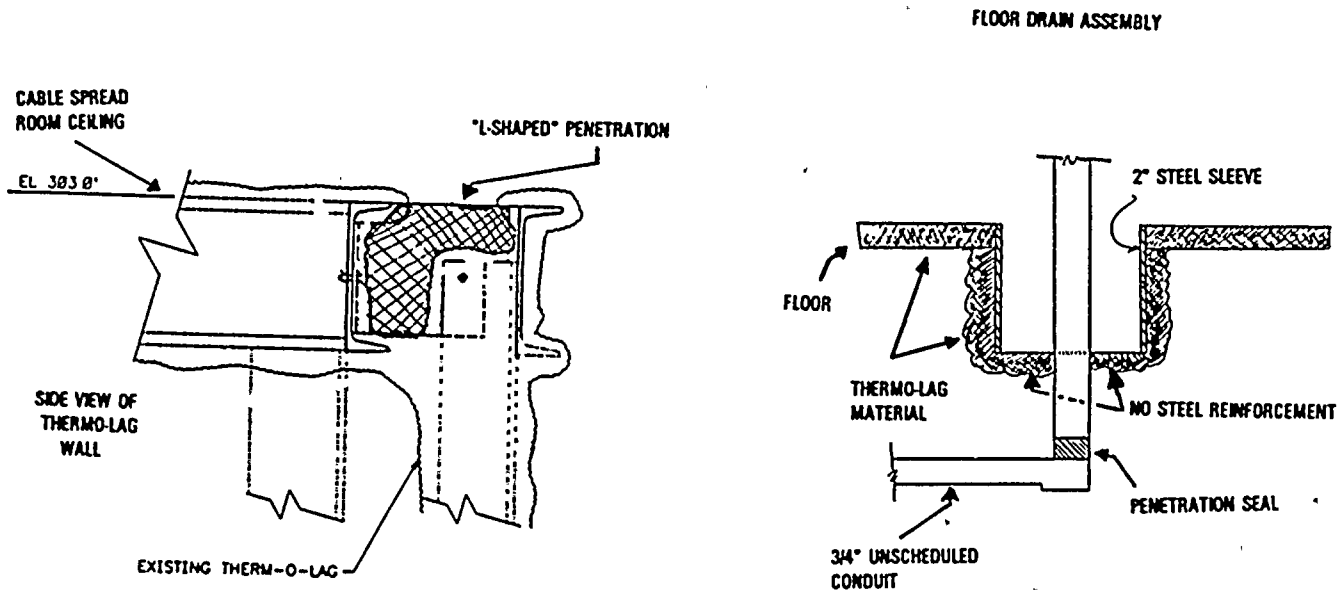
On March 18, 1997, with the plant operating in mode 1 at 100% power, a breach was identified in the thermo-lag fire barrier wall which provides separation between the A-train and B-train cable spread rooms in the reactor auxiliary building. This breach consists of a "L-shaped" hole approximately 8 inches wide by 6 1/2 inches high at the point where the fire barrier wall joins the ceiling. A 3/4 inch conduit containing two wire conductors was found penetrating the breach. These wires were unconnected at each end and investigation revealed that they were unscheduled and not included in the design of this fire barrier wall. The breach is very difficult to see due to its location and configuration, coupled with the fact that it is behind several cable trays. It was identified by maintenance personnel during modifications to the cable spread room fire barrier to resolve concerns expressed in NRC Information Bulletin 92-01 "Failure of Thermo-Lag 330 Fire Barrier System to Maintain Cabling in Wide Cable Trays and Small Conduits Free From Damage".

Follow-up investigation revealed an additional deficiency in the cable spread room thermo-lag fire barrier that involved a floor drain assembly at the base of the wall. This floor drain was initially installed to accommodate sprinkler water flow, but was later abandoned. During initial construction, an electrical conduit was installed through the floor drain penetration. The conduit was properly sealed and the sides of the steel floor drain assembly were covered with thermo-lag coating. However, the bottom of the floor drain assembly, which was also covered with thermo-lag coating, has no steel reinforcement and would not adequately perform as a 3-hour fire barrier. (Please reference the illustrations on page 3)

Investigation could not conclusively determine the cause for these conditions. The fire barrier breach and deficient floor drain assembly appear to have existed since initial plant construction and were most likely the result of inadequate initial design, as well as incomplete as-built design verification.

- Hourly roving fire watches were established for areas containing thermo-lag credited for safe shutdown capability. This was implemented in June 1992 as a result of NRC Information Bulletin #92-01.
- A visual inspection was performed on the breached fire barrier wall, as well as the other thermo-lag barrier walls located in the cable spread rooms and Auxiliary Control Panel room. These inspections were completed on April 10, 1997 and identified no other reportable discrepancies. (Other than the additional item described above.)
- The unscheduled 3/4 inch conduit was removed from the fire barrier breach on April 4, 1997.

- The identified fire barrier deficiencies will be resolved by an existing Engineering Service Request (ESR #95-00715) for penetration upgrades by September 15, 1997.
