# Analysis of Incomplete Control Rod Insertion at Browns Ferry 3

**NSAC-20/INPO-3**

**December 1980**

Keywords: Browns Ferry 3, Incomplete Control Rod Insertion, Water Accumulation In SDV, Common Mode Failure of Scram Systems

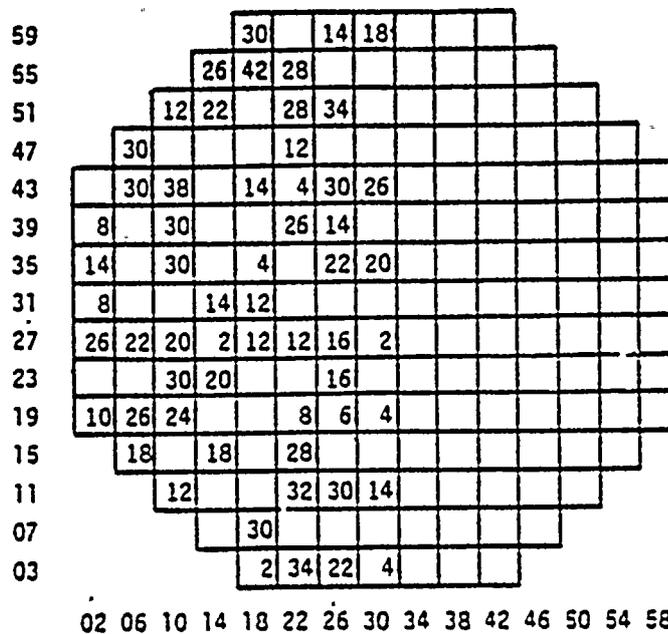
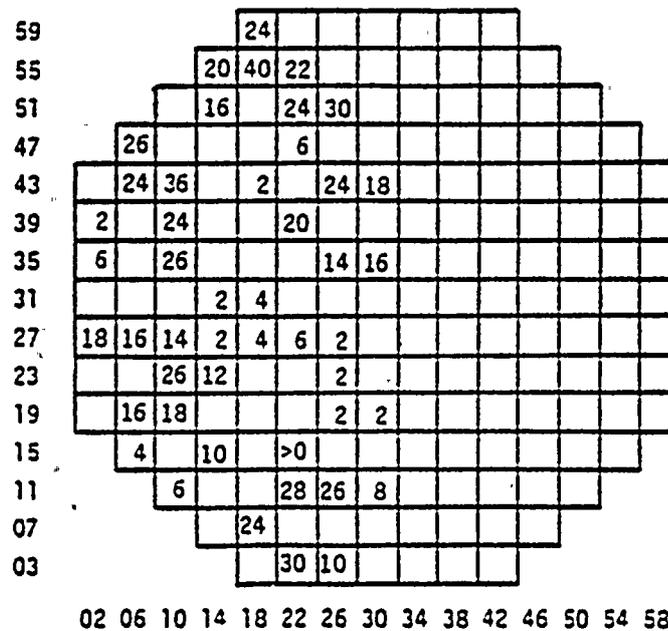
Figure SOE-4. Control Rod Positions

PRIOR TO SCRAM #3

AFTER SCRAM #3
