SUBJECT: Interim deficiency rept re unsupported anchors between concrete floors & equipment base plates, initially reported 801107. Caused by unfilled annular space between pipe shim & anchor. Use of Shims around anchors will be discontinued.

SUSQUEHANNA STEAM ELECTRIC STATION  
INTERIM REPORT OF A DEFICIENCY  
RELATING TO SHIMMING OF BASE PLATES  
ERs 100450/100508      FILES 840-4/900-10  
PLA-586

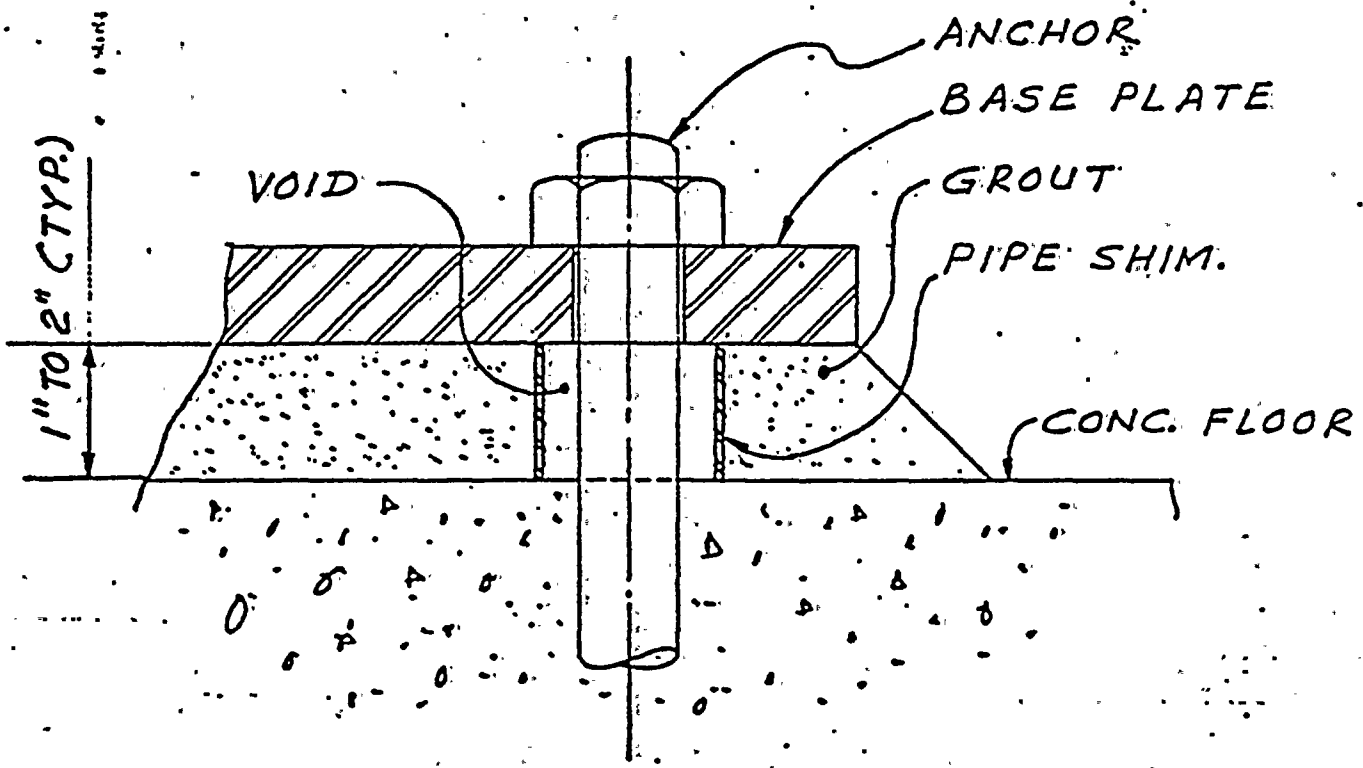
FIGURE 1

Bechtel Engineering became aware that pipe shims have been used around anchors between concrete floors and base plates. These were used for setting and leveling of the base plates of various types of supports. The majority of the existing base plates have been already grouted, however, the annular space between pipe shim and the anchor is not filled (See Figure '1'). The grout thickness (and also the height of the pipe shim) generally ranges between one and two inches. As the anchors are unsupported within the height of pipe shims, their shear capacities may be significantly reduced.

- a. Developing an analytical method for engineering evaluation.
- b. Removing pipe shims, where base plates are not grouted.
- c. Filling the annular space with an approved material.

Bechtel field personnel are currently developing a field procedure for undertaking the inspection program necessary to resolve the use of pipe shims around anchors. The inspection is scheduled to commence in December 1980. Additionally, the field has established the feasibility of filling the void shown in Figure 1 with grouting material.

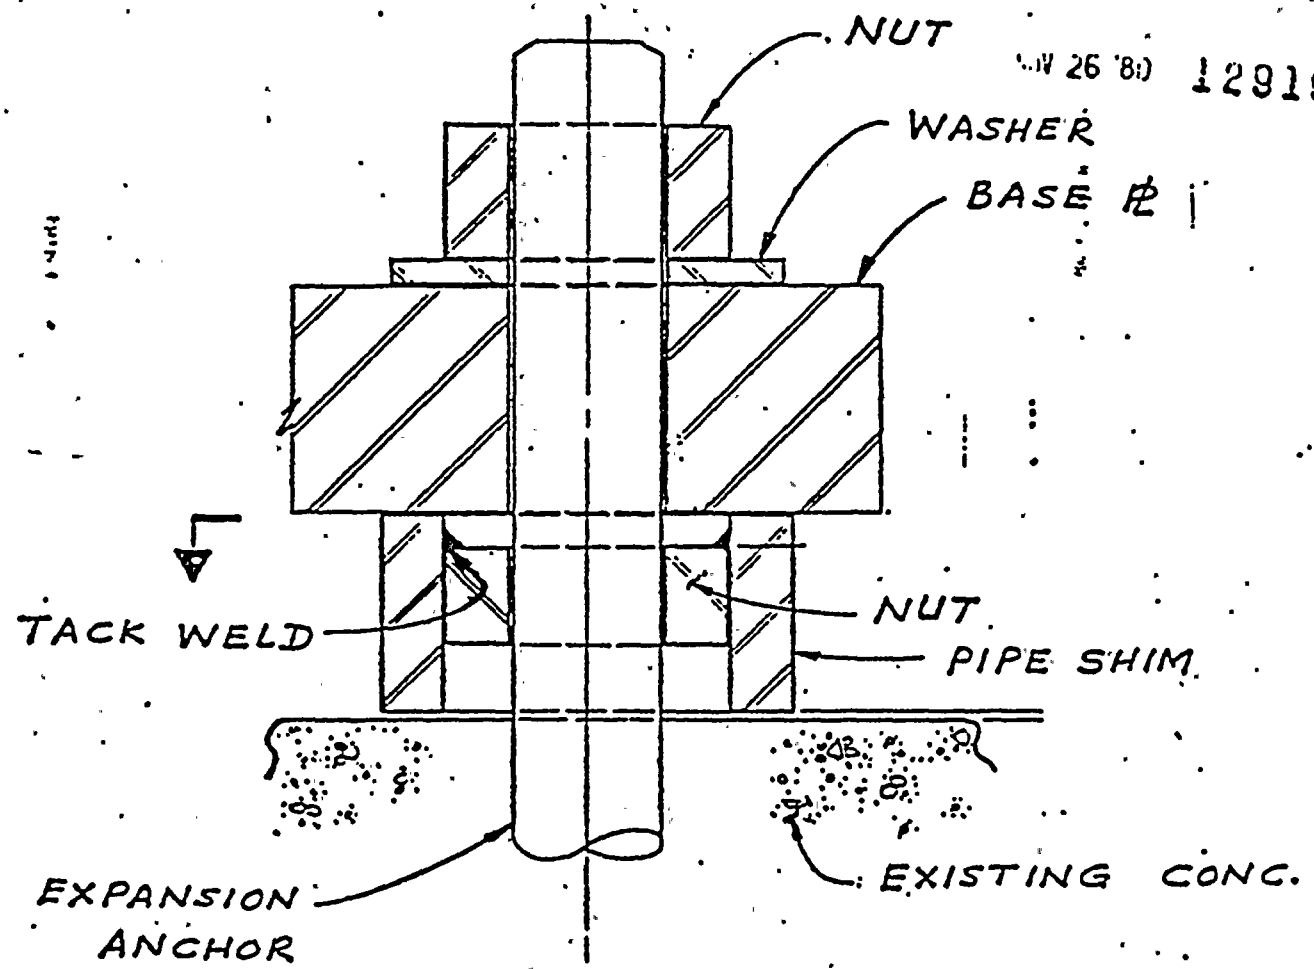
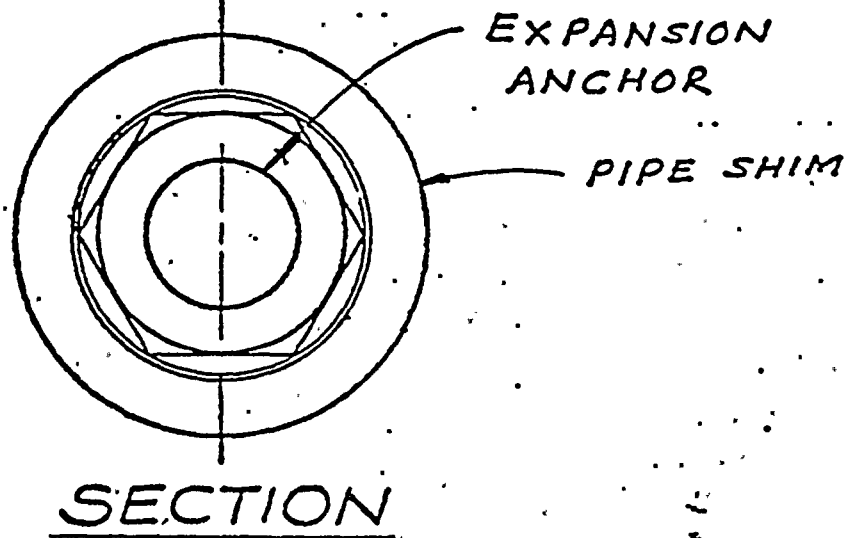
FIGURE 2

In addition to the above condition, on a few floor mounted pipe supports, it was observed that a nut was placed within the pipe shim and tack welded. (See Figure '2') This condition may have an adverse impact in developing and verifying required installation torque/prestress in the anchors.

An inspection and remedial program is presently being planned which will deal with the tack welding of leveling nuts inside pipe shims (Figure 2).
