DESCRIPTION OF DISCREPANCY

NCR-5241 was issued on 1/25/80 to identify a noncompliance to Specification M213, Revision 7, related to small pipe hanger installation. Hanger 19 on Hanger Iso Drawing SP-DCA-137-4H, Revision 0 was not installed in the orientation and location intended by the design engineer. Item 2 (4" x 10 1/2" x 6" plate) identified on Standard Detail SPA 804 was welded on the Reactor Pressure Vessel (RPV) instead of being installed on the Biological Shield liner plate.

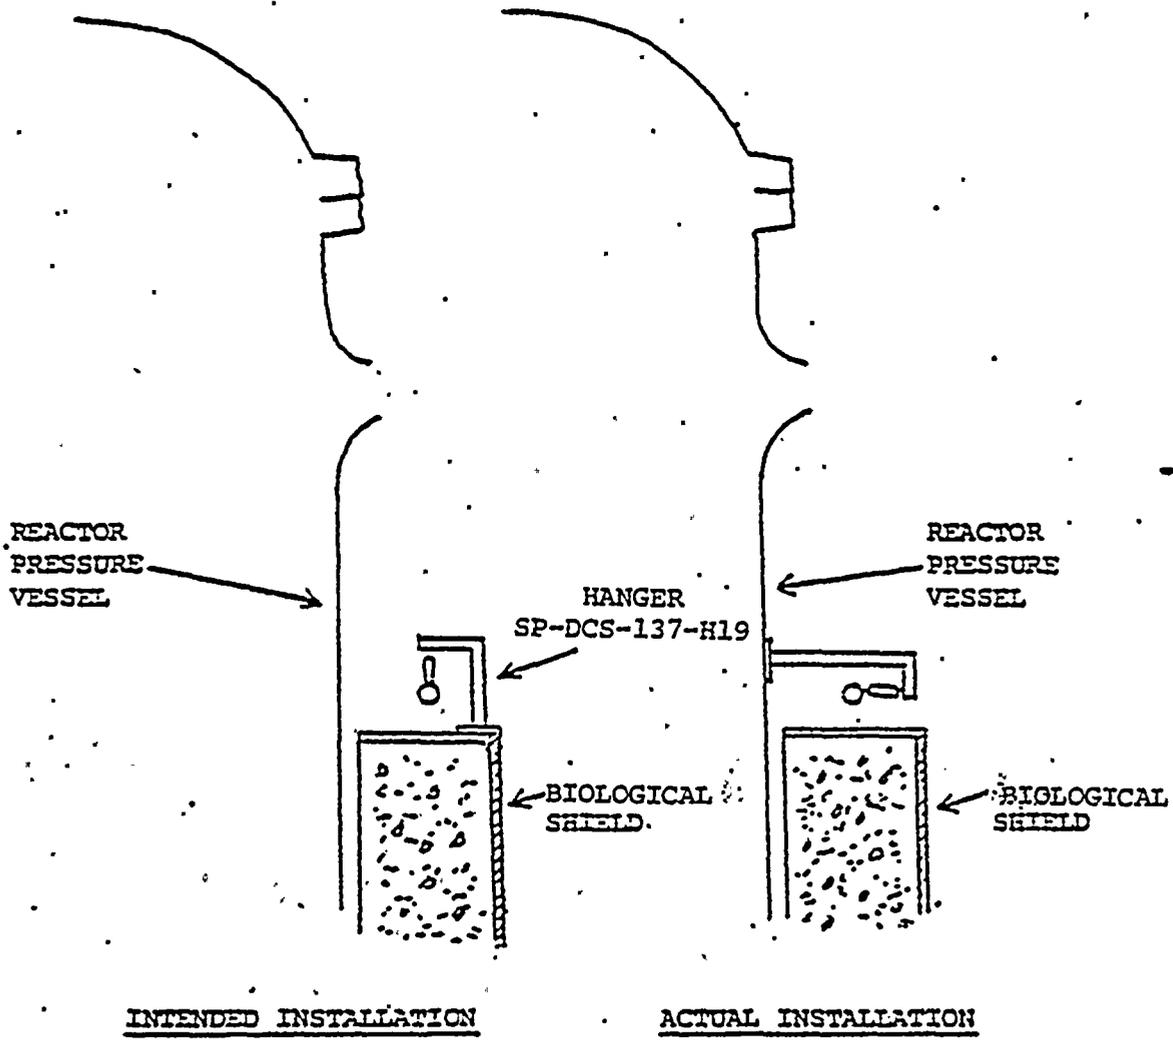
FIGURE 1.

1. The causes contributing to this deviation were determined to be human error compounded by the fact that the construction drawings were unclear. The installation orientation was misinterpreted by both the installers and the responsible Field Engineer, resulting in improper mounting of the pipe support in a horizontal position rather than vertical (see Figure 1.) This involved welding the pipe support to the RPV rather than attaching it to the top of the Biological Shield as the designer intended.

Thickness measurements by means of UT have been taken of the RPV wall where Hanger H19 had been attached by welding. They indicate an existing minimum wall thickness of approximately 6-7/16 inches (excluding cladding thickness) vs. a minimum specified wall thickness of 6-3/16 inches. This provided sufficient excess wall to permit removal of the weld and heat-affected zone without need for a weld repair. Blending and NDE of the RPV surface was all that was required for the final disposition of FDDR-KRL-193.

In response to NCR-5241 and Bechtel letter M-1-1397 dated January 31, 1980, General Electric issued FDDR-KRL-193 to cover removal of the hanger and attachment weld and to remove the heat-affected material from the RPV surface. Following completion of this portion of the work, as-built data of the vessel surface and wall thickness were forwarded to GE/NEBG for final dispositioning of the FDDR and NCR.

The Field initiated FCI-M-180 to describe this ASME Section XI repair of the vessel surface and its approval by PP&L (including PP&L's ANI), GE/NEBG and Bechtel was obtained by June 30, 1980. Completion of the initial work, submittal of the as-built data, reissuance of FDDR-KR1-193, and reapproval of FCI-M-180 by all applicable parties was accomplished by July 7, 1980. Also, completion of the repair, close-out of NCR-5241 and submittal of final as-built data to GE/NEBG was accomplished by August 7, 1980.
