SUBJECT: Interim deficiency re potential deficiency in amphenol connectors & Cutler Hammer E-30 switches. Defective conditions not fully analyzed for safety implications. GE 791210 ltr encl.

SUSQUEHANNA STEAM ELECTRIC STATION
UPDATE IN THE STATUS OF POTENTIAL DEFICIENCY IN
AMPHENOL CONNECTORS AND CUTLER HAMMER E-30 SWITCHES
ERs 100450/100508 FILE 840-4
PLA-438

SUBJECT: SUSQUEHANNA 1 & 2
DEFECIENCIES IN AMPHENOL CONNECTORS AND ELECTRO SWITCHES

SIZE 16 AMPHENOL PIN RETENTION

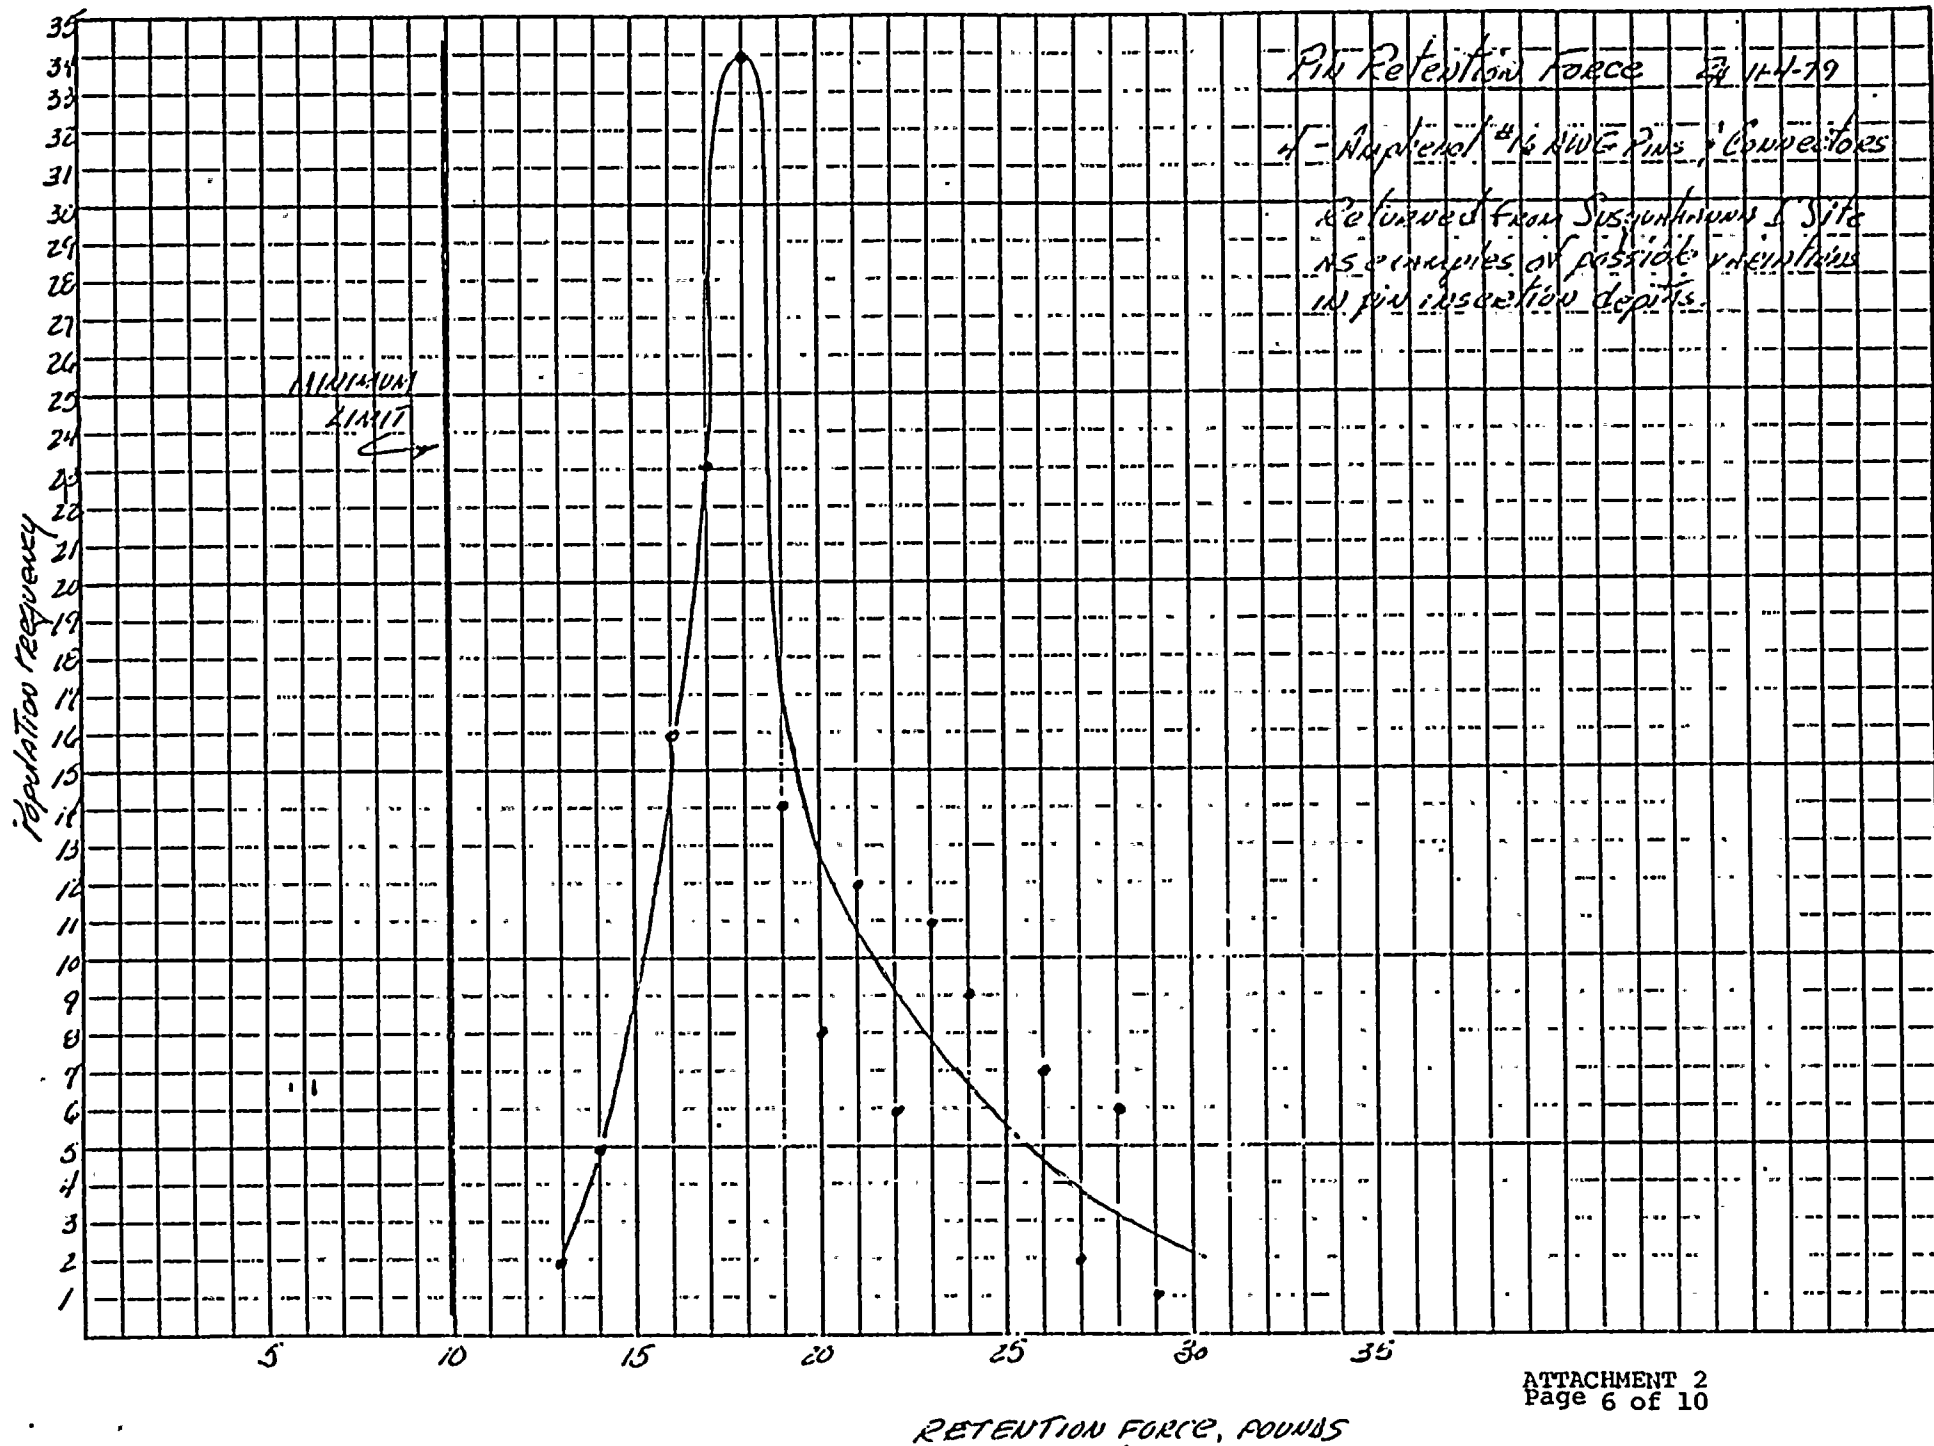
Appendix A

Extraction Force vs Population histogram is attached as Appendix "A". Every pin in each connector was tested.

- A. All pins evaluated for pin retention values (size 16 contacts) in the four (4) tests (above) were found acceptable and no site action is required (except as noted in B below).

Acceptance Criteria	10 lbs. minimum
Minimum Value Tested	10.5 lbs.
Mean Value Tested (Test A, B, & D)	20.9 lbs.

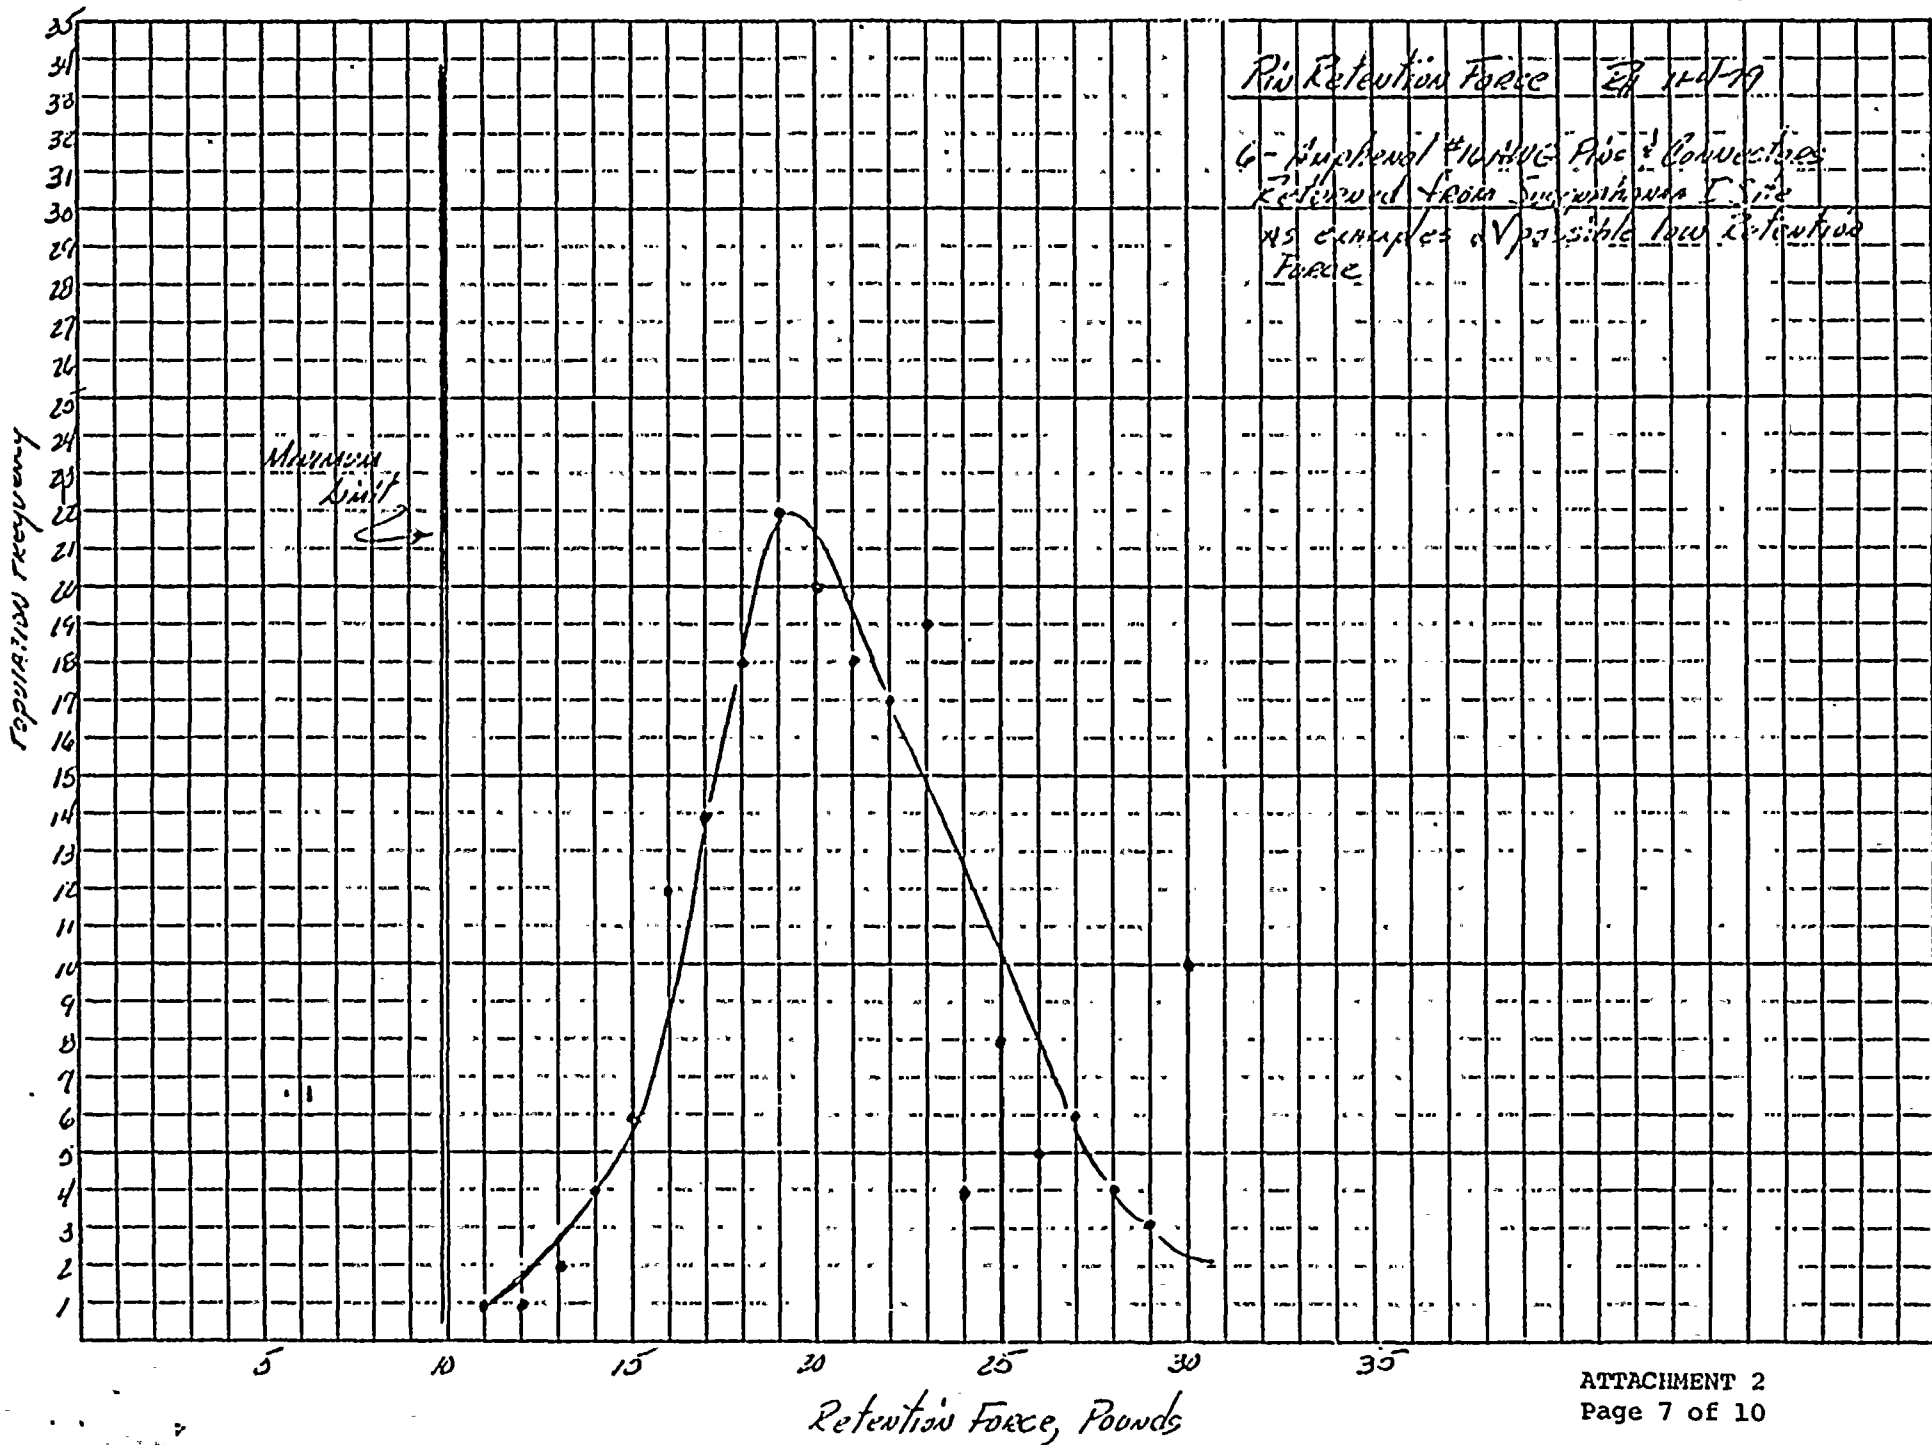
Appendix "B"

An Extraction Force vs Population histogram is attached as Appendix "B". Every pin was tested.

- B. All six of the Test B connectors (rejected during site inspection of pin crimps strength) were expected to have a least one pin each with a retention value under eight (8) pounds if they were assembled with a 20AWG cable. Three of the six connectors were 48-pin size, all of which have 20AWG cables. The fact that they did not have low values suggests that some electricians are pulling with a greater force than specified or that some Ametek L-30 spring testers are not set or calibrated correctly. Both of these possibilities should be investigated at the site, with corrective action taken as appropriate.

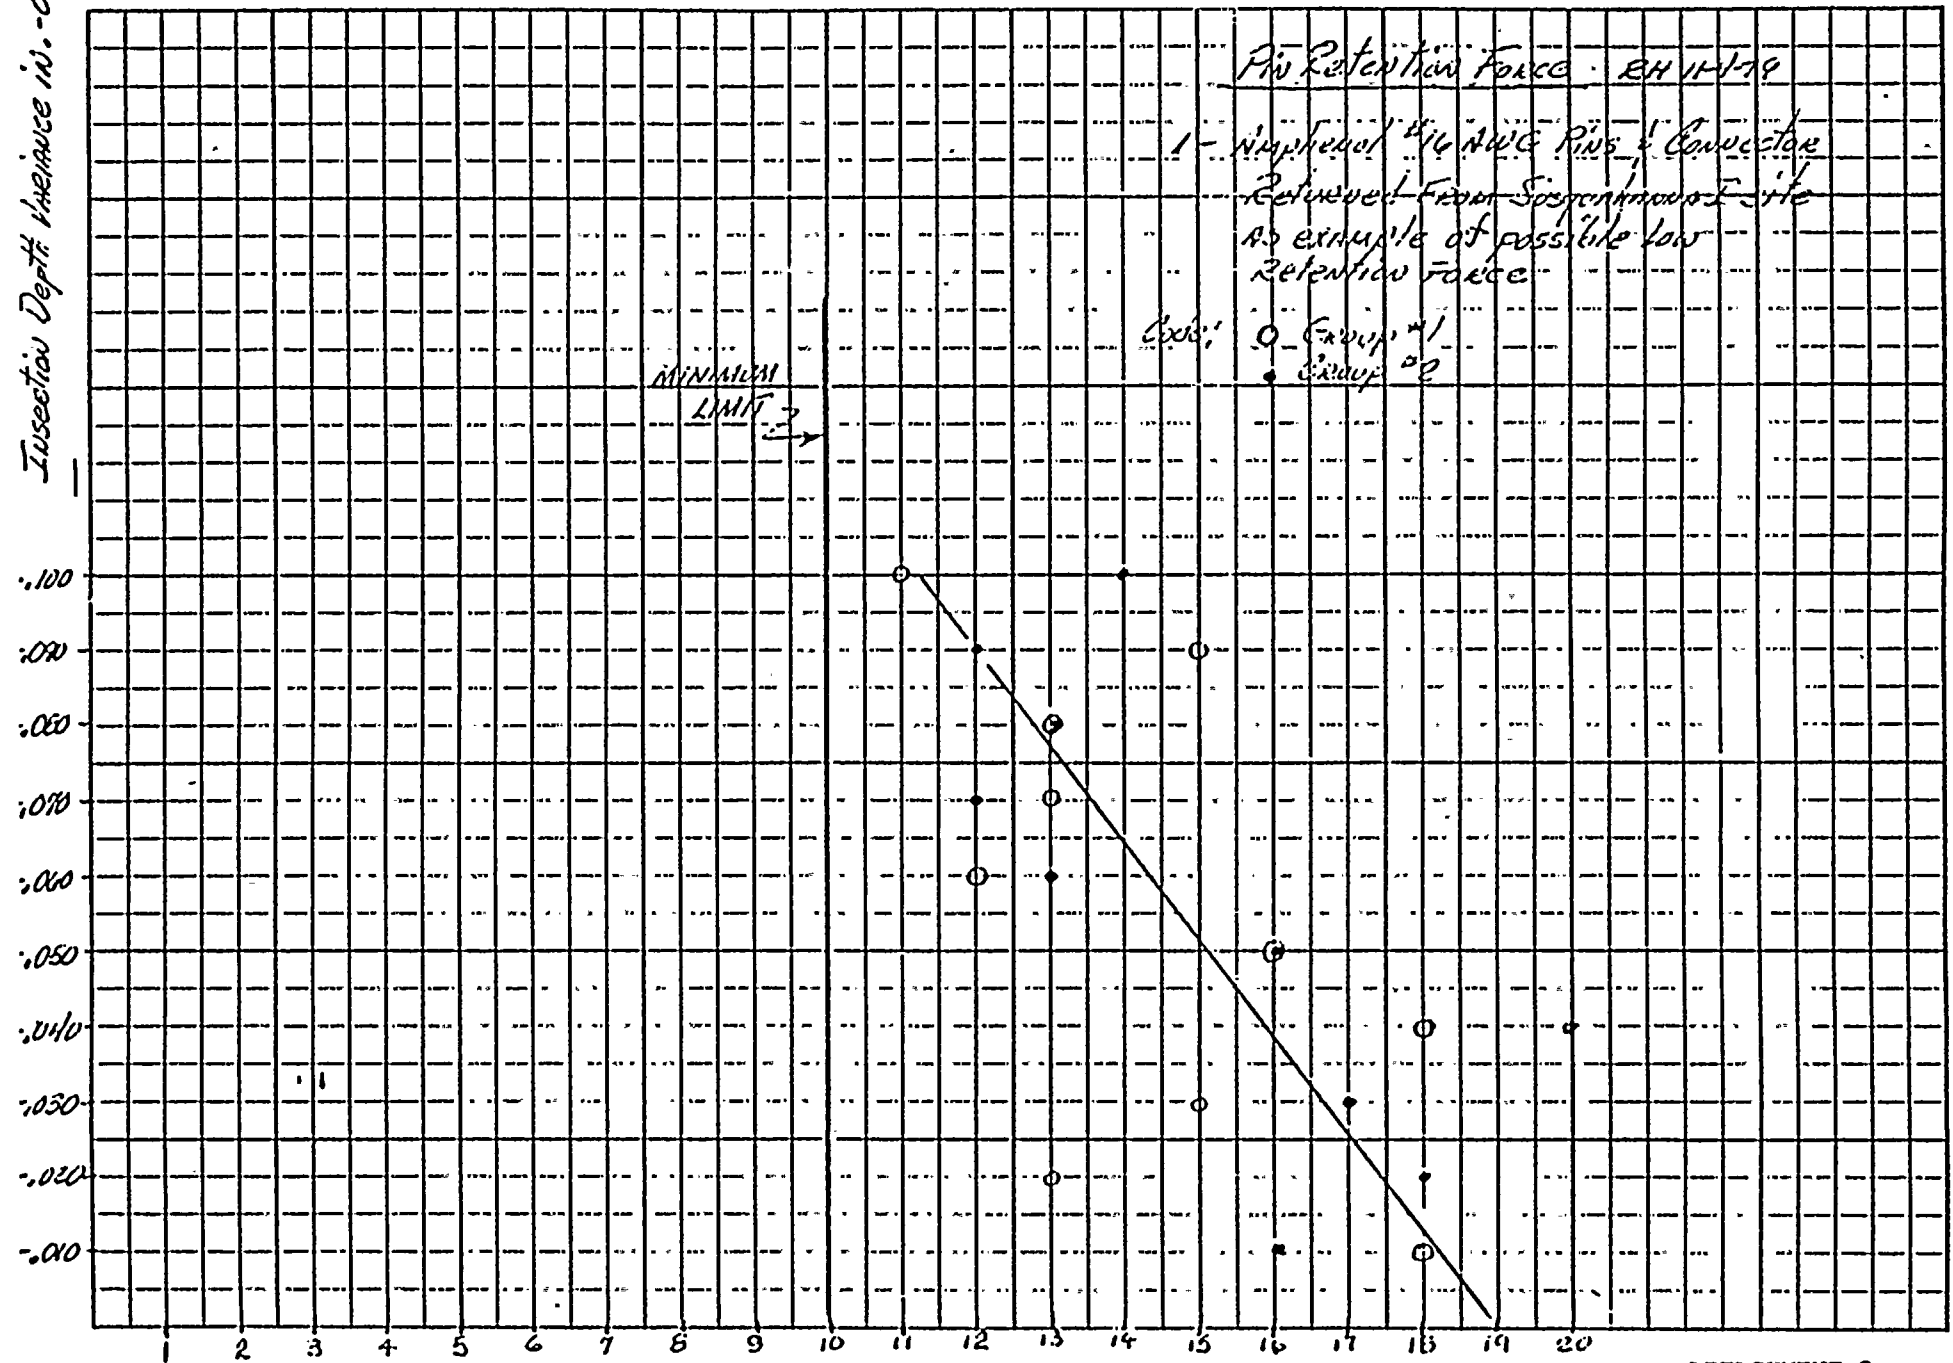
Appendix C

Extraction Force vs Depth histogram attached as Appendix "C".

The test demonstrated that pins inserted to less than the full specified depth did have substantially lower retention forces but were still above the required ten (10) pounds. The results varied from 11 pounds for a pin backed out 0.100" to a maximum of 20 pounds for pins backed out to a smaller degree (See Appendix C).

Our conclusion is that the locking collar aids pin retention but is not necessary to meet the minimum requirements of the MIL-STD.

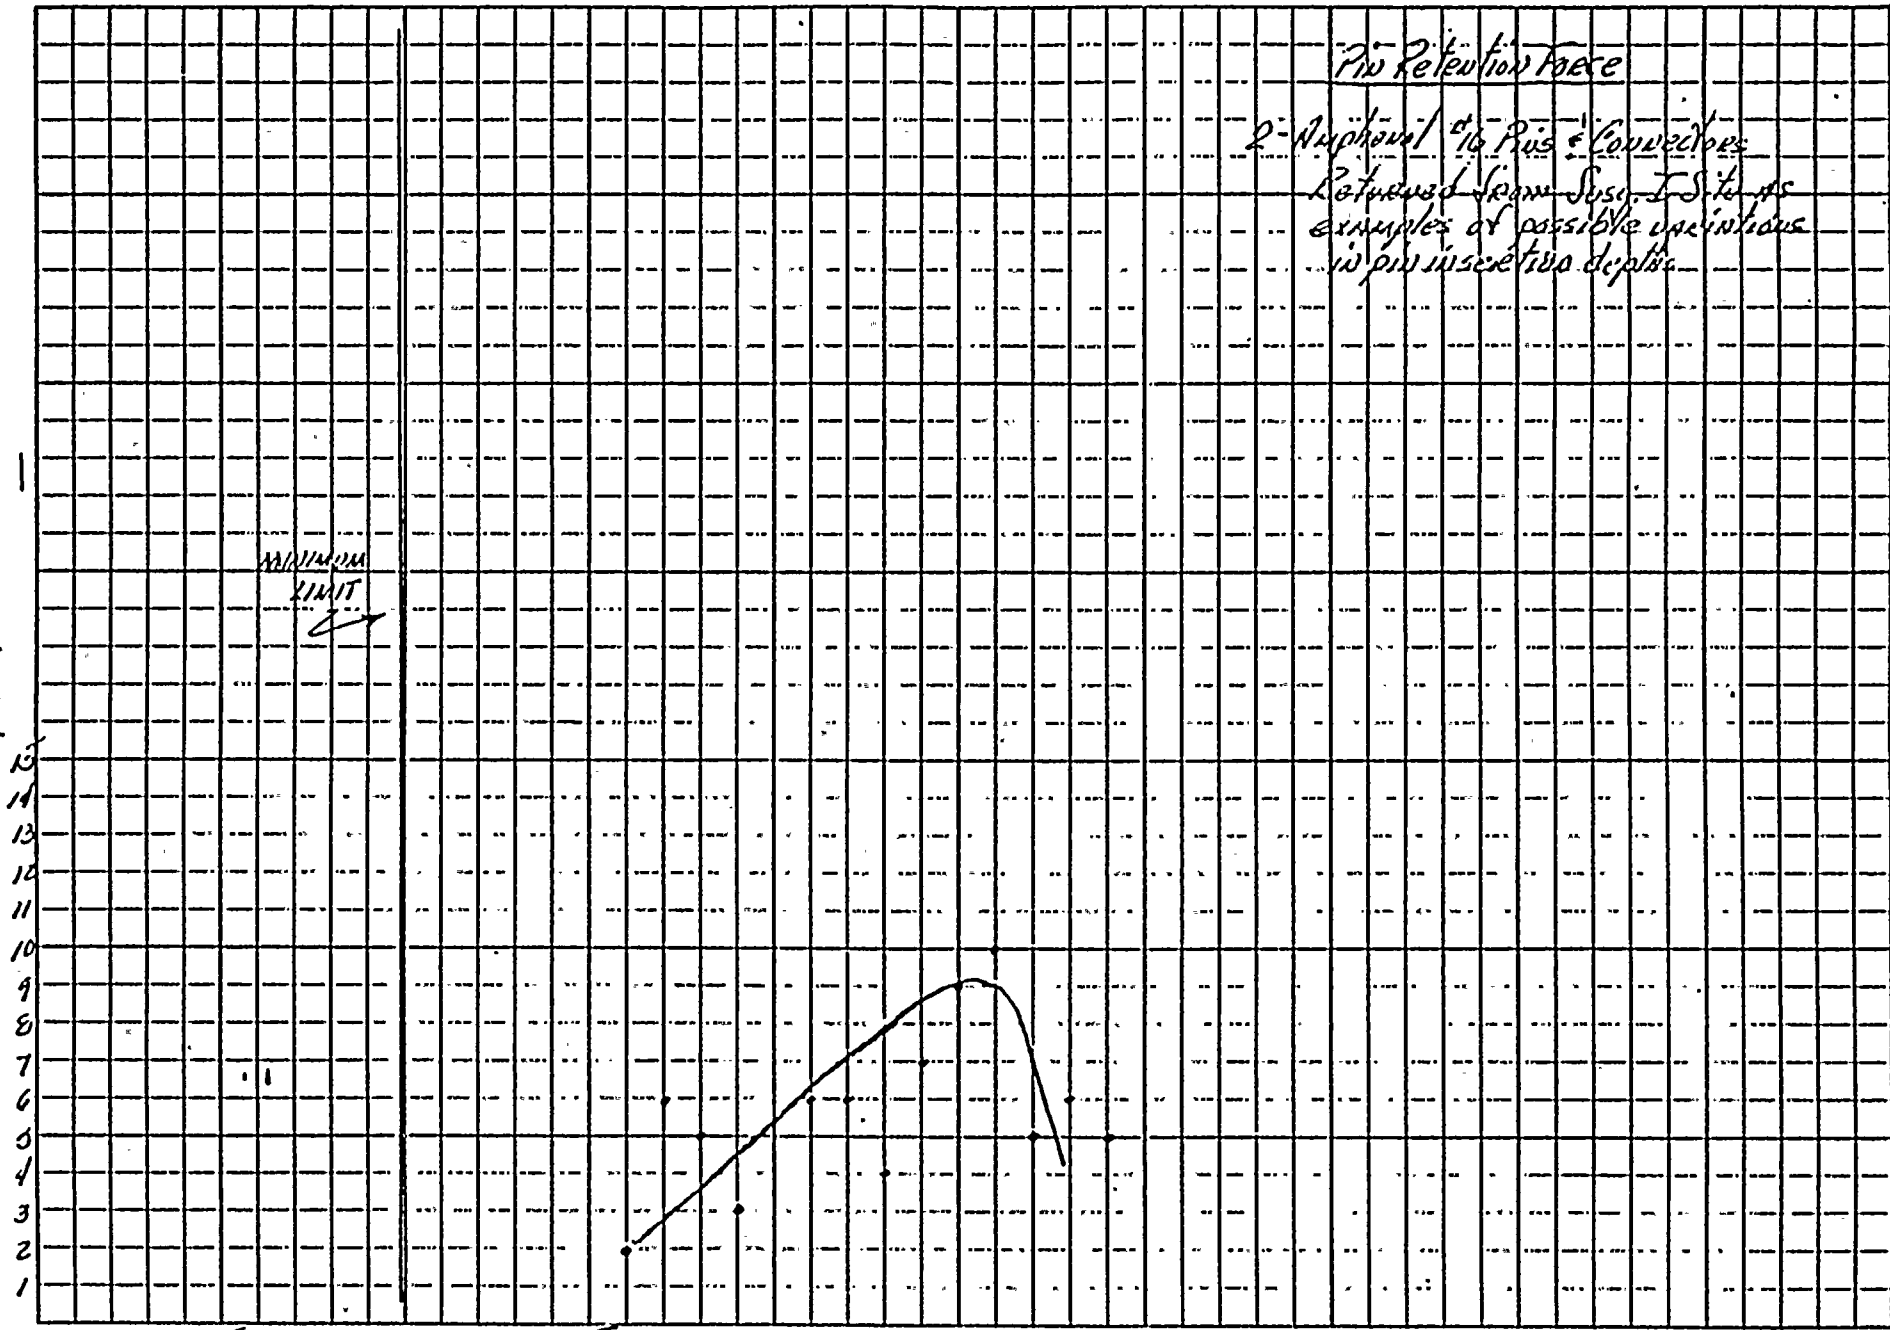
Appendix "D"

- D. These three connectors were received from the site in mid-November and the issue of this report was delayed to incorporate the results from them. There were six (6) pins in one (1) connector found to be recessed more than the allowed fifty thousandths of an inch (.050") as received. None of these pins showed low retention force as previously suspected.

All the pins in the three (3) connectors met the minimum acceptable ten pound (10 lb.) retention force requirements by a wide six pound (6 lb.) margin. Some pins were bent but none to a degree which interfered with the mating connectors or which caused any noticeable vertical movement when mated.

2-Naphthol to Pins & Connectors
Retrieved from Susq. T. Site as
examples of possible variations
in pin insertion depths.

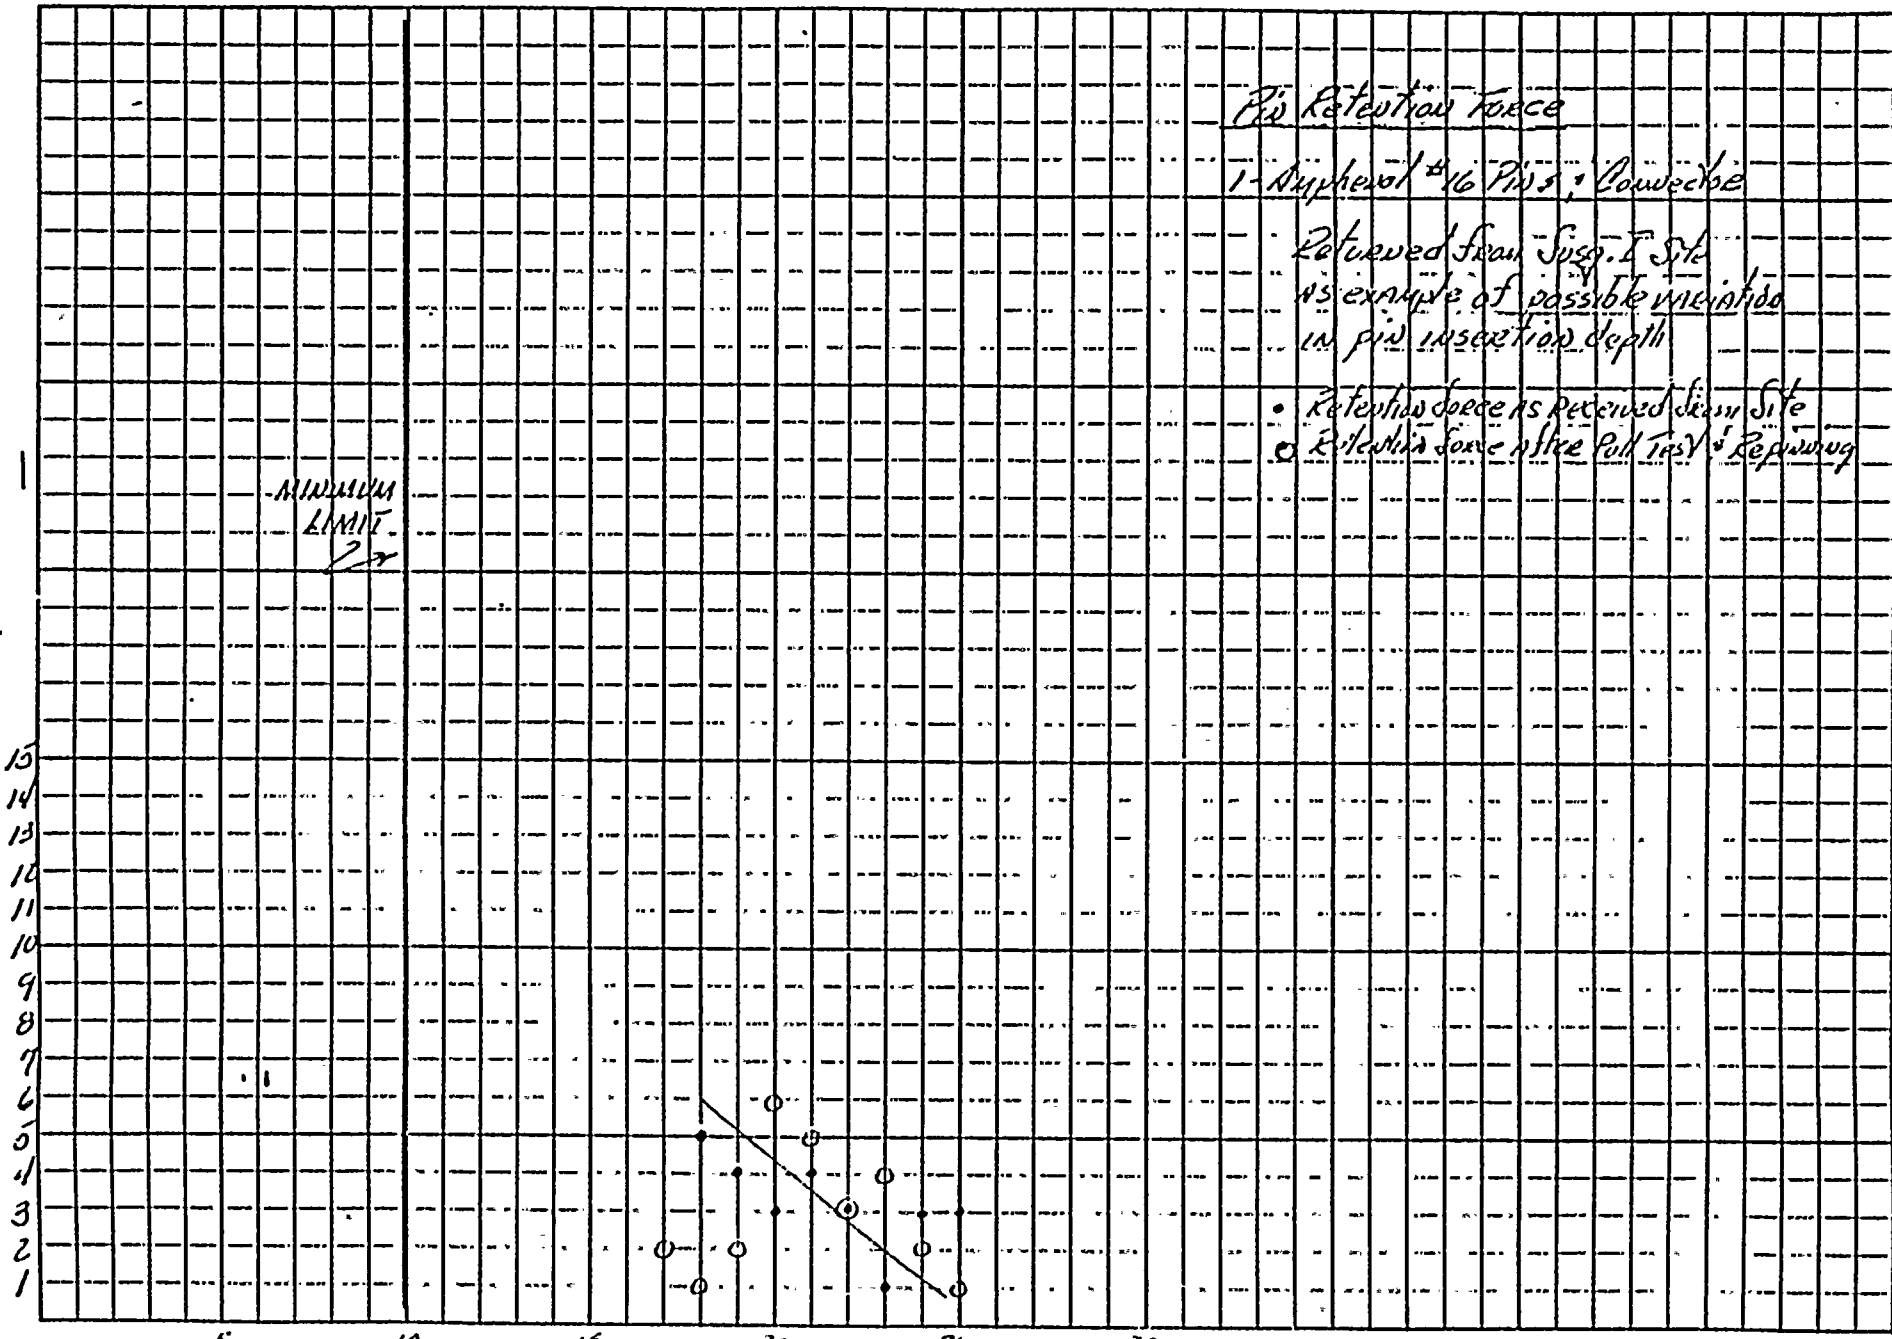
Appendix 5

This particular connector was of interest because the pin location of the conductors required a "basket weave" to get them from their location in the cable to their required location in the connector. After the first extraction test of this cable, a shop operator was asked to repin the connector to the original configuration. She admitted having a difficult time with one pin but was successful in achieving evenly seated pins. This connector had been reworked at the site prior to being cut off and returned to San Jose. It is probable that the six uneven pins were due to difficulty experienced in assembly by a less experienced electrician after site reinspection.

Probable cause of pin seating nonconformance was due to causes not related to these connectors (i.e. damaged mating connector, errors during assembly or rework at the site, etc.).

Retrieved from Susq. I Site
as example of possible variation
in pil insertion depth

- Retention force as received from site
- Retention force after Pull Test & Repriming
